Slippery External Walkway

Mr Darren Teo, Ms Adeline Chin
KKH Facilities Management

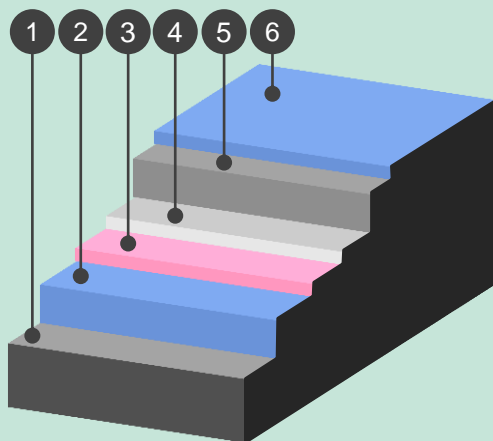
New floor finish layering

- Existing RC (*Reinforced Concrete*) slab
- GEO foam – substitute product to fill up floor level to desired height instead of using cement and sand.
 - Insulation enhancement
 - Low water absorption
 - High compression strength
 - Energy saving
 - Easy to install
 - Light weight
- Separation layer
- BRC (*Bar Reinforced Concrete*) layer
- Cast in-situ cement & sand
- Floor finish layer

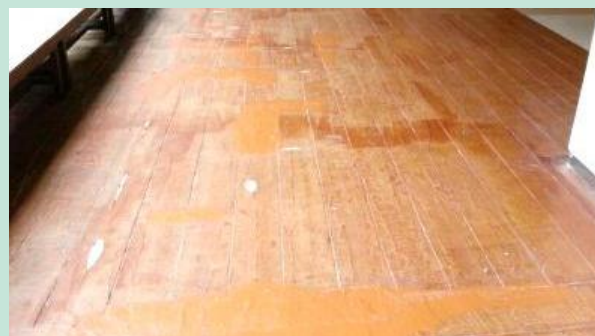
Previous flooring condition

Previous coloured cement screed finish flooring crack easily, requiring constant repair works, and causing unevenness to floor colour.

Slippery during rainy day. House keeping team need to lay rubber mat and warning sign to prevent slip & fall and remove it after the rain.
