Introduction:

Objective:

The aim is to work with all relevant stakeholders to identify the shortfalls in transportation of liquid nitrogen vessels and to improve on the work conditions and emergency response measures.

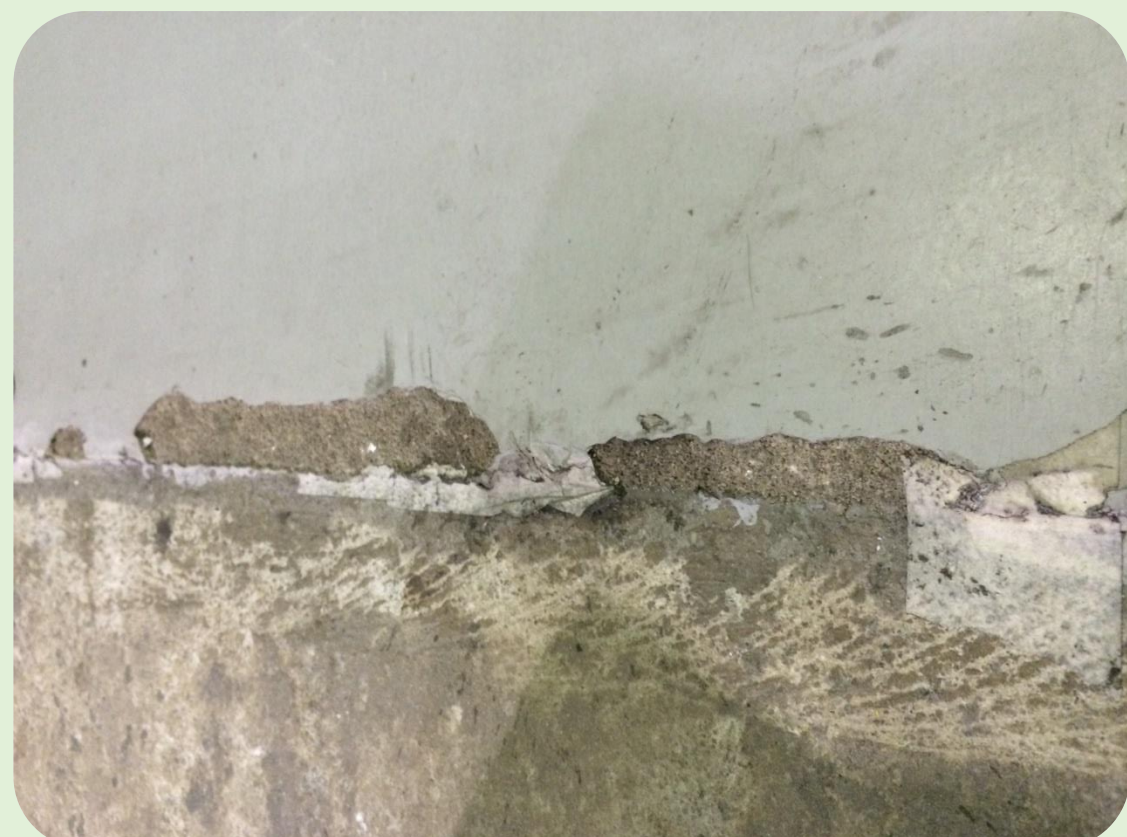
It was discovered that although the designated route by-pass the common human traffic, it was so heavily utilized that damages in the form of cracks and holes on the cement floor had developed. This had caused the wheels of the vessel to get stuck and toppled when maneuvered. Therefore, it is crucial to inspect the transportation route frequently and any damages to the flooring should be reported for repair as soon as possible. The imperfections on the floor of the transportation route was identified and repaired.:

Before: Cracks and holes of flooring that can caught the wheels and cause vessels to topple.

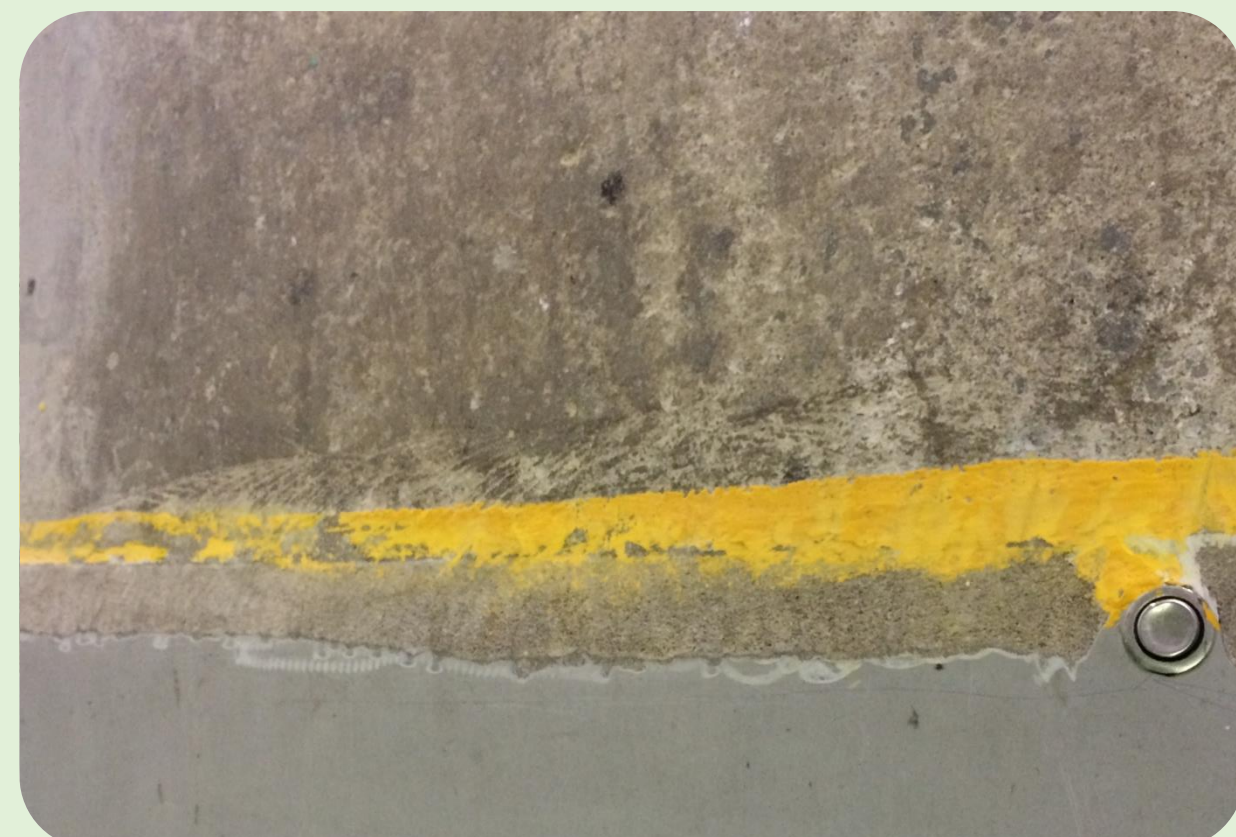
After: Damaged flooring repaired. Yellow lines drawn to mark elevated grounds.

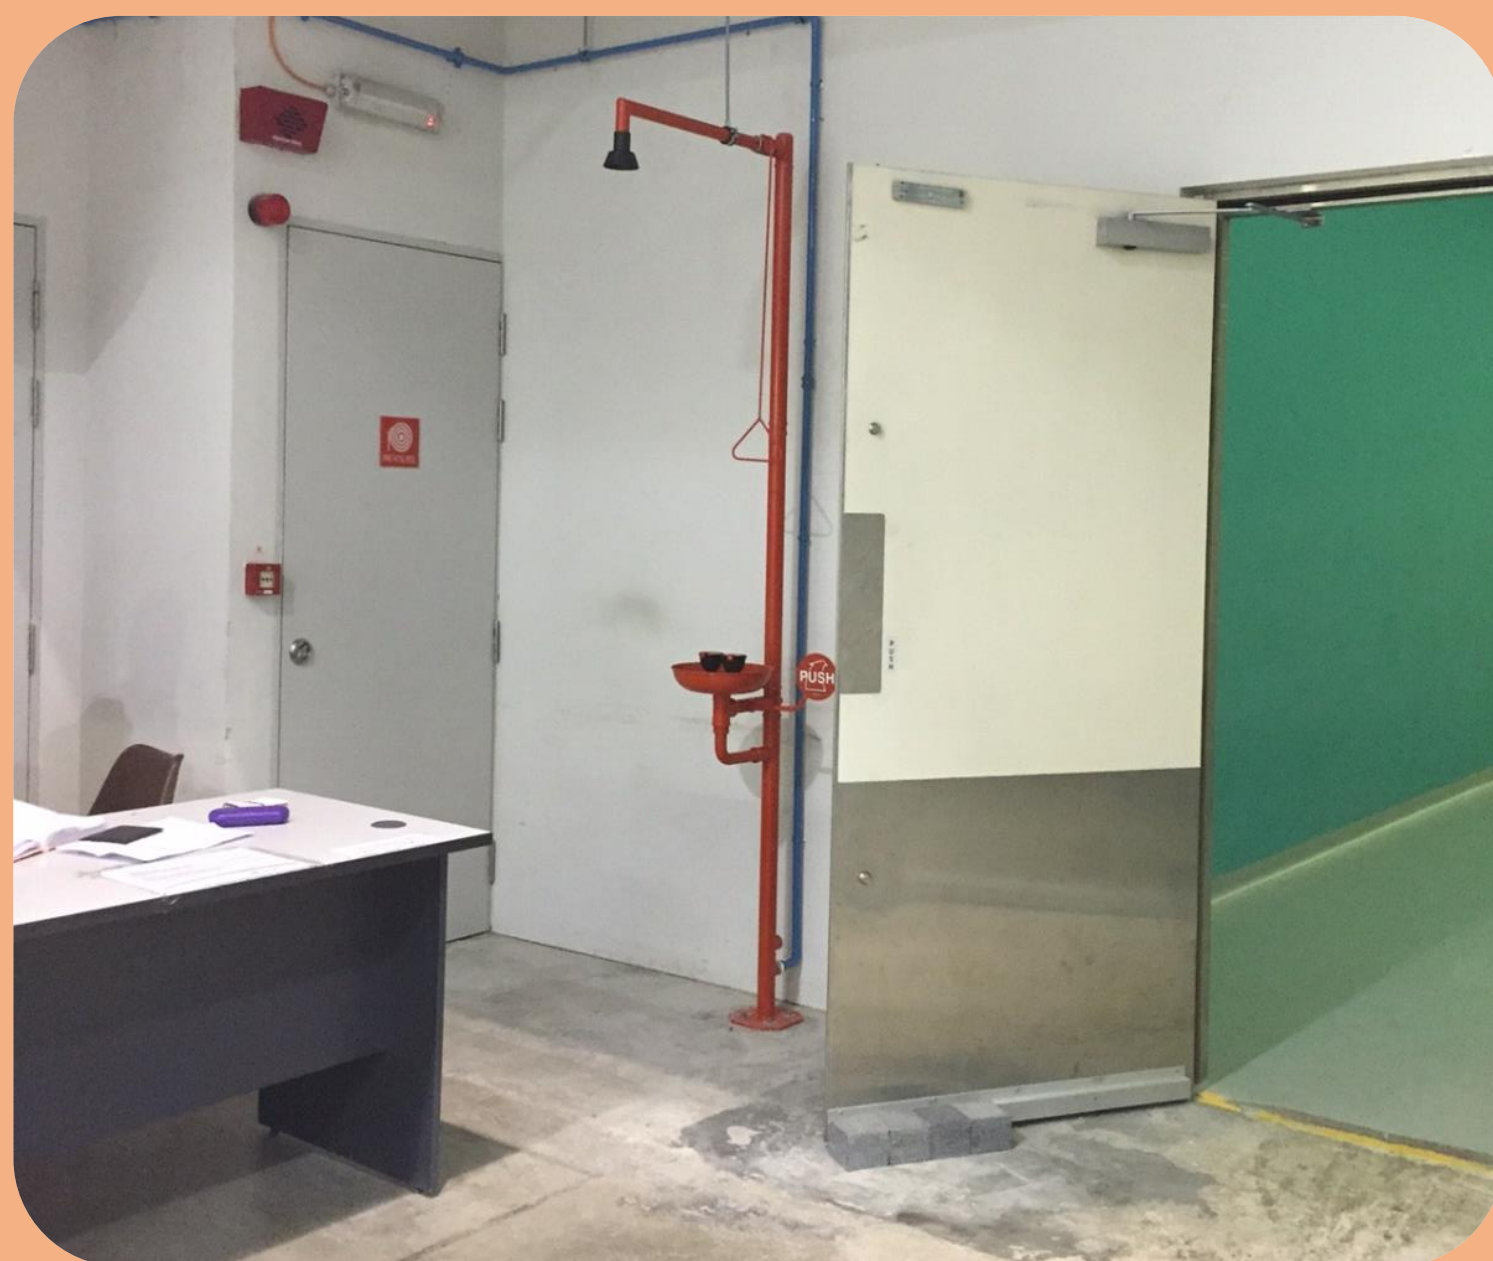
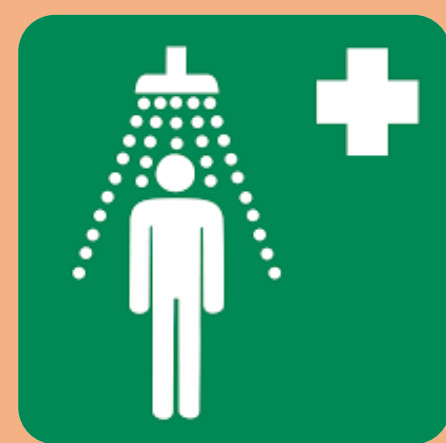
The liquid nitrogen spillage incident at Academia prompted the safety team to look into the emergency response features available along the transportation route. It was discovered that the designated topping up area – the loading / unloading bay, was not equipped with flushing facilities. The area also serves as the main entrance point where chemicals will be delivered by vendors. The flushing facility would facilitate the flushing off of chemical spillages on the body. Working with SGH Facility Department, an emergency shower was installed at the loading unloading bay.

Emergency shower installed at site near where refilling of liquid nitrogen will be carried out.

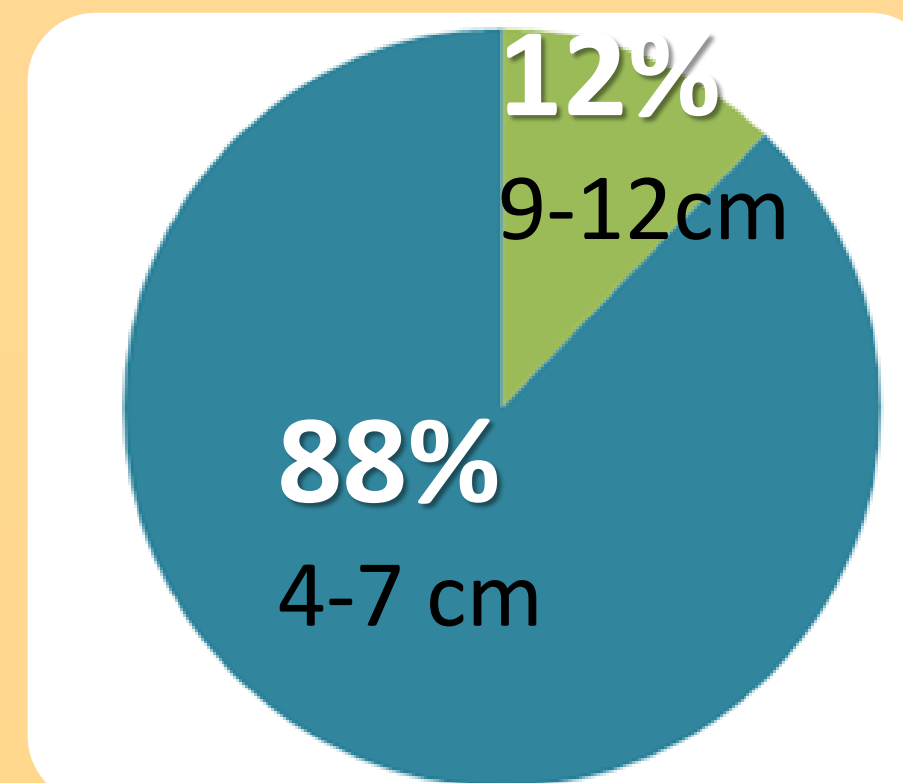
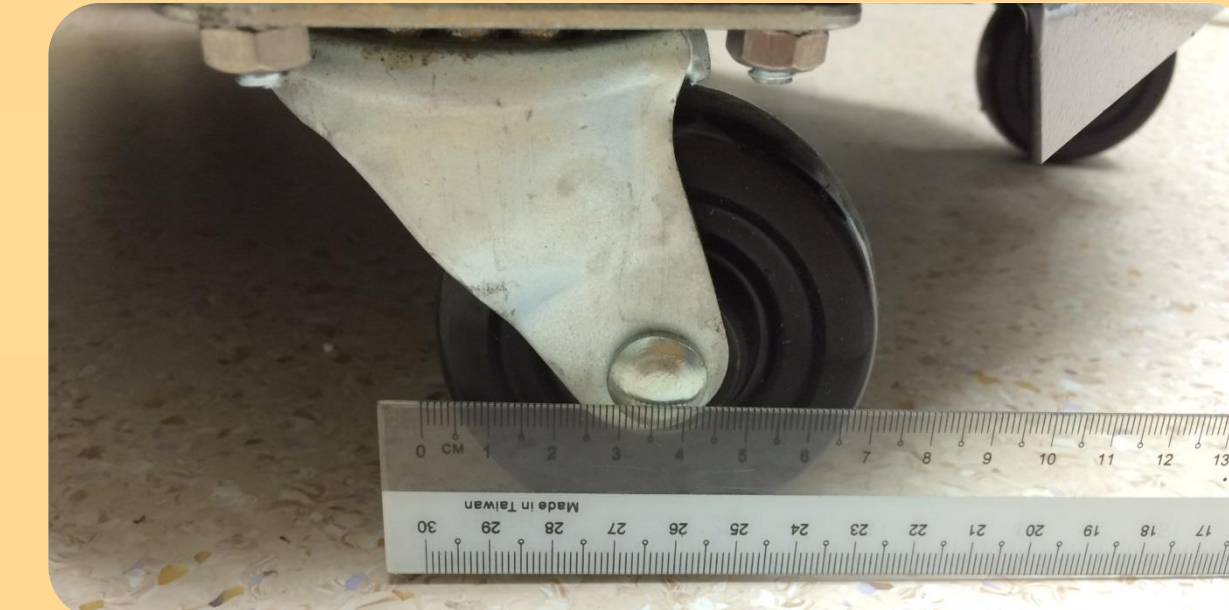
The wheel size (diameter) of the liquid nitrogen vessel's transport cart was analyzed as it had played a crucial role in getting the vessel to topple when the wheels struck obstacles or run over holes on the floor. When inspected, it was discovered that the transport cart involved in the incident was about 7cm in diameter. When tested, the smaller wheels of the transport cart (≤ 7 cm) were found to be prone to get trapped in gaps formed between the lift car and lift lobby. The small wheel size was also prone to get caught at the holes formed on the damaged flooring. A larger wheel may allow the vessel to ride over lift gaps and any floor damages or holes more efficiently.

The wheels of 41 liquid nitrogen vessels (Dewar tanks) were measured, and 36 of the tanks had diameter of less than or equals 7cm:

Of the 41 wheel size measured, 88% of the wheels were ≤ 7 cm

- To acquire transport carts with larger wheel size, preferably larger than 10cm. Transport cart with smaller wheel size for movement within the room only.
- Check the wheels regularly, carts with damaged or loose wheels should not be used.
- Engage liquid nitrogen suppliers to transport the refilling tanks to top up the Dewar tanks on site. This eliminate the need to transport vessels for refilling.

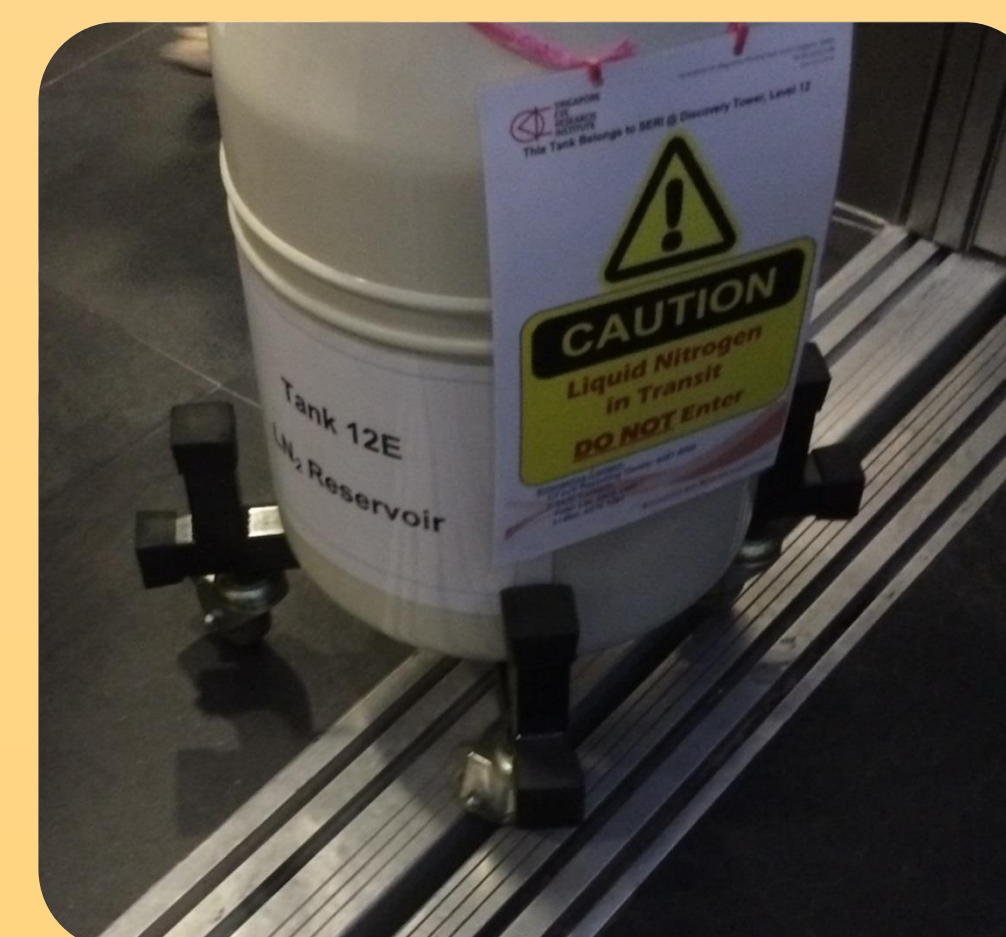
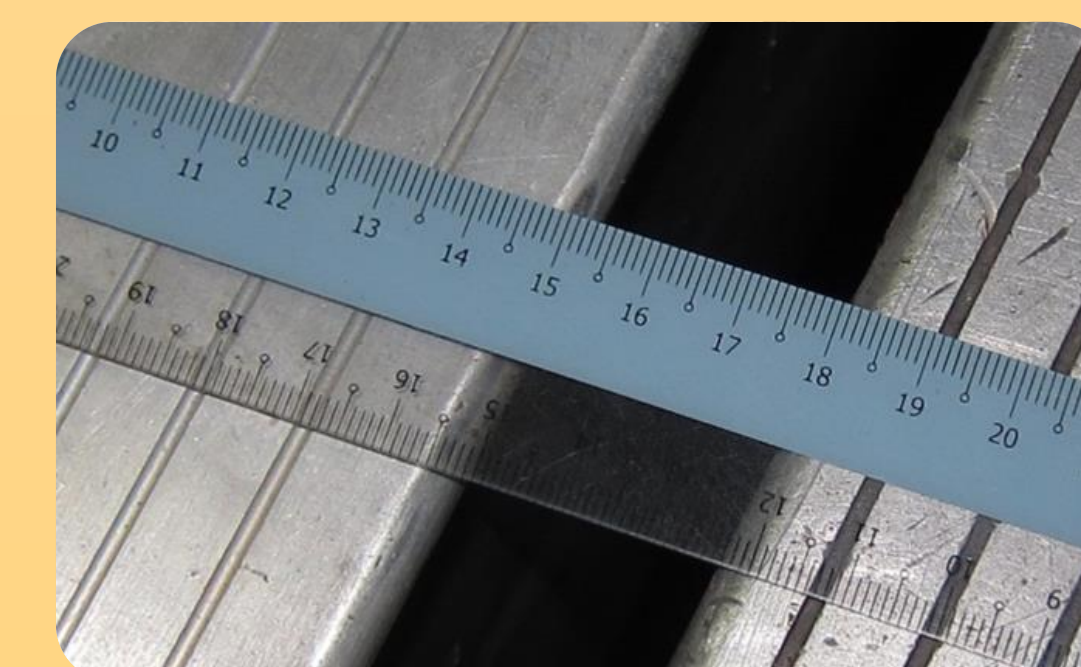
Lift gaps were measured to be 3cm. When tested, wheels size of less than 7cm were prone to getting trapped and had to be lifted to bypass the gap.
