To Reduce the Rate of Breakage of Periodontal Probe during the Central Sterile Service Department (CSSD) Sterilisation Process

Singapore Healthcare Management 2021

National Dental Centre Singapore

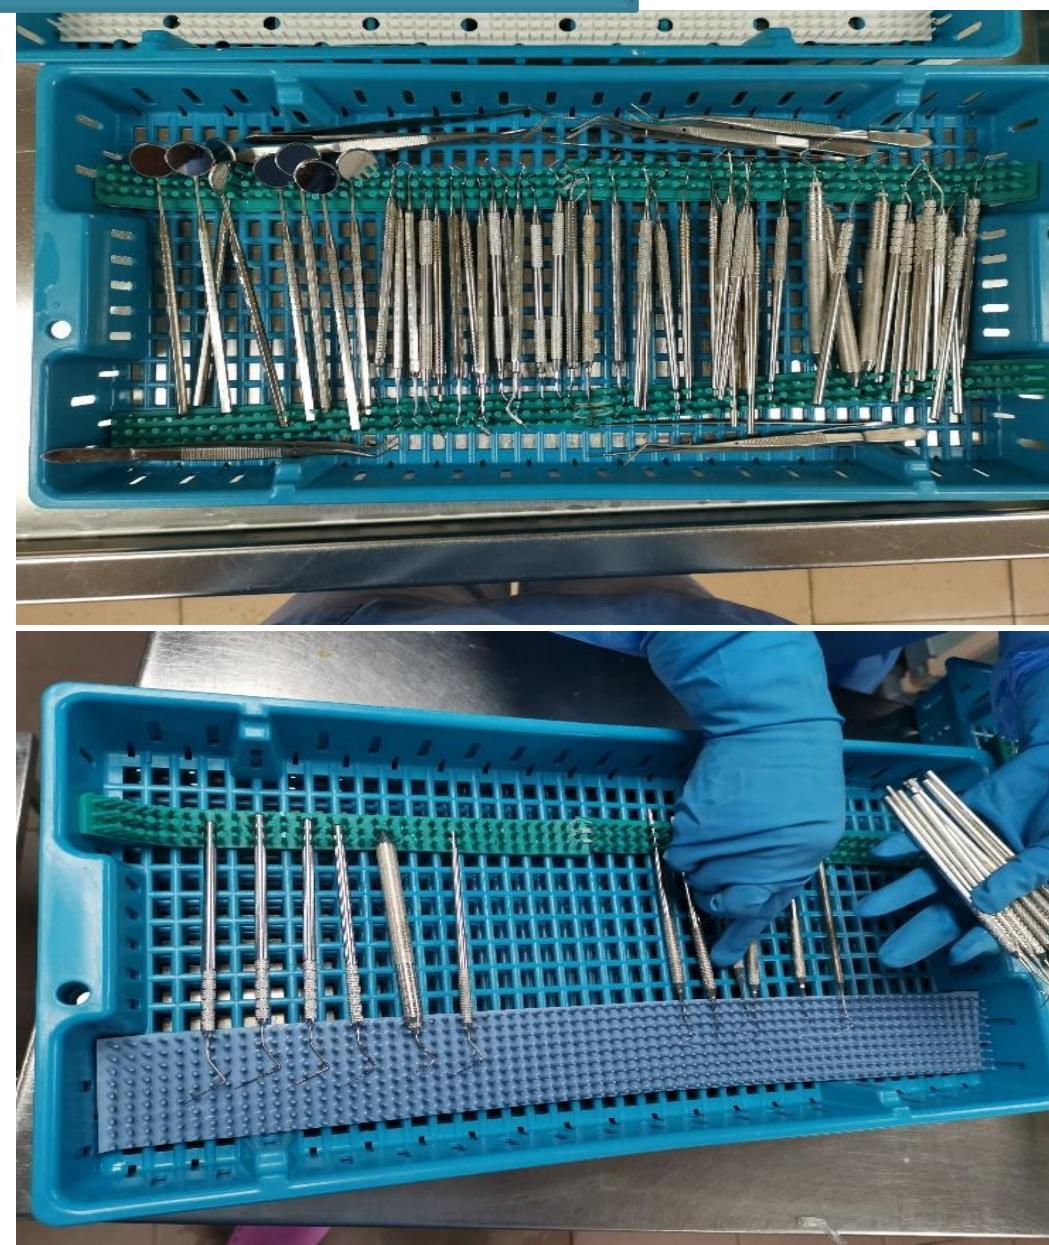
Root cause:

Breakage of perio probe due to instruments colliding with each other :

Mixture of heavy and fine instruments in the same tray.

Over crowding of instruments in one tray. Intervention:

Segregate the Perio Probe from other instruments onto tray for washing.

To dedicate the space on the silicone mat for putting of sharp instruments.

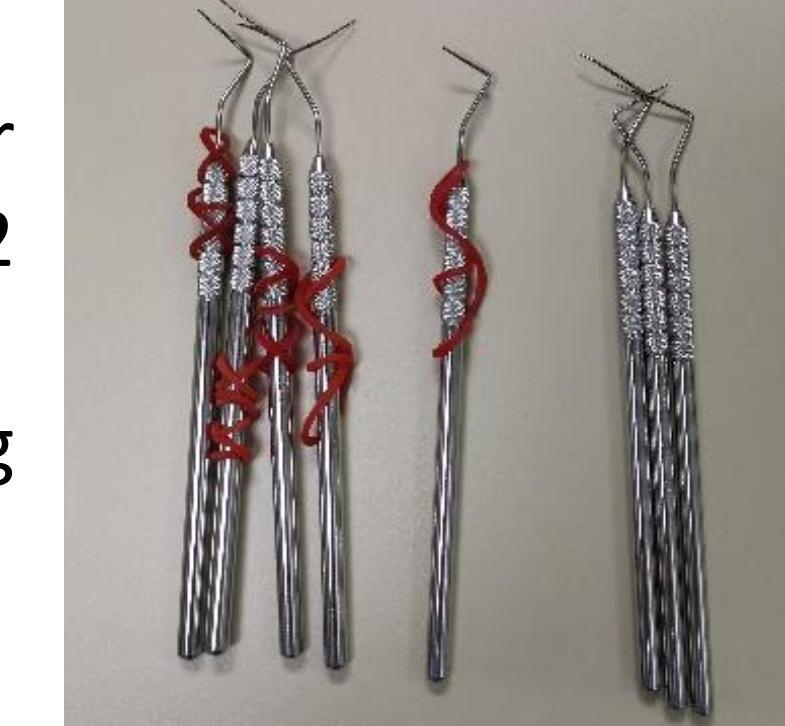
Not able to identify at which point in the sterilisation workflow did the instrument breakage occur.

checks for Incorporate instrument breakages at 2 additional check points.

- 1. Dirty instrument receiving station
- 2. After washer station

(1)Perio probe that is received in broken condition, in the dirty instrument receiving station will be marked with rubber band. (2)Perio probe that is found broken after washer station will be segregated without rubber band.

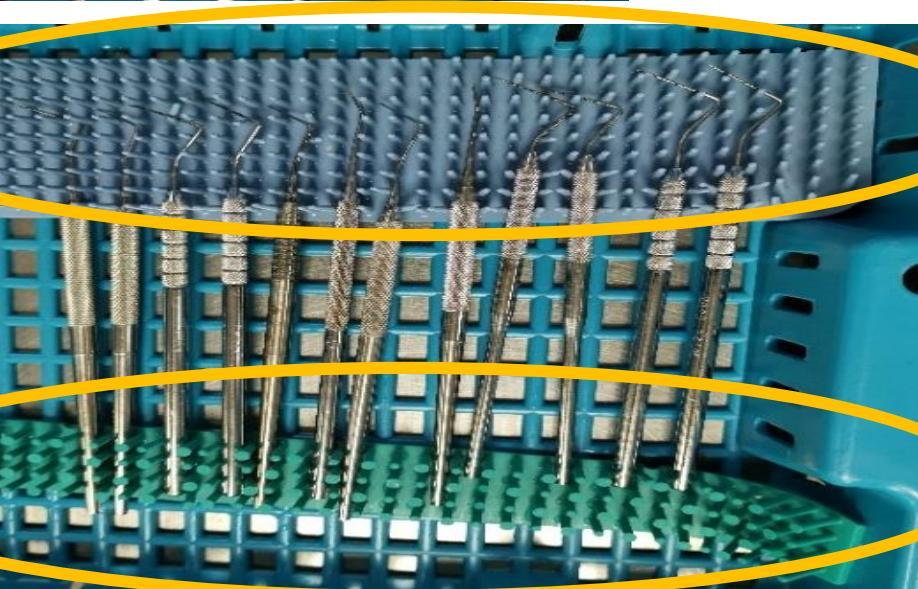
Root cause: The tip of the Perio Probe is not adequately protected.

The width of silicone mat used to hold perio probe in place in the washer rack is too narrow. In the process of transporting, perio probe may poke out of perforated holes and is prone to breakage.

After: Silicone mat with broader width protects the tip of perio probe from breakage.

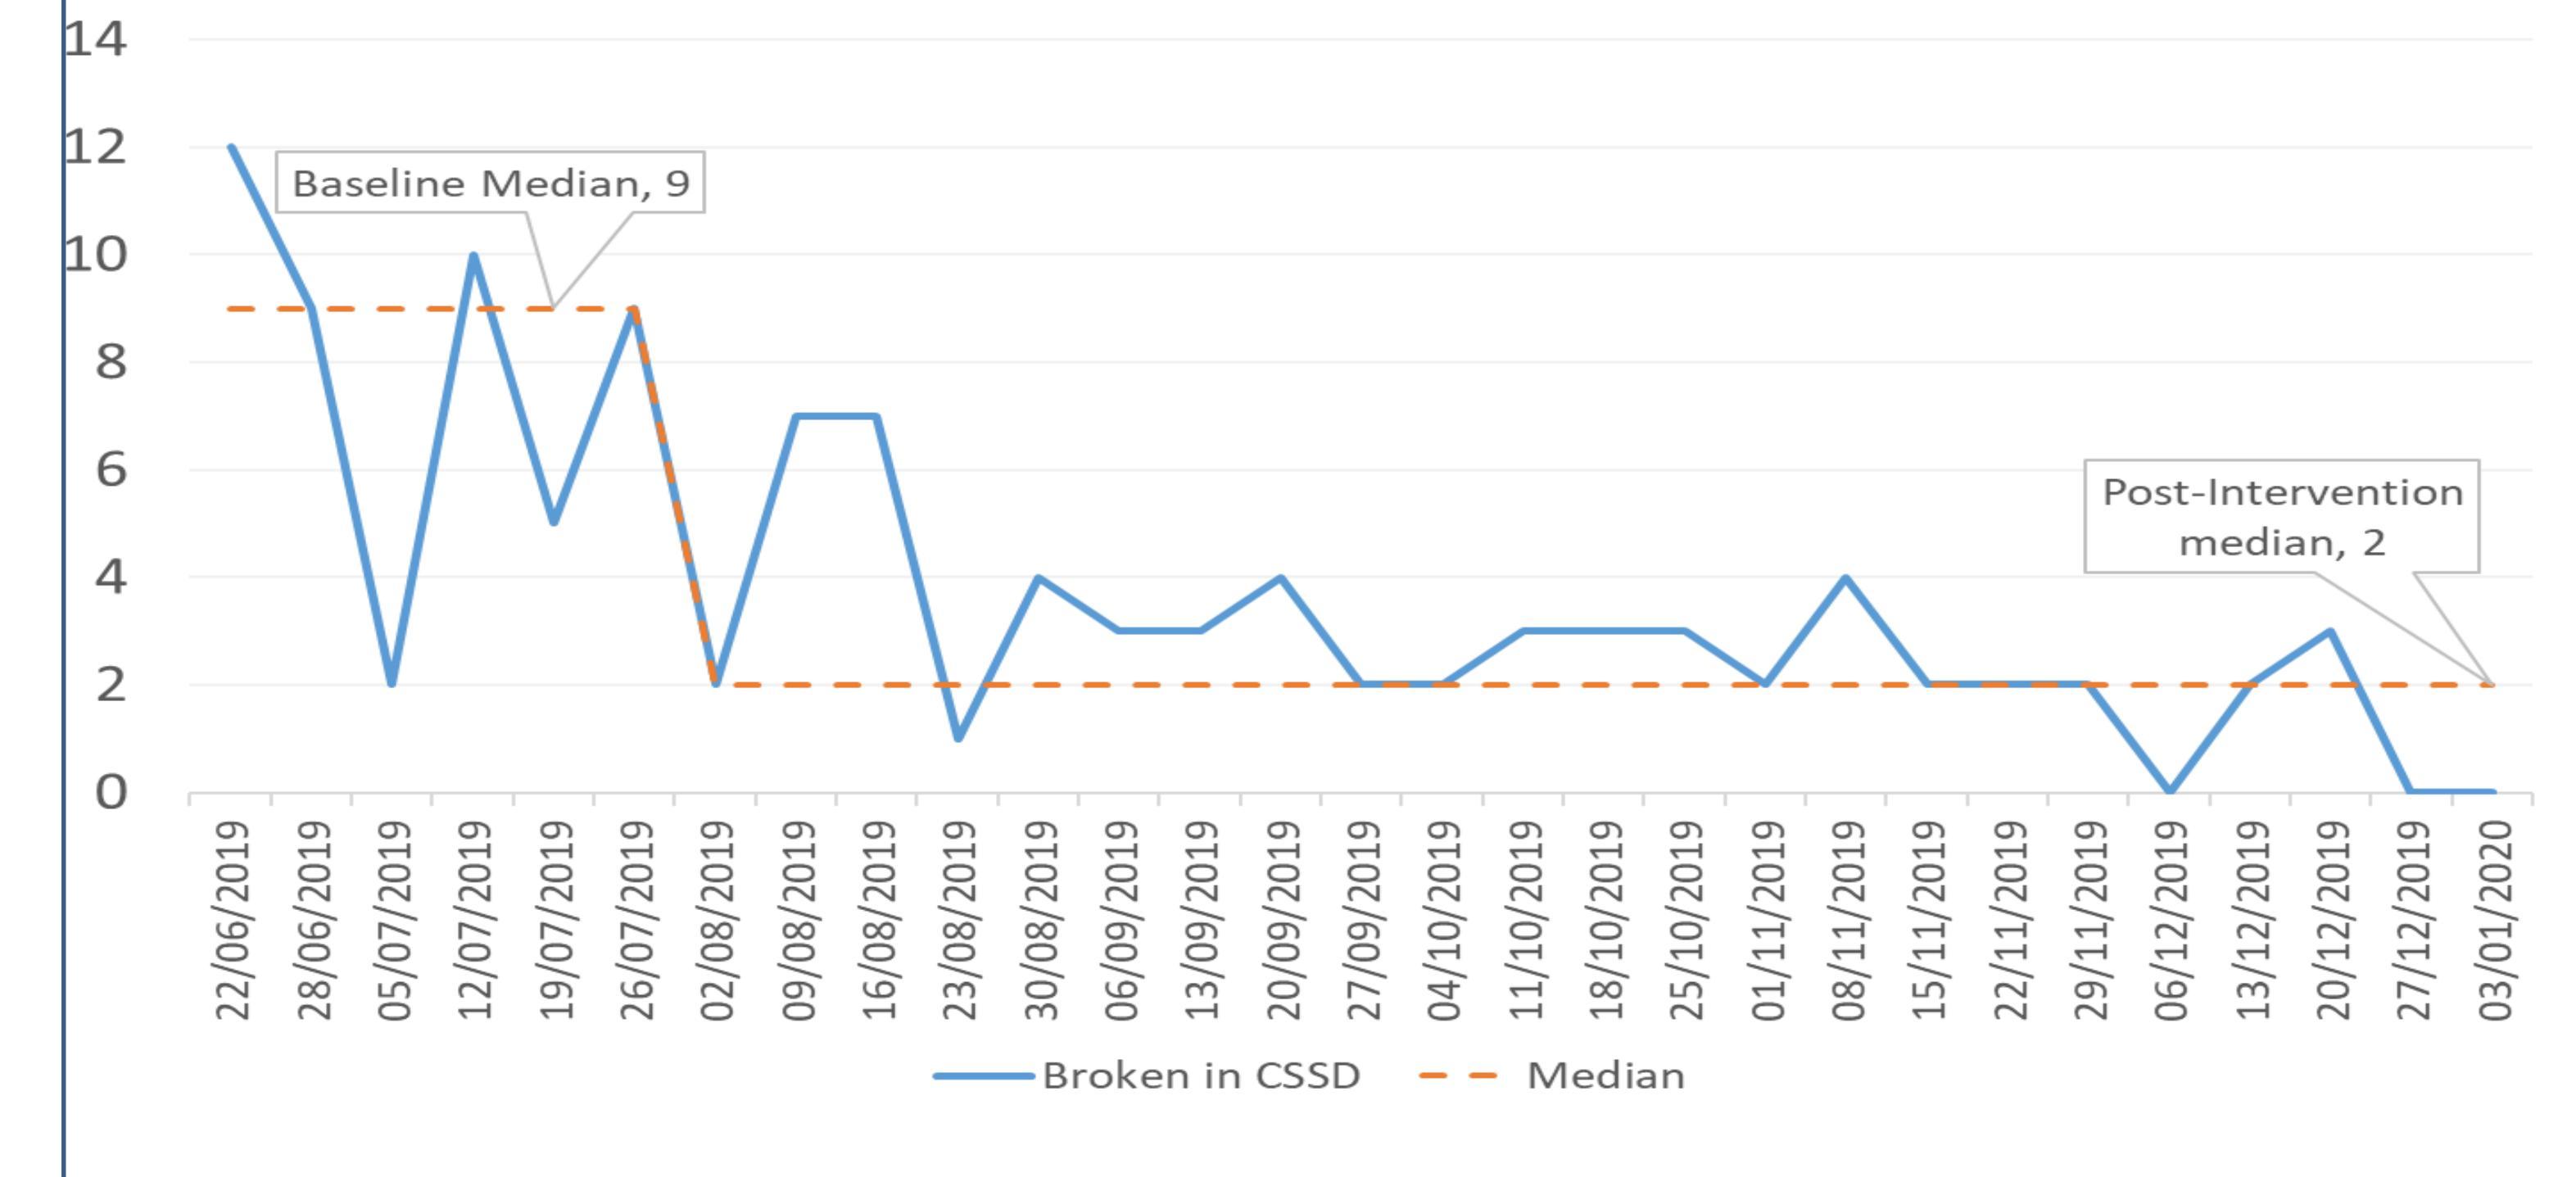
Weekly Number of Instruments Broken within CSSD Sterilisation workflow

Before After • The baseline median weekly • Post intervention, the median weekly breakage showed improvement, and is breakages happening in reduced to 2 cases per week. CSSD is 9 cases per week. Additional check before and after washing of Broken instruments that is instruments helps to pin-point sterilisation found in CSSD is condemned and replaced steps that pose higher risk to the instruments. These steps are redesigned to without distinguishing the source of breakage. mitigate breakage risks.

• Annualised replacement cost is \$1,872. Replacement cost would be reduced by 77.8%, with \$6,552 projected savings annually.
