To eliminate displacement of nasoscope from trolley during transportation from ward 55A to other departments

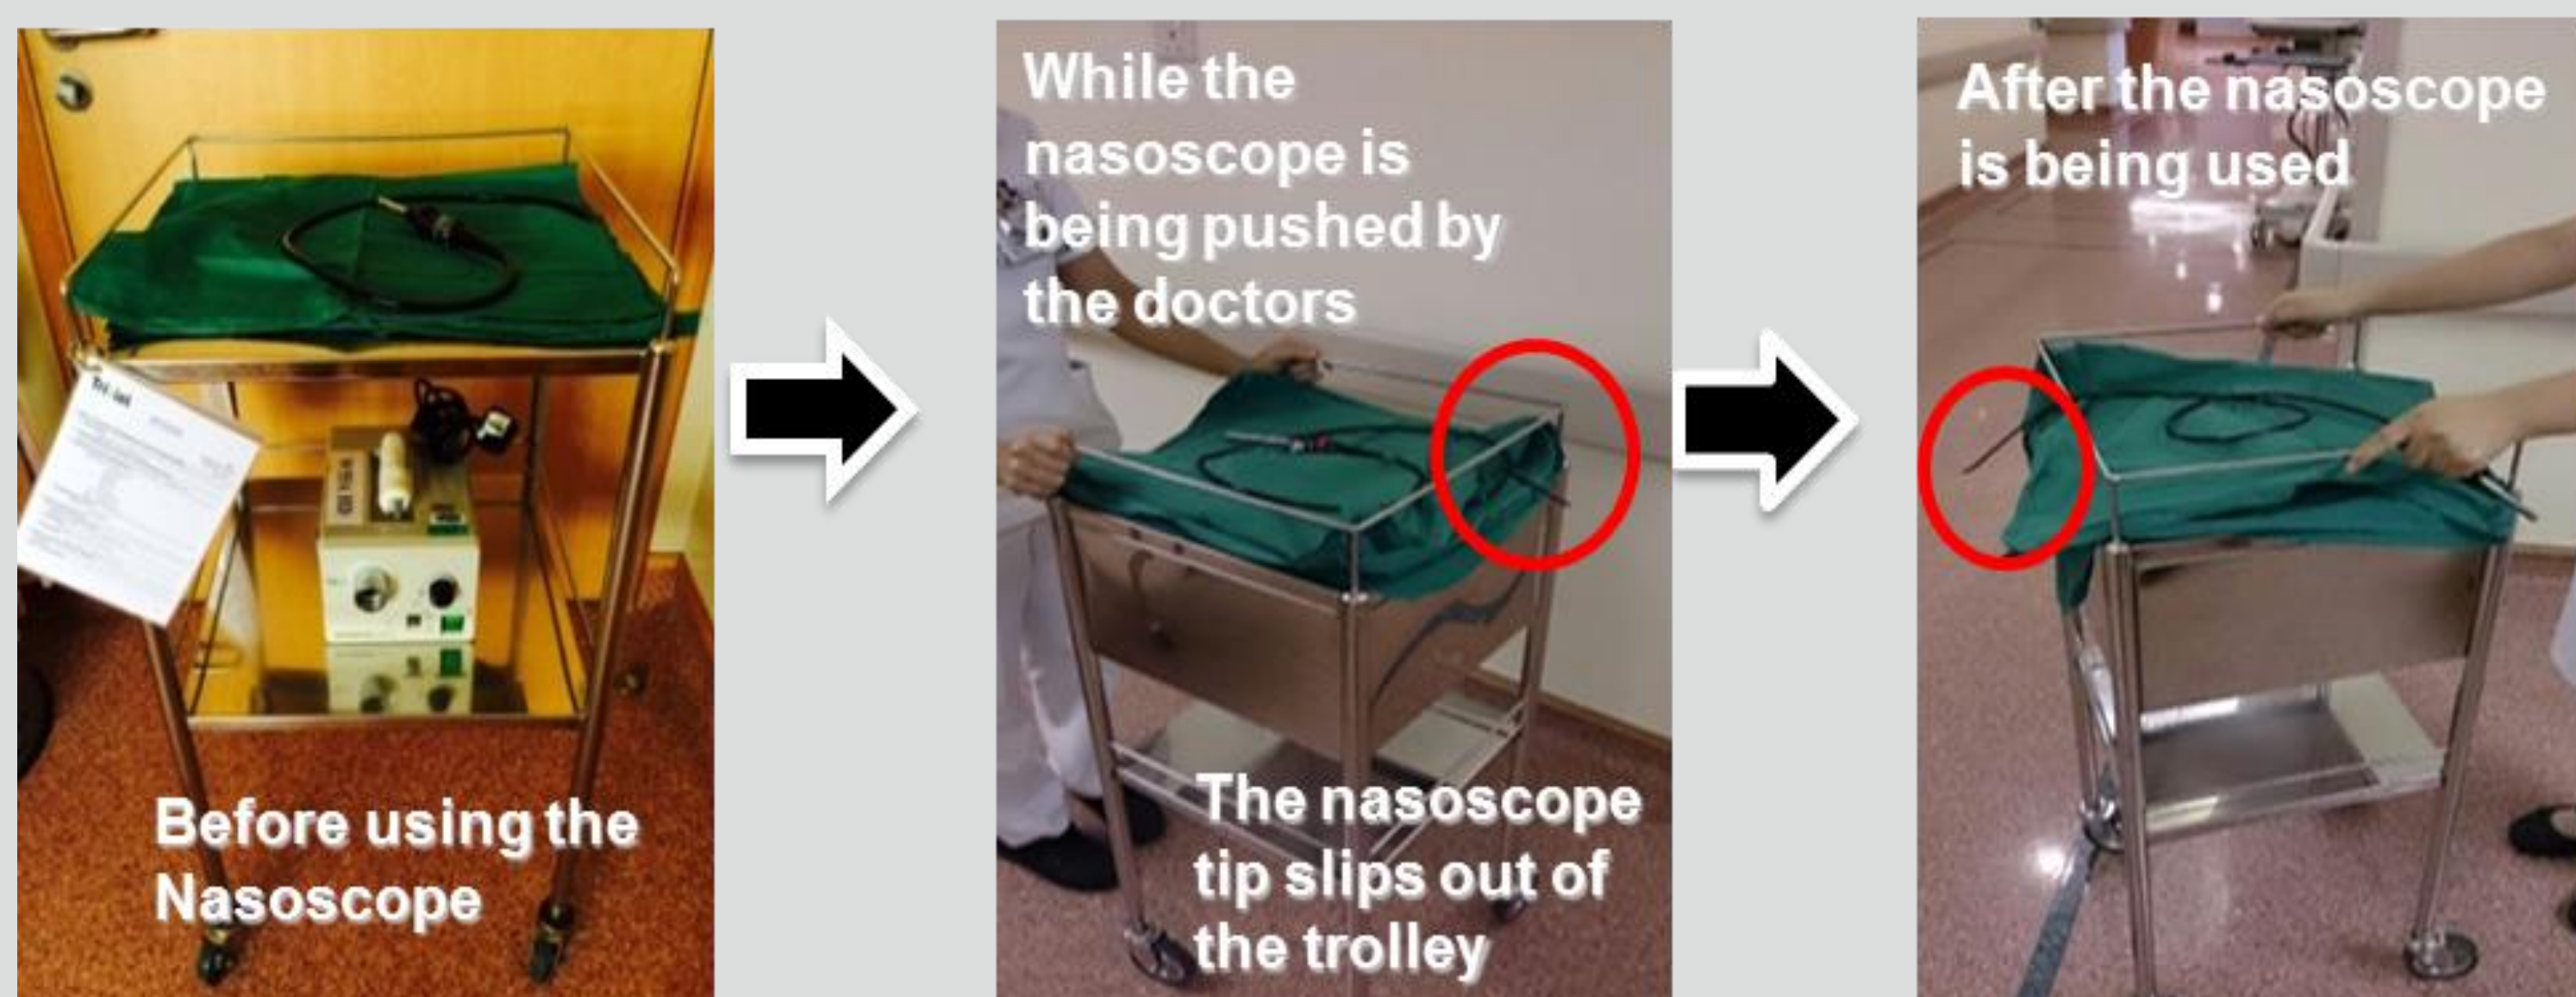
Fig. 1 Pre-Implementation

The nasoscope is placed on a trolley for transportation, and the tip often slips out from the side of the trolley during transportation (Fig. 1). When the tip slips out from the trolley, there is a risk for contamination and damage to the nasoscope.

1. Contaminated Scope would require additional cleaning. Cleaning process will take about 15 mins which can cause delay in treatment. Unnecessary consumable items were used.
2. There were 2 incidents of severe damage to the nasoscope in the past:
 - a. One scope was sent to USA for 10 months for parts replacement which cost \$5000.
 - b. Another scope was damaged beyond economical repair. A new piece was purchased for about \$10000~\$13000.
