Mission Statement

Ang Mo Kio Polyclinic (AMK) nursing team initiated a quality improvement project to further improve the current work process of wound dressing for nurses.

As part of this initiative, the dressing room team members designed a new dressing trolley for use in the newly renovated dressing room.

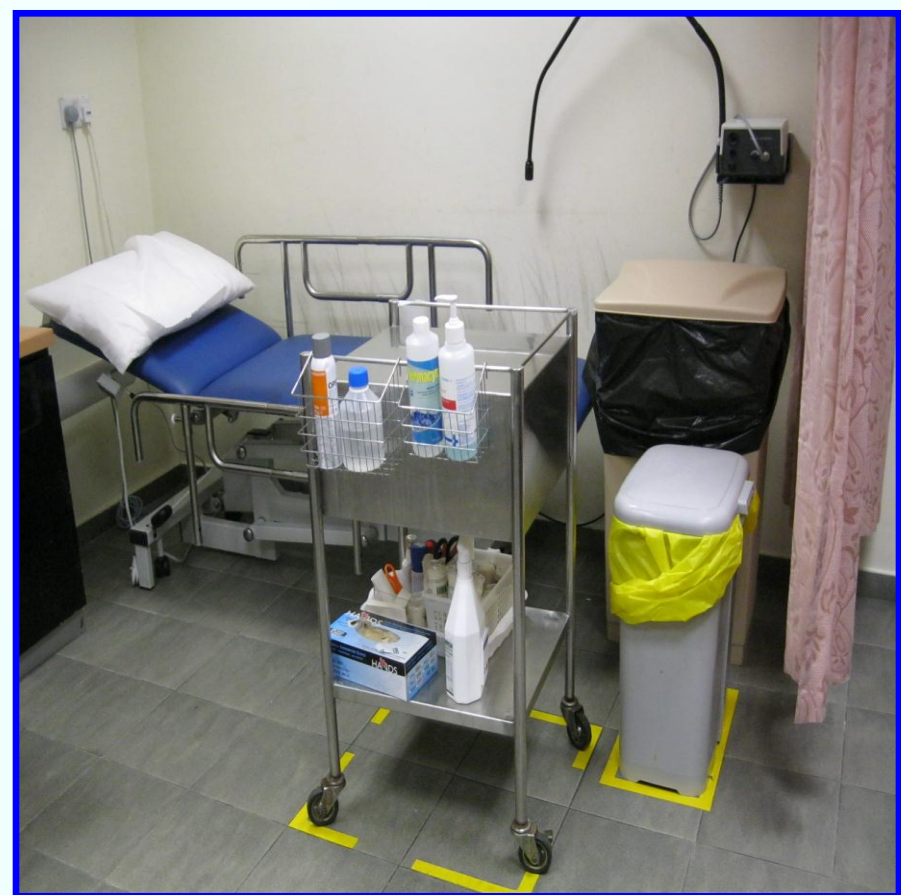
Current design of dressing trolley

The dressing trolley that is currently in use have the following problems and limitations:

- Insufficient storage space for dressing items causing inconvenience when retrieving them.
- Poor segregation of sterile and non sterile items resulting in poor compliance to infection control guidelines.
- Poor ergonomics - On an average working day, a nursing staff had to bend about 30 times to retrieve dressing items for use from the lower compartment.

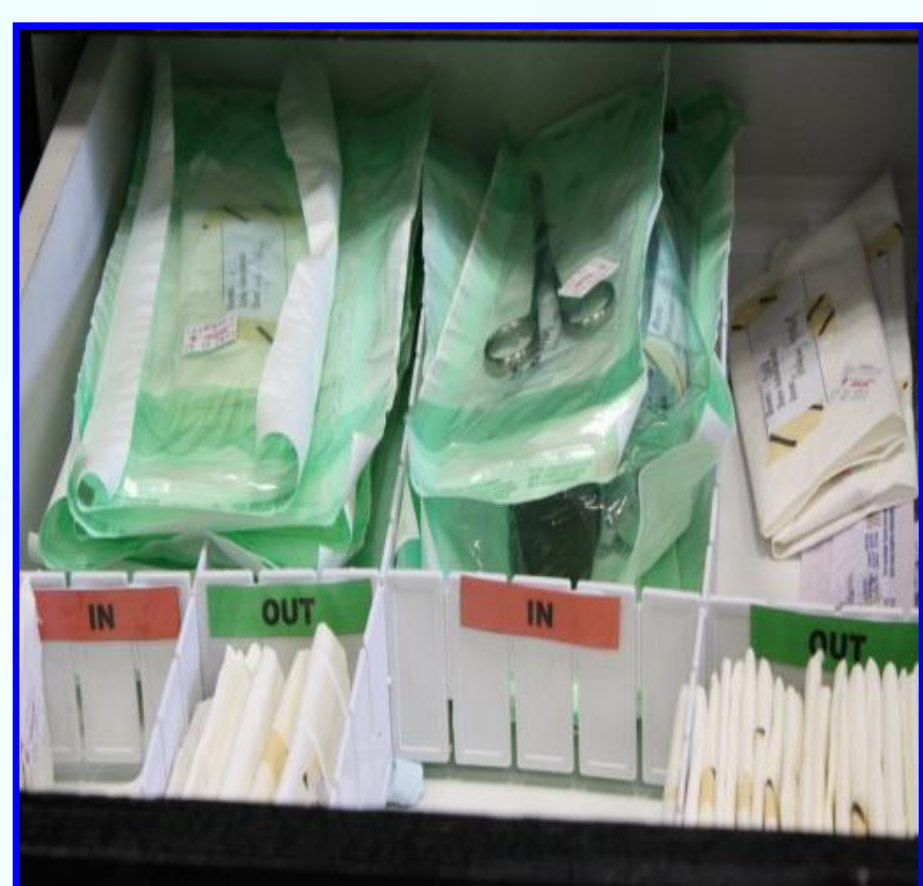
Poor segregation of dressing items

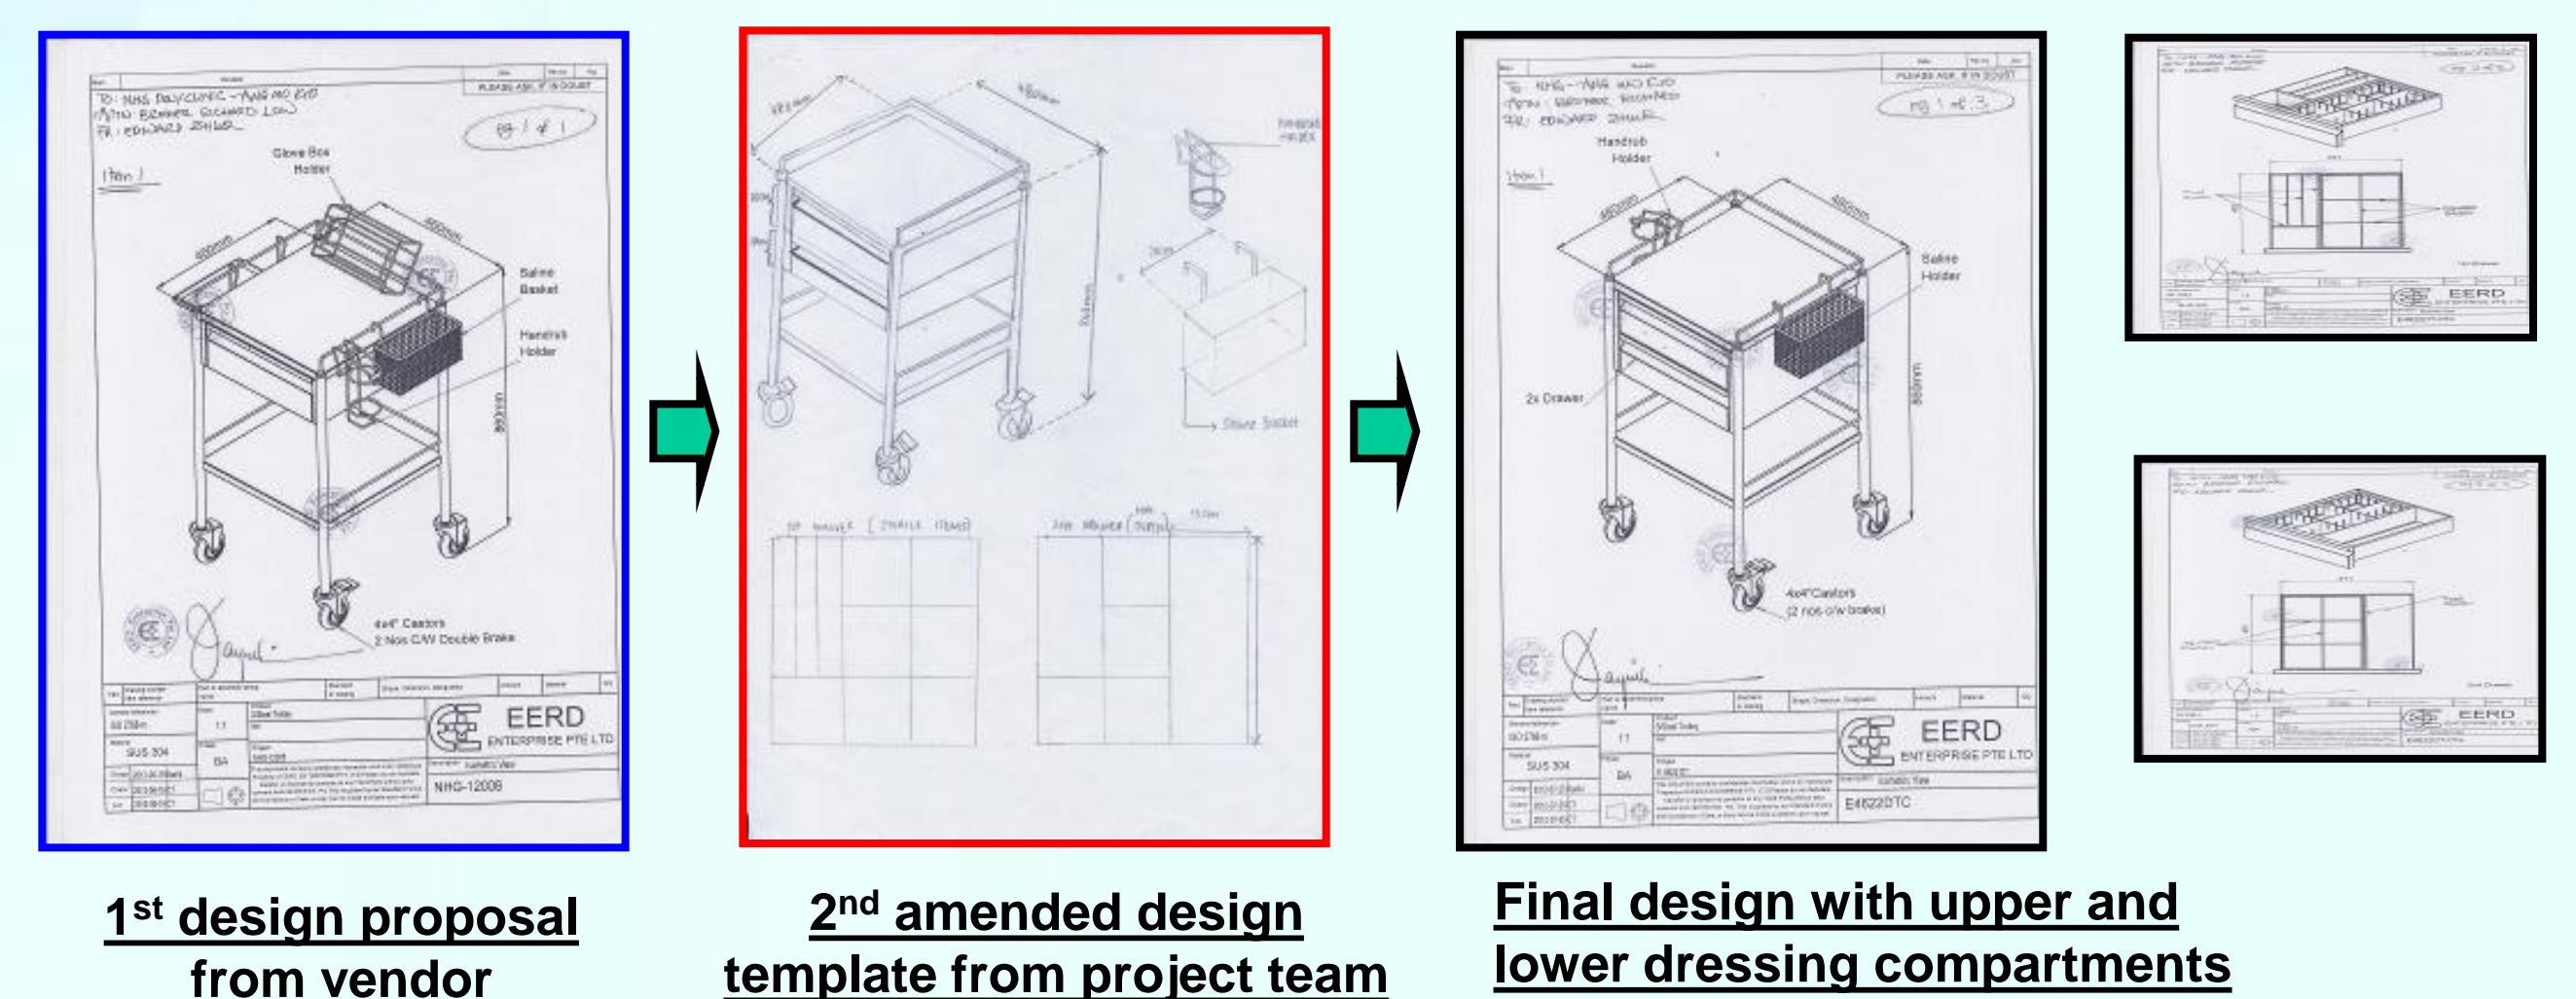
The project team went through 3 rounds of discussion to confirm the final design template of the new dressing trolley.

- As part of the design process, the team worked on the exact technical specifications they envisioned for the new dressing trolley.
- This was done through a process of examining all the dressing items currently in use and deciding on where each dressing item should be placed using the 6S methodology.
- The exact measurements of every dressing item were also taken as well to ensure that all items can fit well into the new trolley.

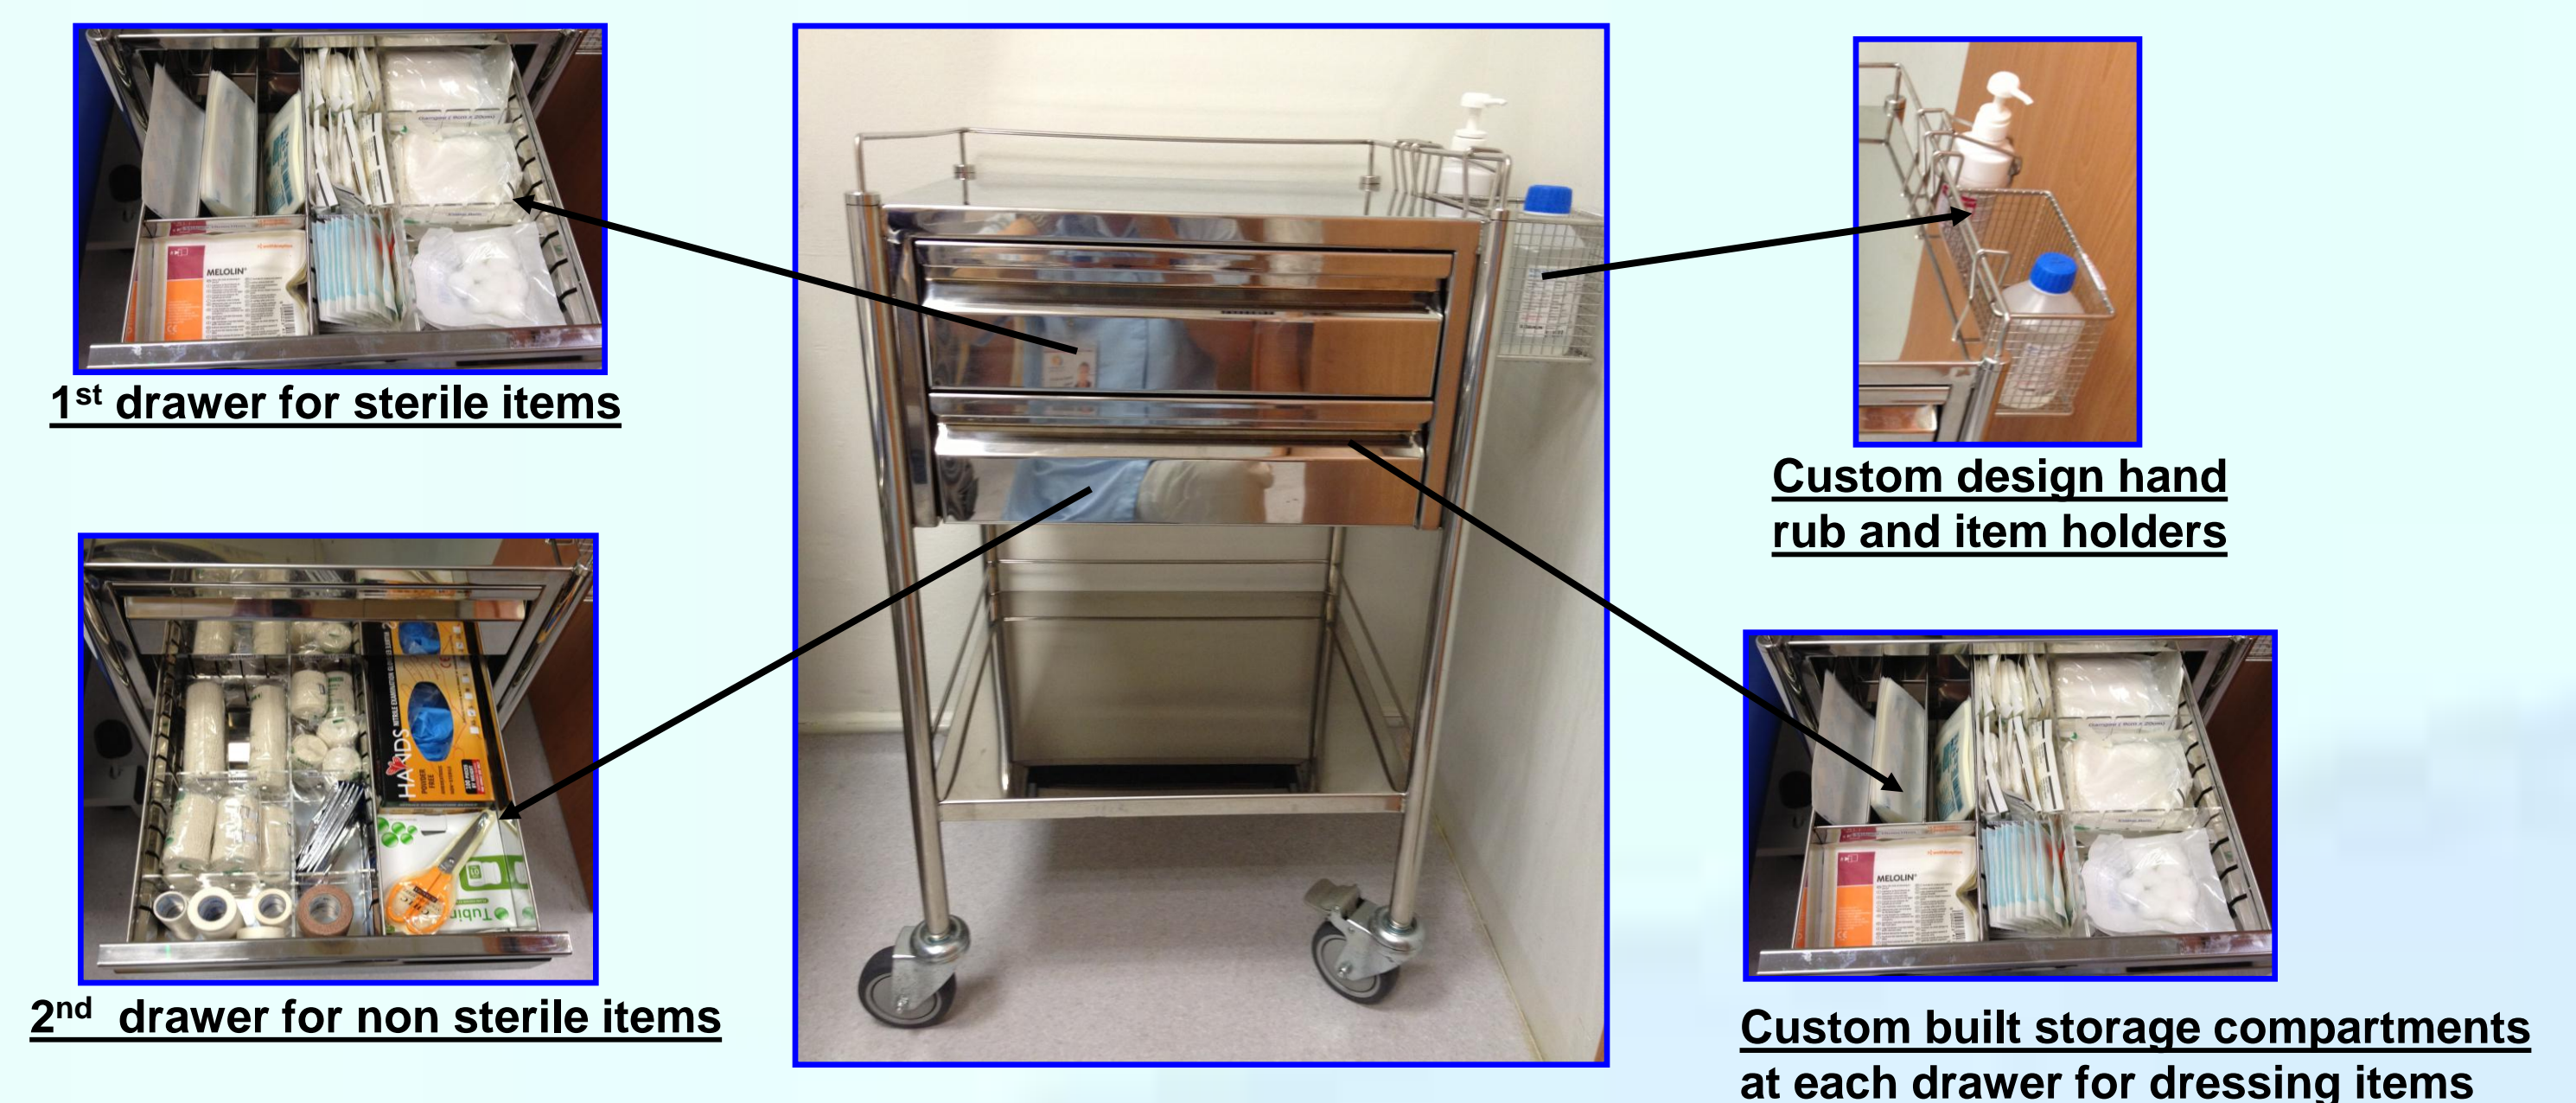
The selected vendor constructed the dressing trolley based on the design specifications stipulated. A sample of the dressing trolley below:

- Adequate space for all relevant dressing items.
- Compliance to infection control guidelines with proper segregation of sterile and non sterile items in top and lower compartments respectively.
- Custom built storage compartments at each level enabling easy storage and retrieval of items. Internal compartments can also be easily changed to fit in new items.
- After 3 months of implementation, end users gave a 100% satisfaction rating to the new dressing trolley.
- Improved ergonomics with no more bending to retrieve dressing items.

- The depth of the dressing trolley was not long enough for one dressing item. For future versions of the trolley, to consider increasing the depth.
