Singapore Healthcare
Management 2019

Custom-designed Trolley with Lifting Mechanism for Stowing and Transporting both Medical Waste and Infectious Linens

Sengkang
General Hospital
SingHealth

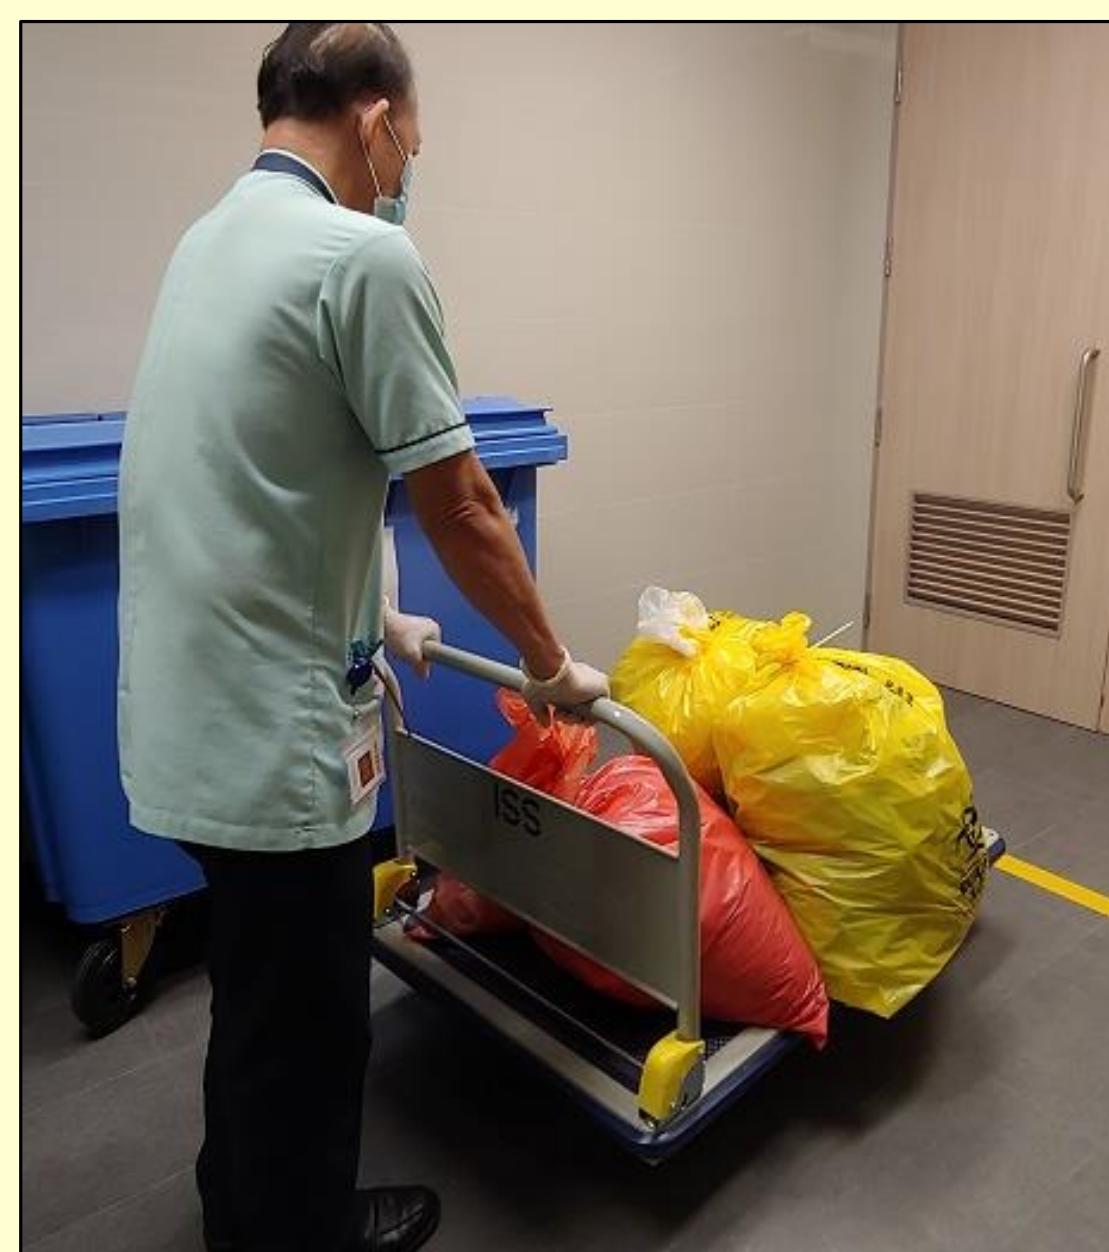
Transferring to sub-holding
room via Platform Trolley

A platform trolley is used to transport Medical Waste and Infectious Linens bags which are stacked onto it. As the trolley is not enclosed, the bags may fall onto the floor and contents may spill.

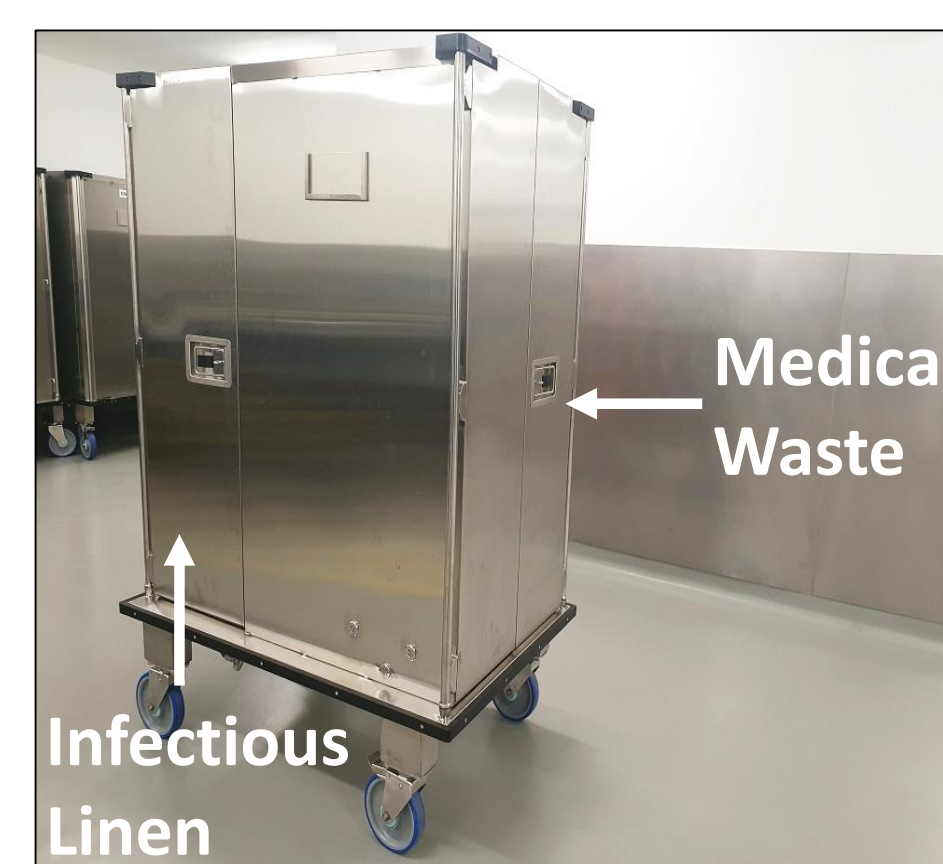
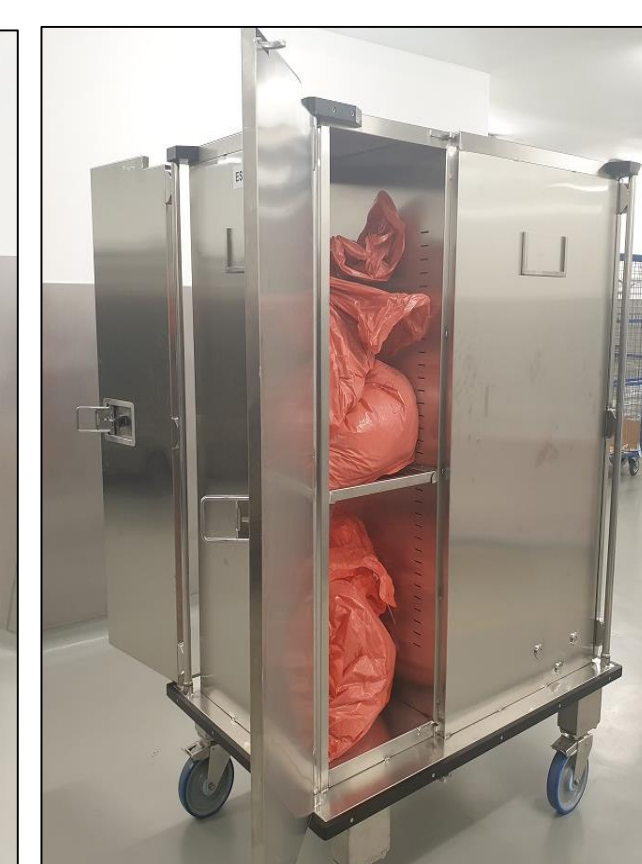
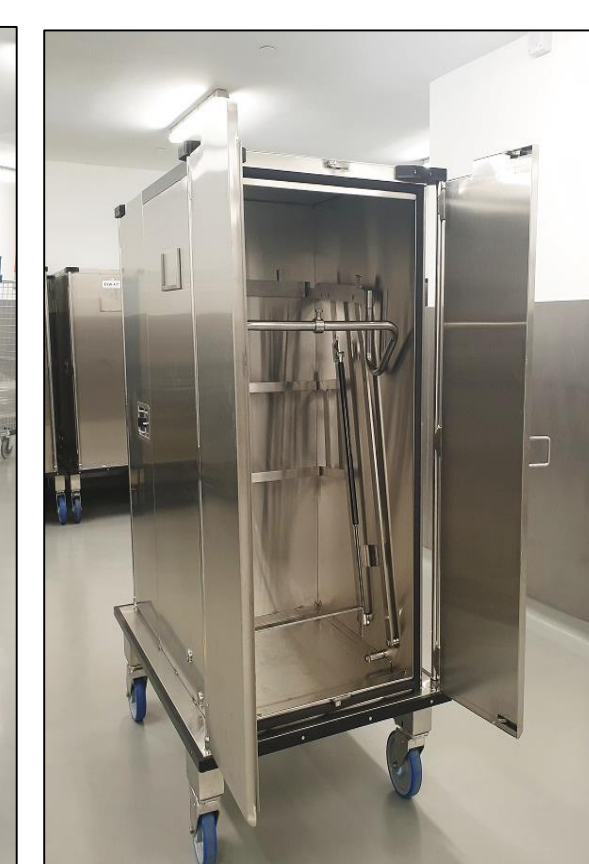
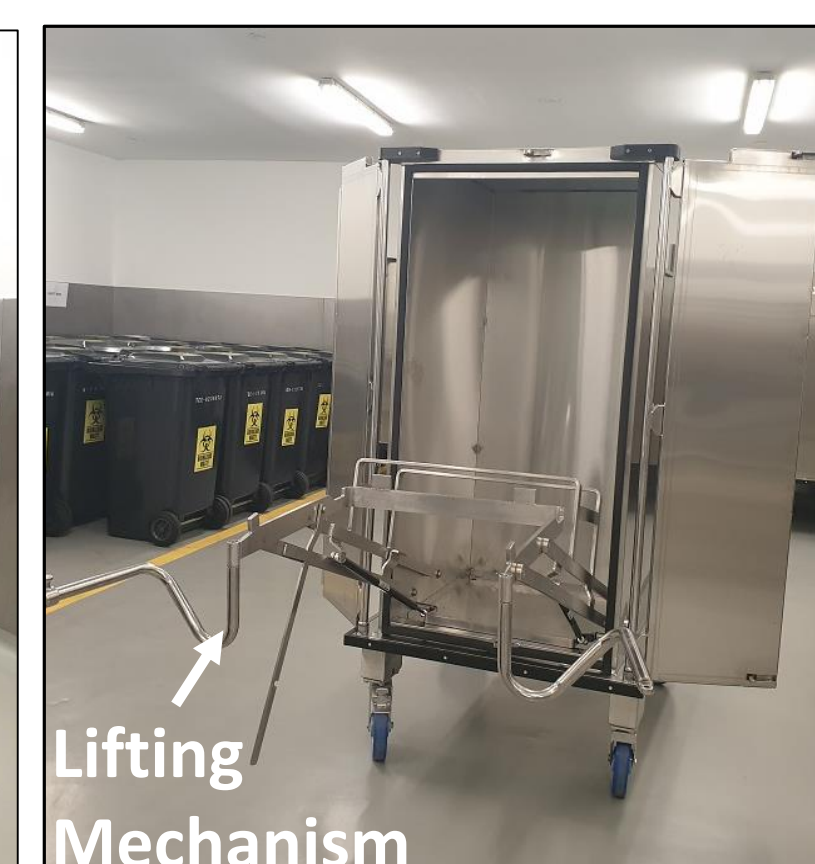
Custom-design Trolley

- ✓ Fully concealed with lockable doors, to eliminate unauthorized tampering, spillage and odor. Contents are securely stowed in the trolley.
- ✓ In-built lifting mechanism for ease of loading and unloading of Medical Waste bin and compartments for storage of Infectious Linen bags.

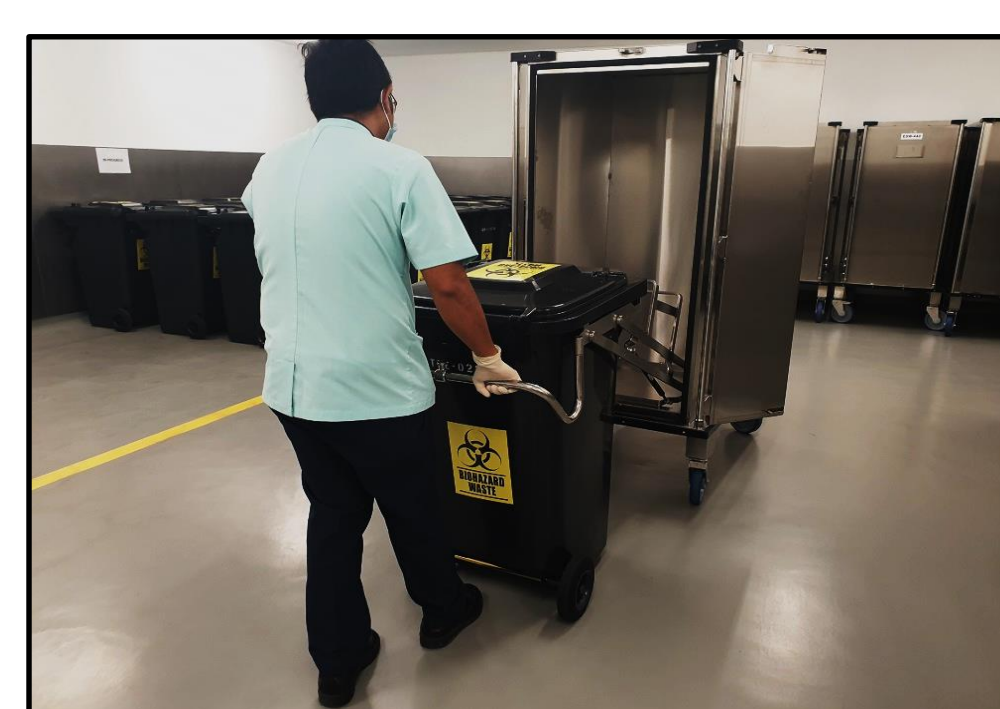
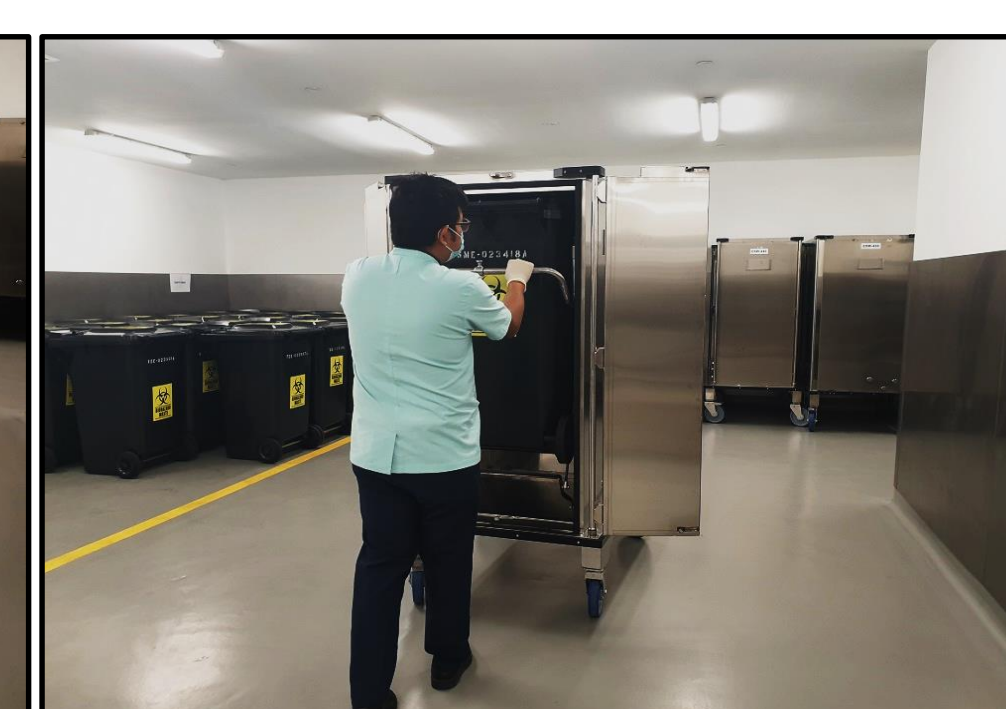
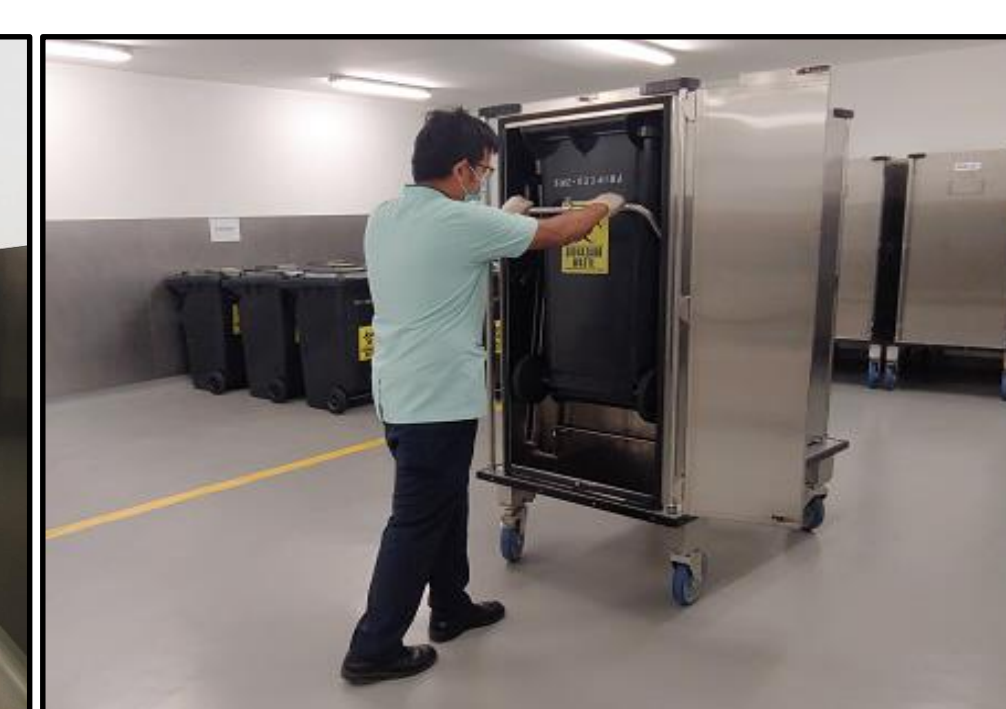
Loading of 240 litre Medical Waste Bin

In-built mechanism:

- ✓ Eases the retrieval process to one-man operation mode.
- ✓ Relieves the housekeeper from having to manually lift and push 240 litre bin (30kg) from designated location to centralized waste room.

The trolley is transported via AGV to the centralized waste holding room where the bins are then retrieved using the lifting mechanism for the appropriate disposal management.
