Constant worry over costly replacement of damaged seat cushions in the hospital's fleet of vehicles is now over

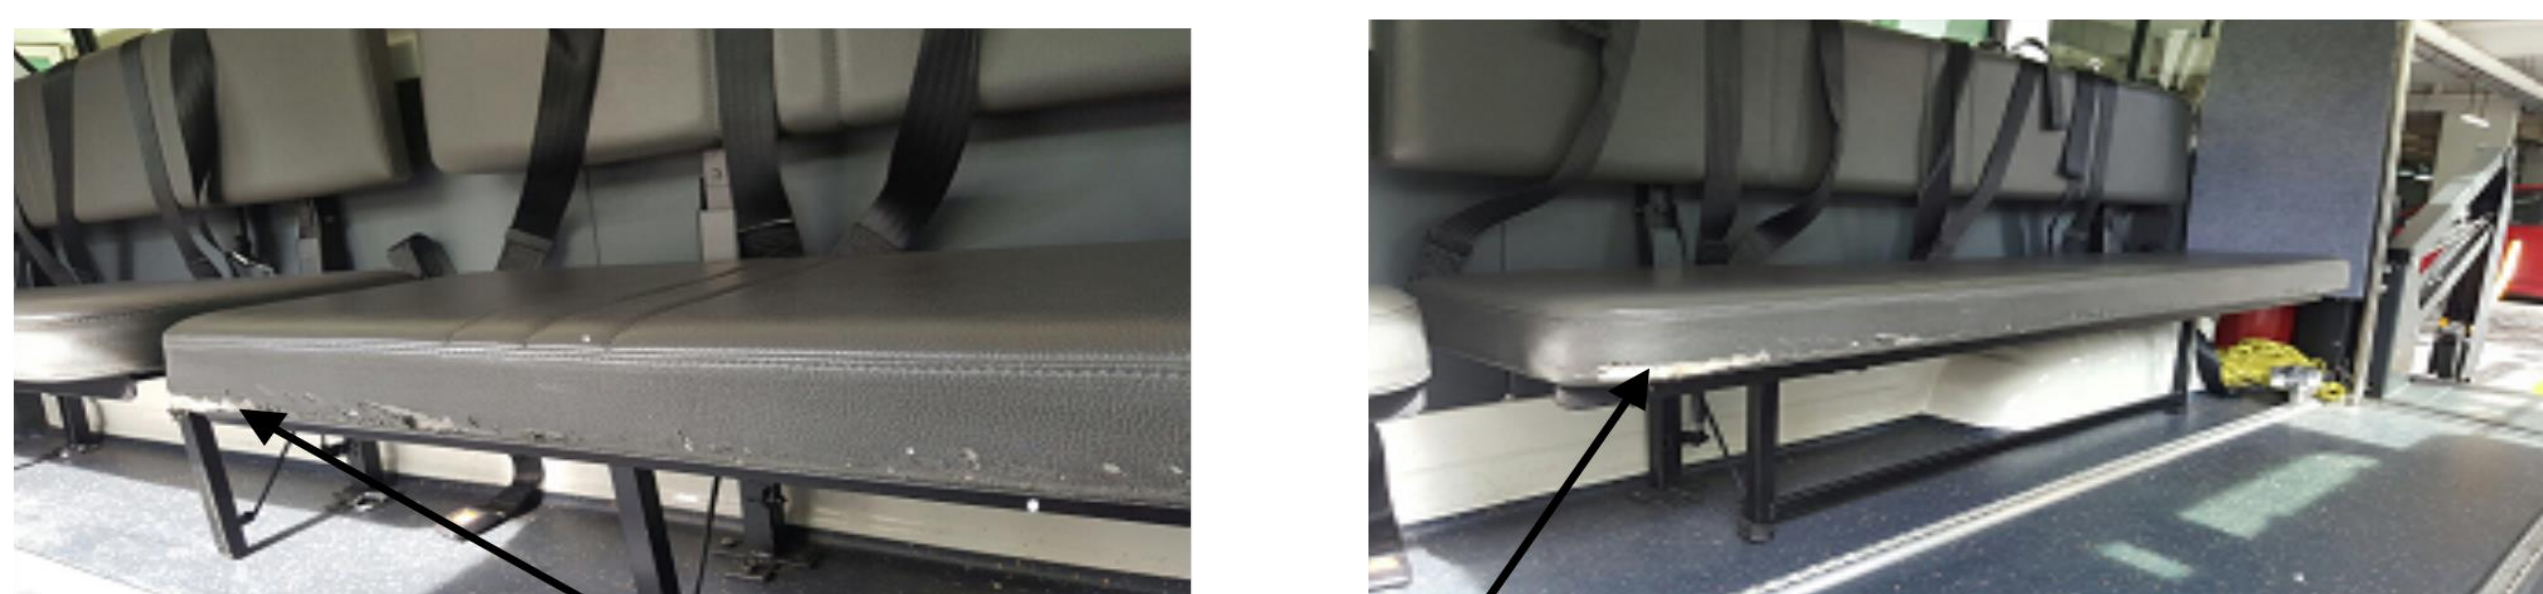
After the wheelchairs or trolleys have been hoisted into the back of the mini-vans, they are limited to forward or backward movement along the aisle, which might result in their accidental and, occasionally forceful contact against the passenger seats mounted on either side of the aisle. The cushion covering over the seat rails have always been most vulnerable to serious damage by such jarring. Without any protection, it is just matter of time before the cushions become damaged irretrievably.

You can already see the how the early damages on the cushion covering over the seat front rails look like in the two pictures below:

Damages on cushion covering over seat rails

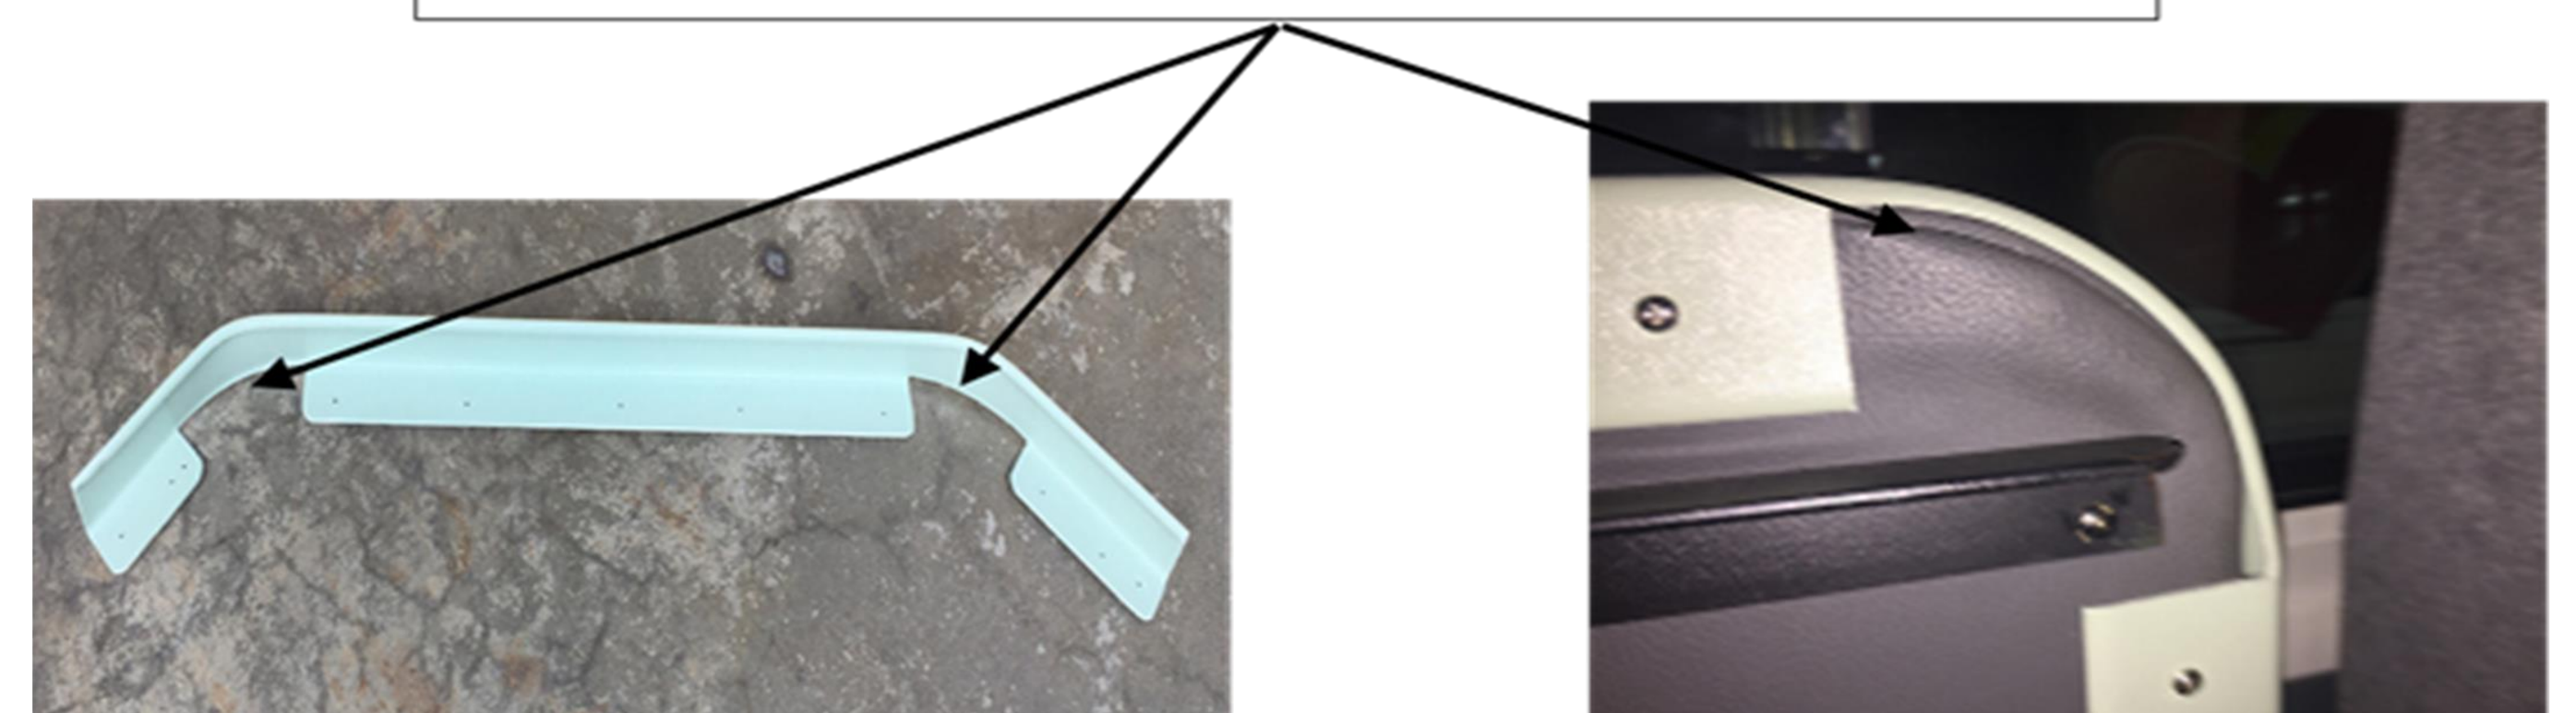
Plan B in the Plan-Do-Check-Act cycle is to cut a groove into the wall guard's L-shaped cross-section and then try to bend it around the weakened grooved section. The pictures below will convince anyone that Plan B has been a great success.

Grooves cut into the L-shaped cross section before attempting to bend the PVC wall guard to fit the seat corner

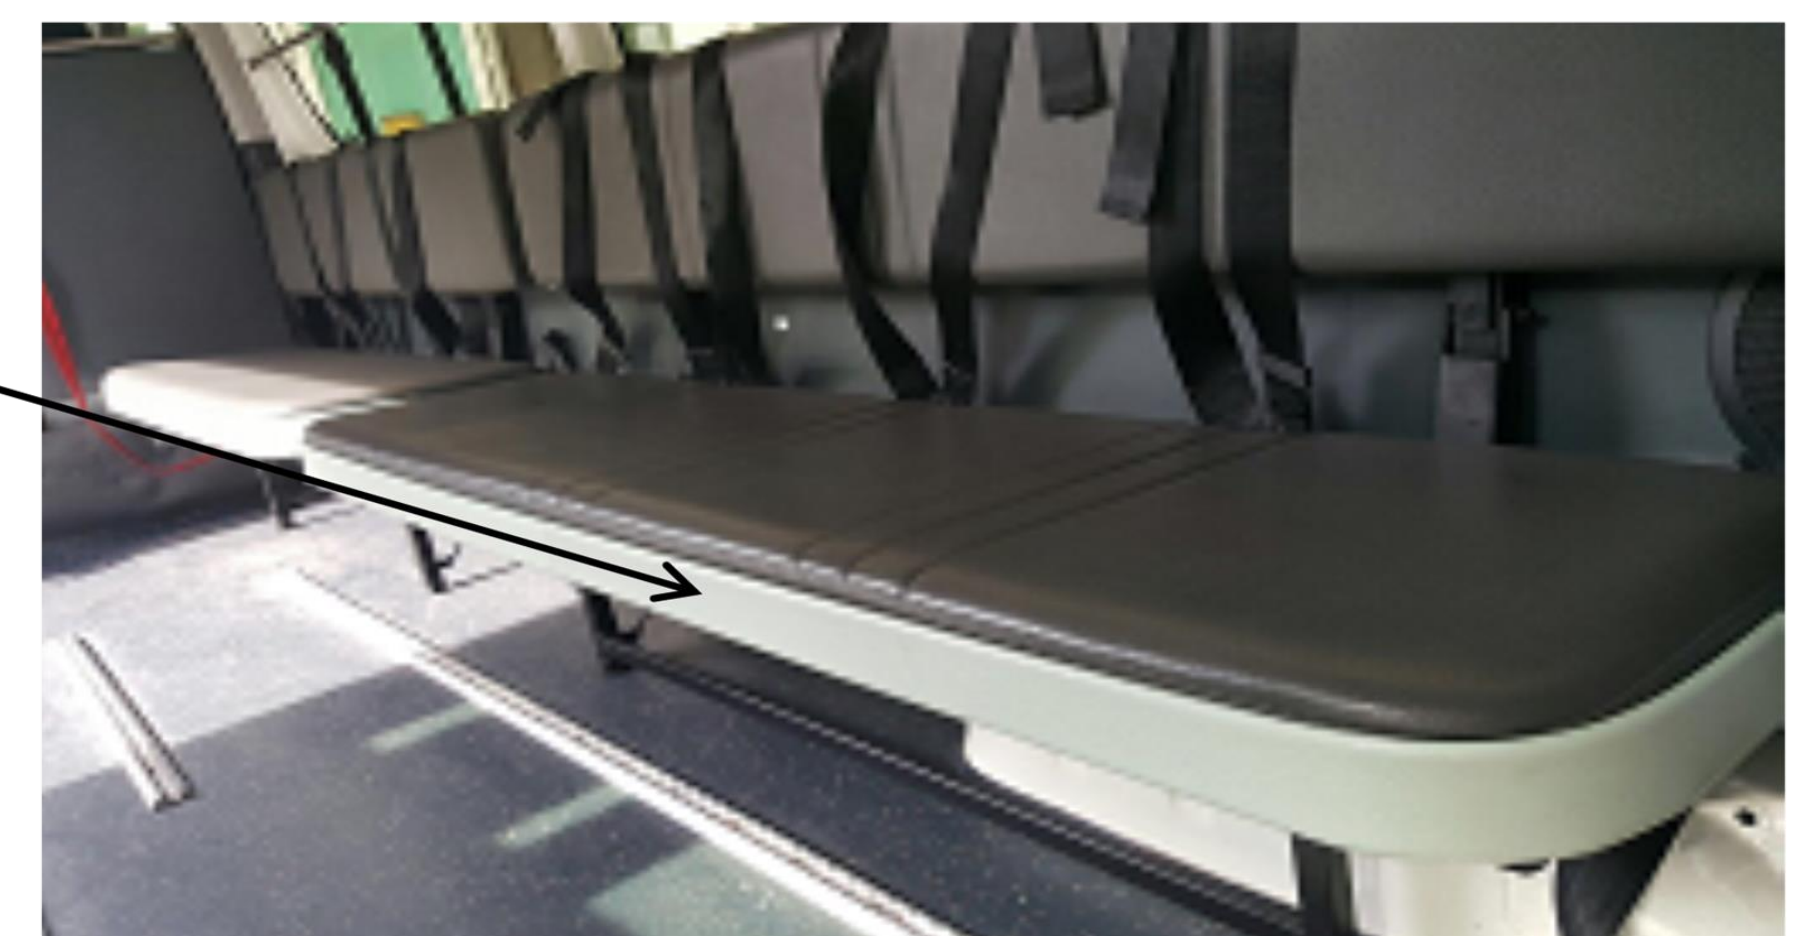
The wall guards have already been secured all around the seat rails in all three vehicles to protect the cushion underneath. With the protective barriers in place, there is no longer any worry about hard accidental knocks against the soft cushion on the seat front rails when moving wheelchairs or trolleys through the passage of the narrow aisle. Moving those objects is now anxiety-free, smoother and a lot much faster. Everyone is happy.

Wall guards recycled costlessly and modified aesthetically for use as protective barriers for vehicular sofas
