Singapore Healthcare Management 2021

To Design a PICCC Safeguard to Prevent Dislodgement of PICCC

Changi General Hospital
SingHealth

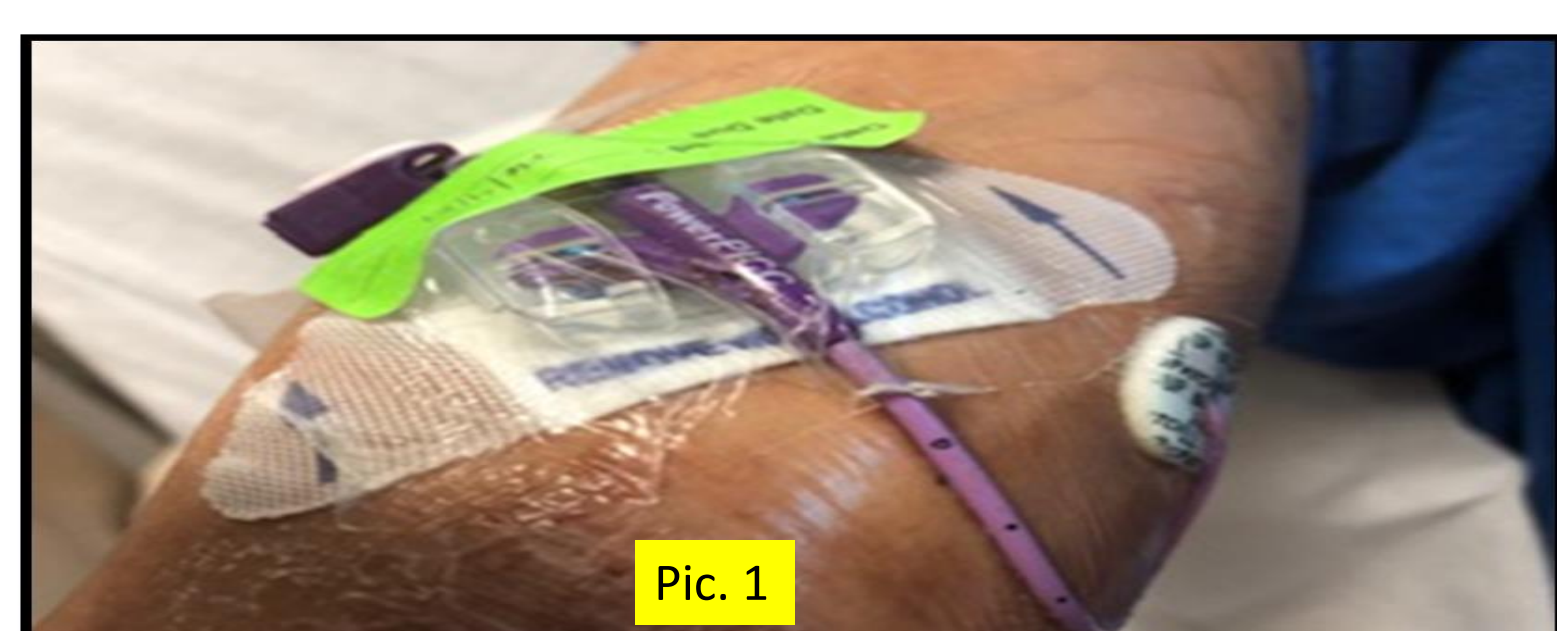
PICC dressed up with stat lock and transparent dressing

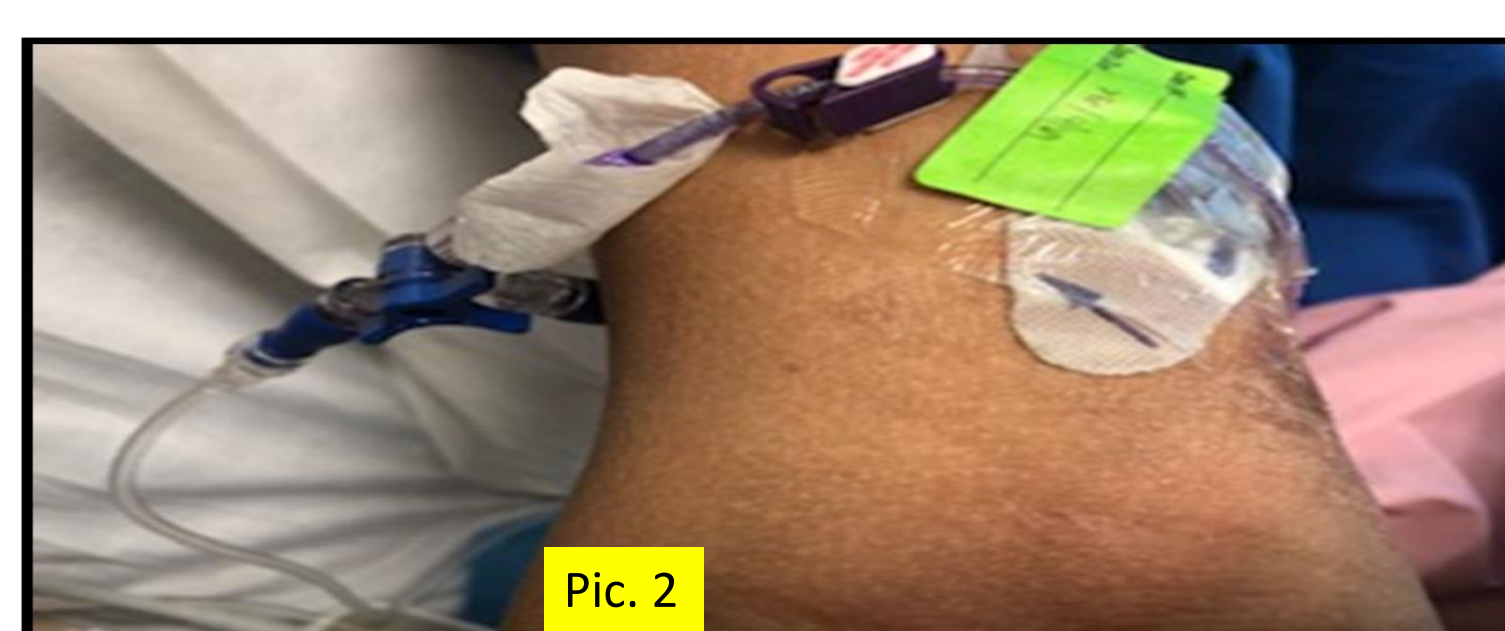
PICC External lines exposed and tangling without support potentially loosen PICC dressing and increase risk of dislodgement

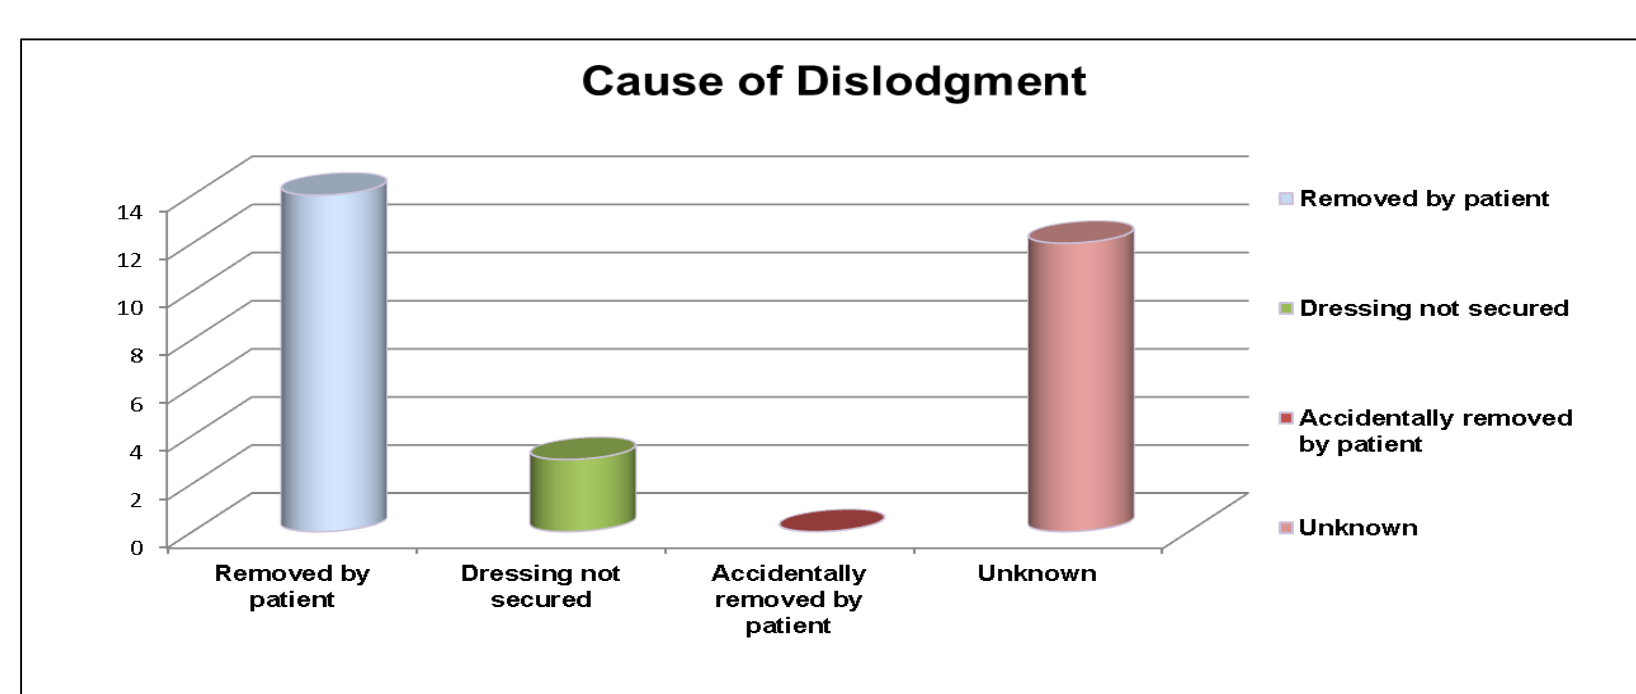
Fig. A

With the incident data and the survey from 226 nurses, we identified the top 2 reasons of the PICC dislodgement were: (1) removed by patient and (2) dressing was not secured (Fig. A). 40.7% of nurses experienced PICC dislodgement (Fig. B) and 53.5% felt that there is a need to improve securement method for PICC (Fig. C).

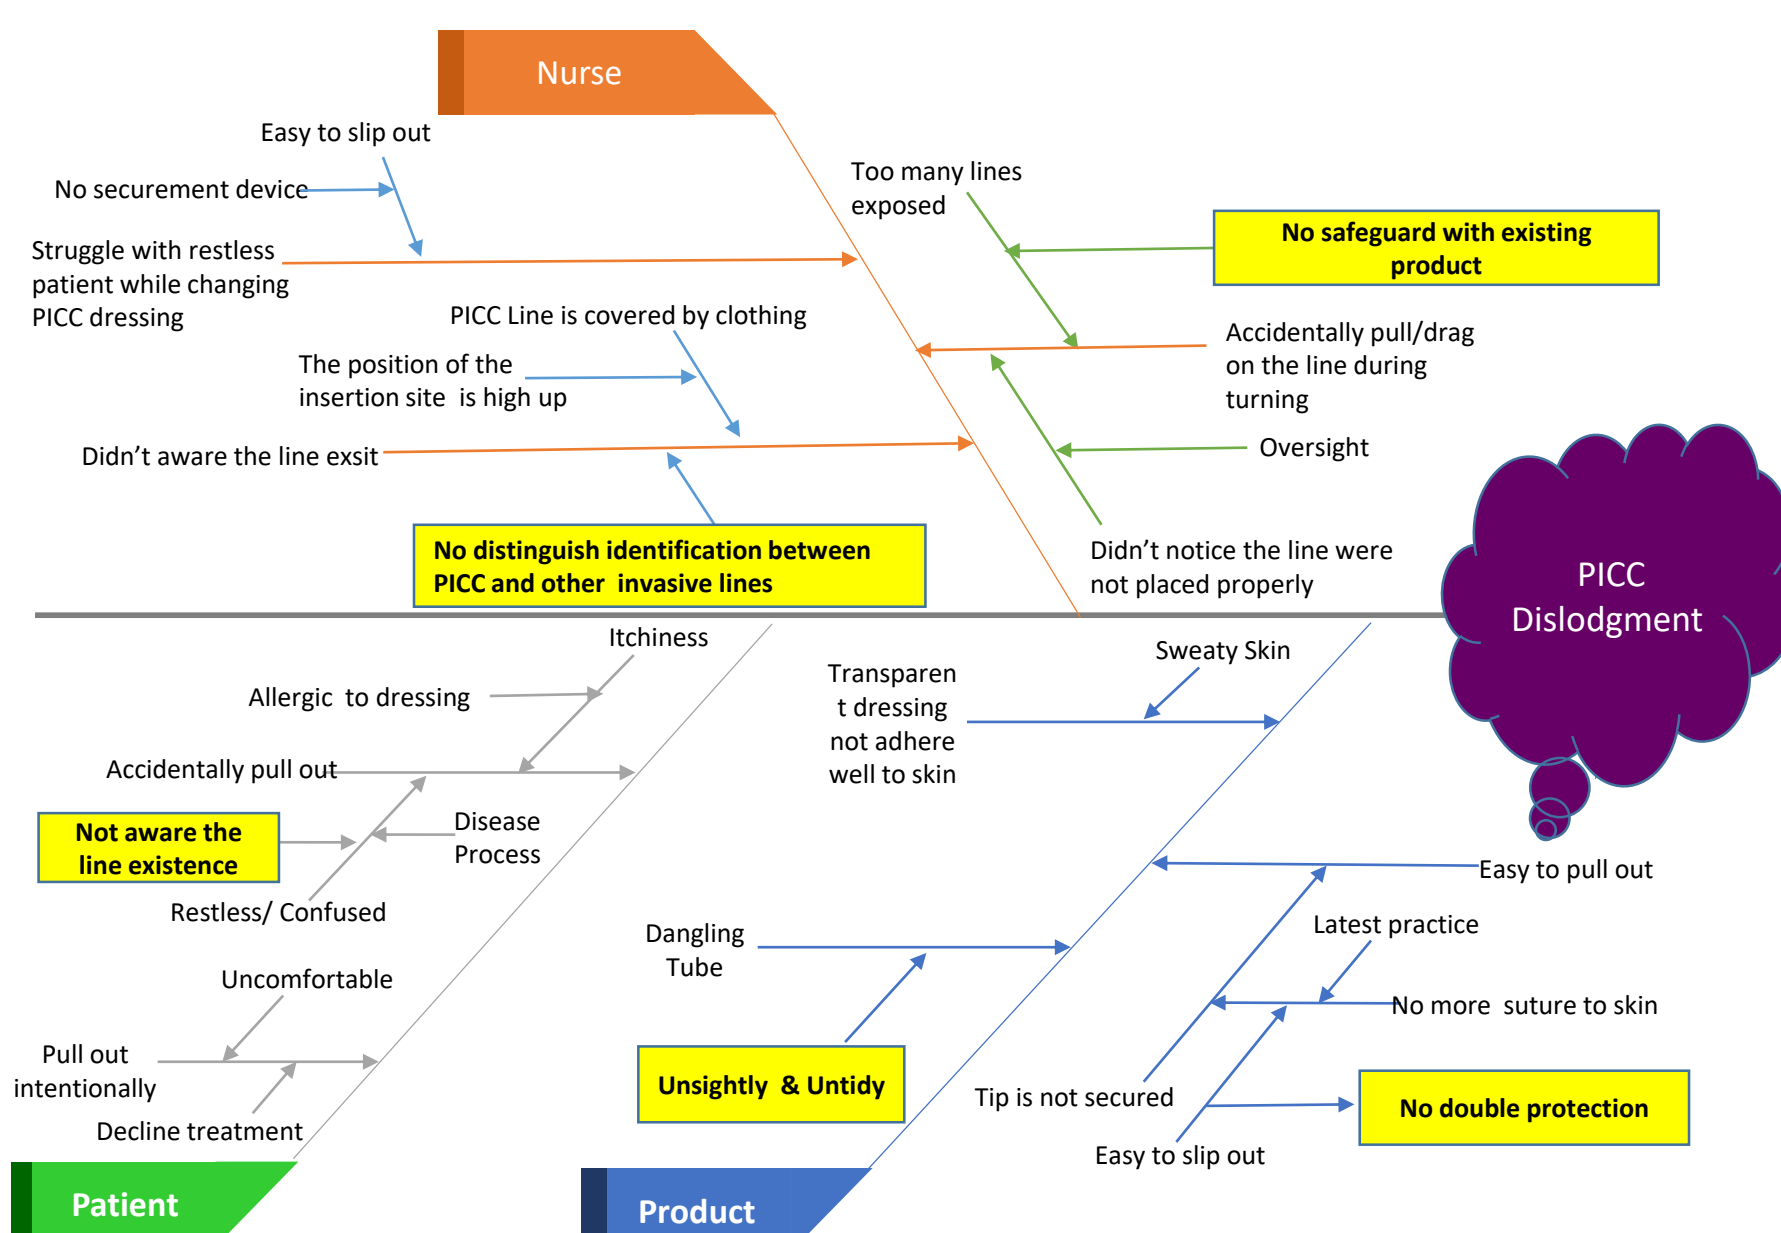
Fig. D

Root Cause Analysis conducted with 5 Root Causes Identified (Fig. D)

Fishbone Diagram

- No safeguard of existing product
- No distinguish identification between PICC and other invasive lines
- No double protection
- Not aware the line existence
- Unsightly and untidy

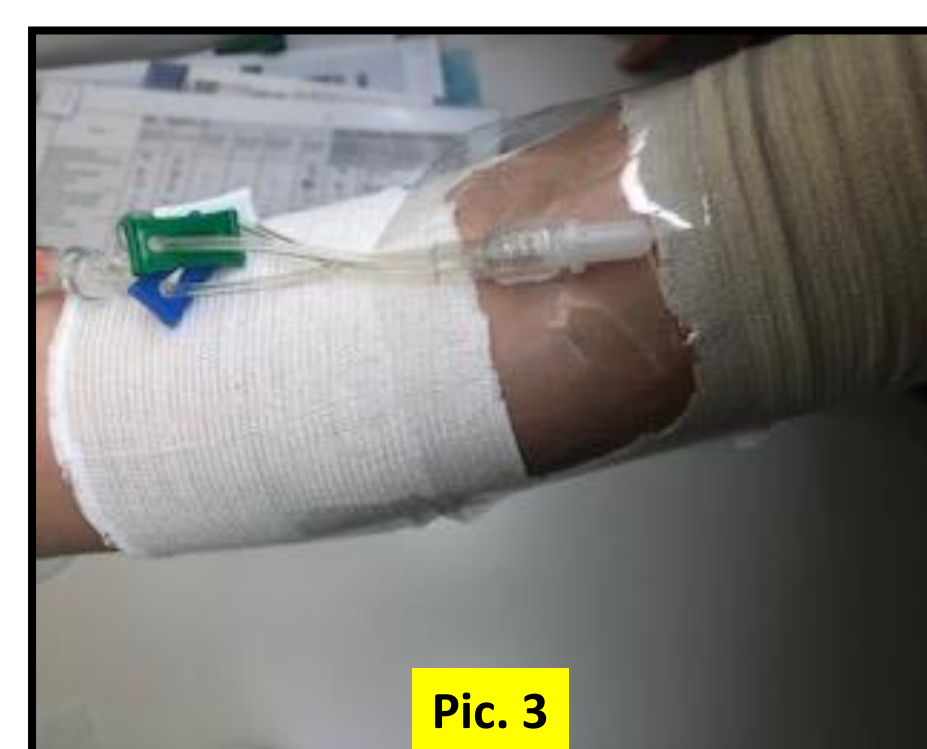
PDSA Cycle 1
1st Prototype created based on root causes identified on 3/2/2019

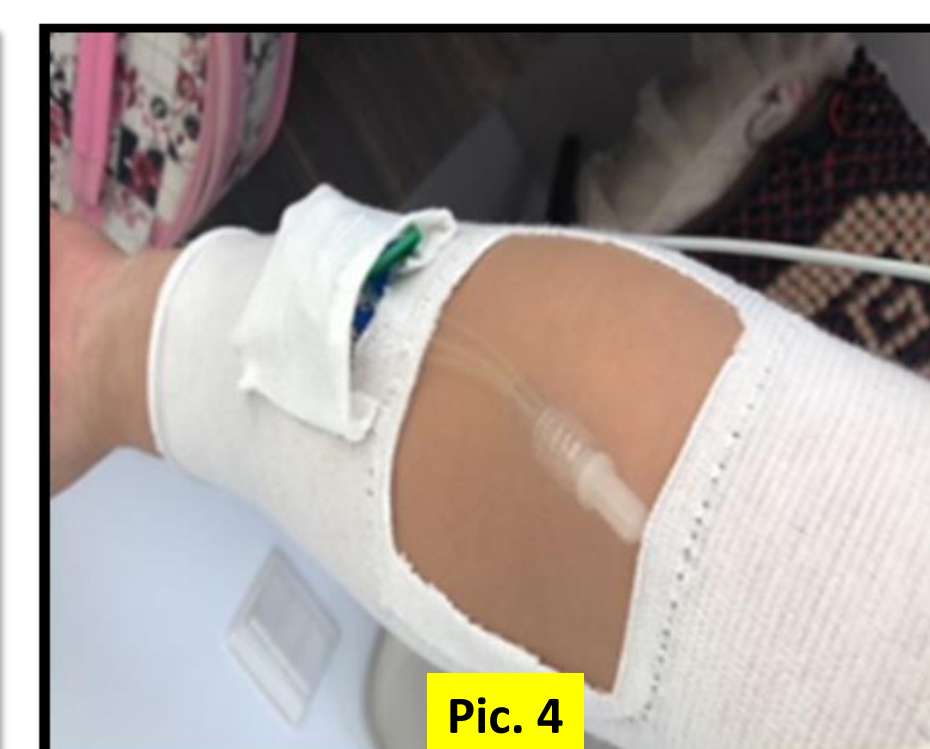
PDSA Cycle 2
Window material changed from plastic to stocking

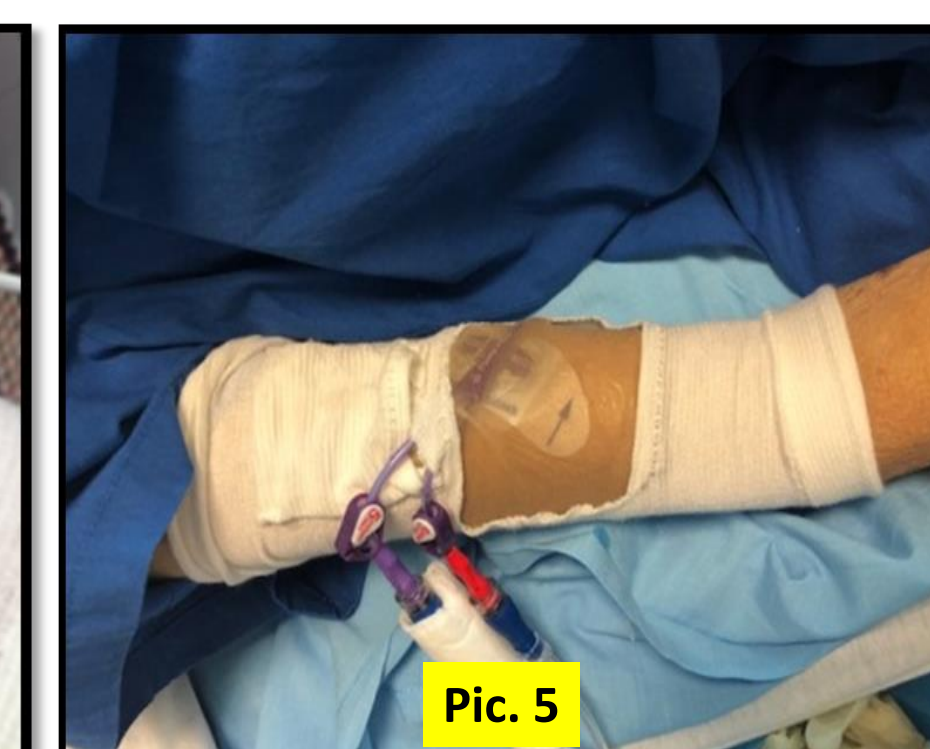
PDSA Cycle 3
Improve material elasticity based on feedback

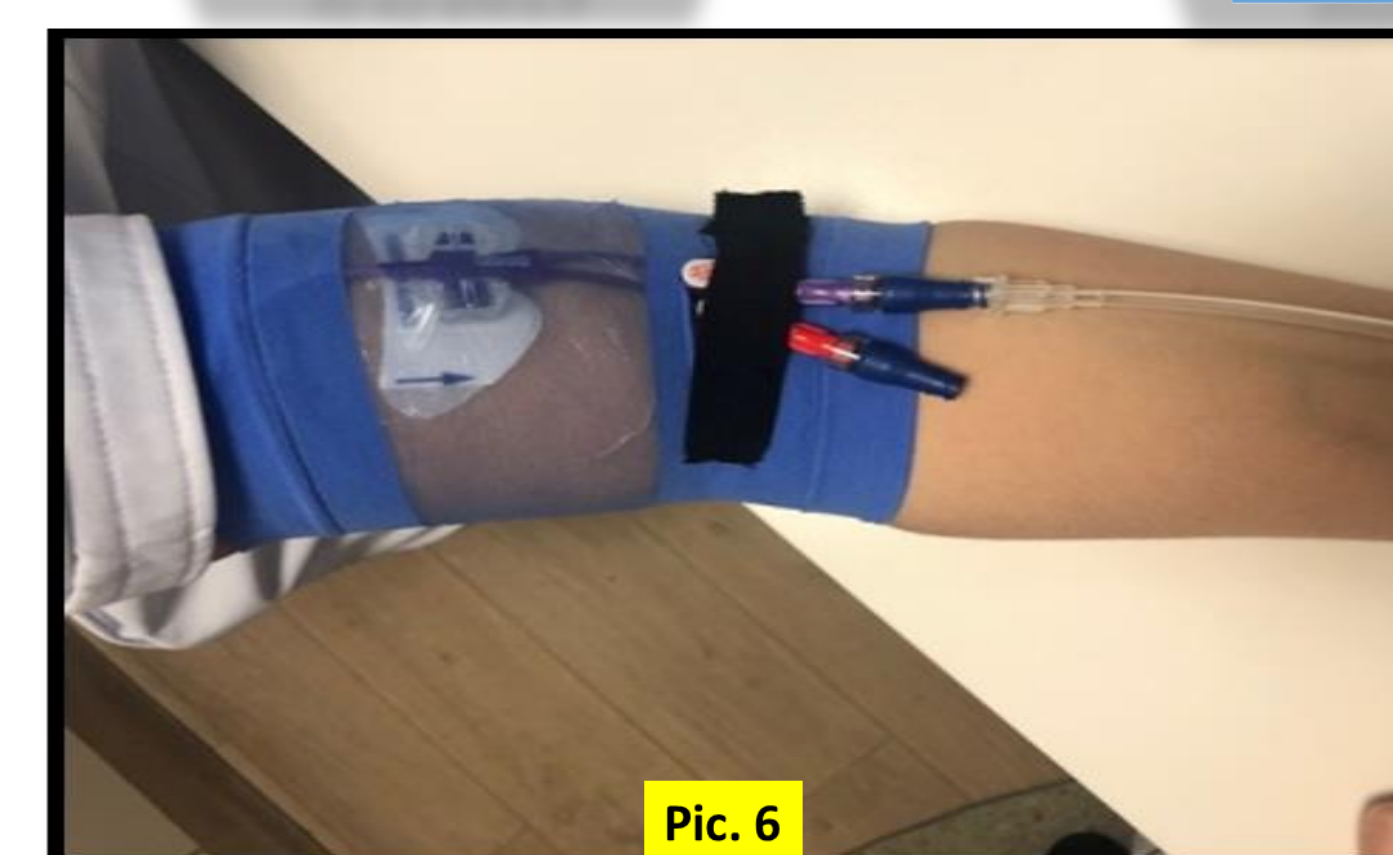
PDSA Cycle 4
Collaboration with External Vendor for Mass Production

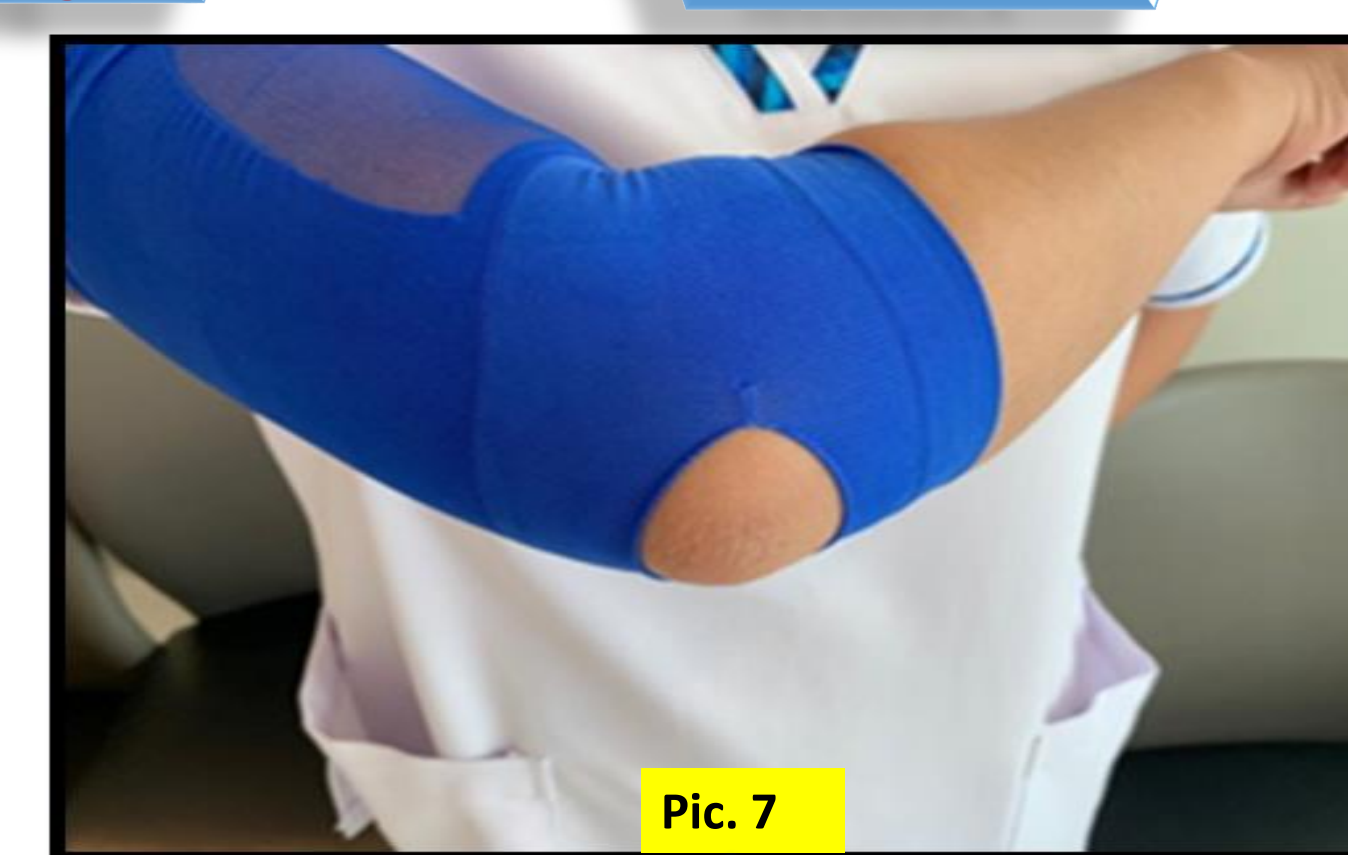
PDSA Cycle 5
Create Opening at elbow for patient comfort and skin integrity assessment

- The material is stretchable
- Good Securement
- Comfortable, not hot
- Visible at insertion site
- Fit to all arm PICC circumferences
- Fit for different directions of PICC insertion

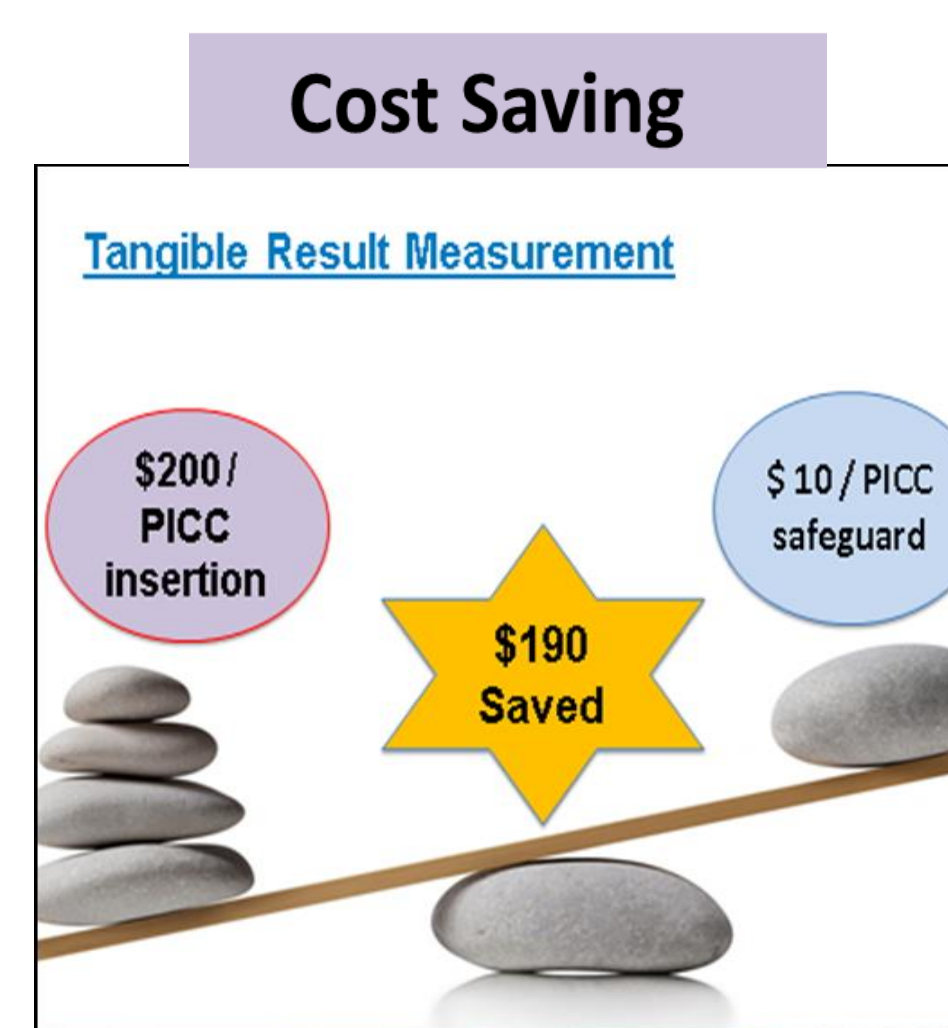
Fig. E

- Zero dislodgment incidents during the trial period
- 95% Cost saving for both patient and organisation (Fig. E)
- 100% positive feedback from both staff (Fig. F) and patients (Fig. G) that result in improved staff confidence and patient's satisfaction
- Promote patient safety and prevent prolong hospitalisation
