Proper discharge of used Ear Thermometer probe cover

KK Women's and
Children's Hospital
SingHealth

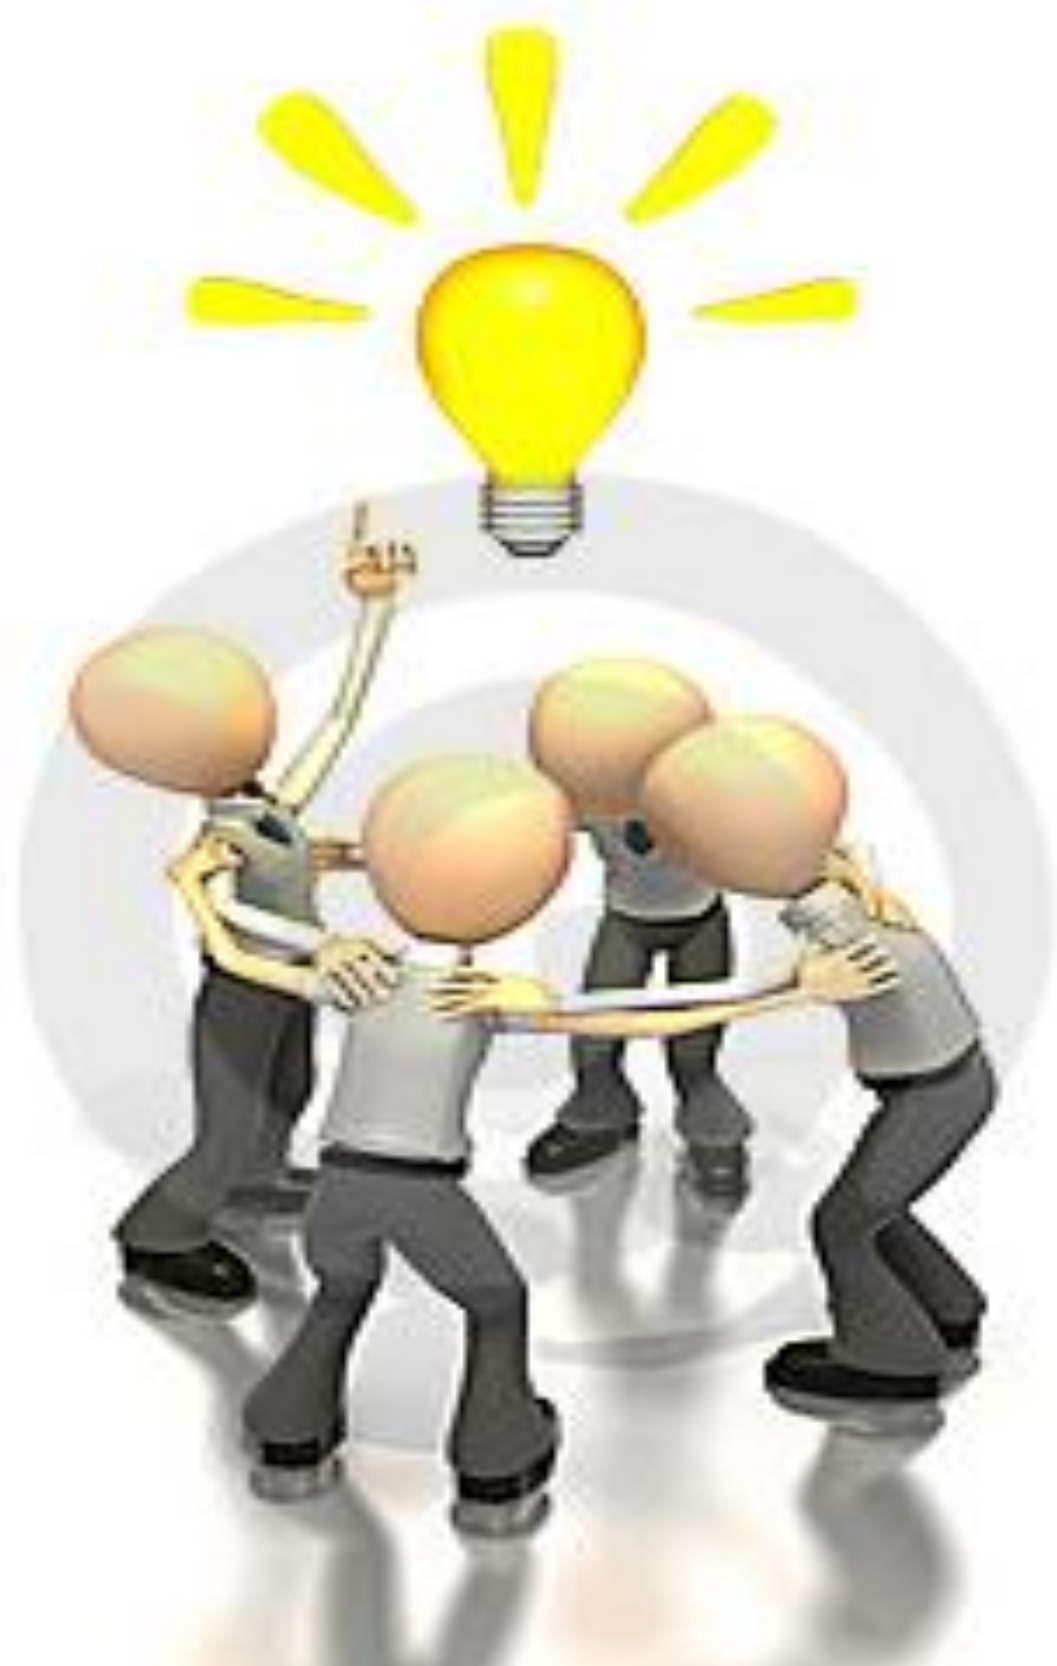
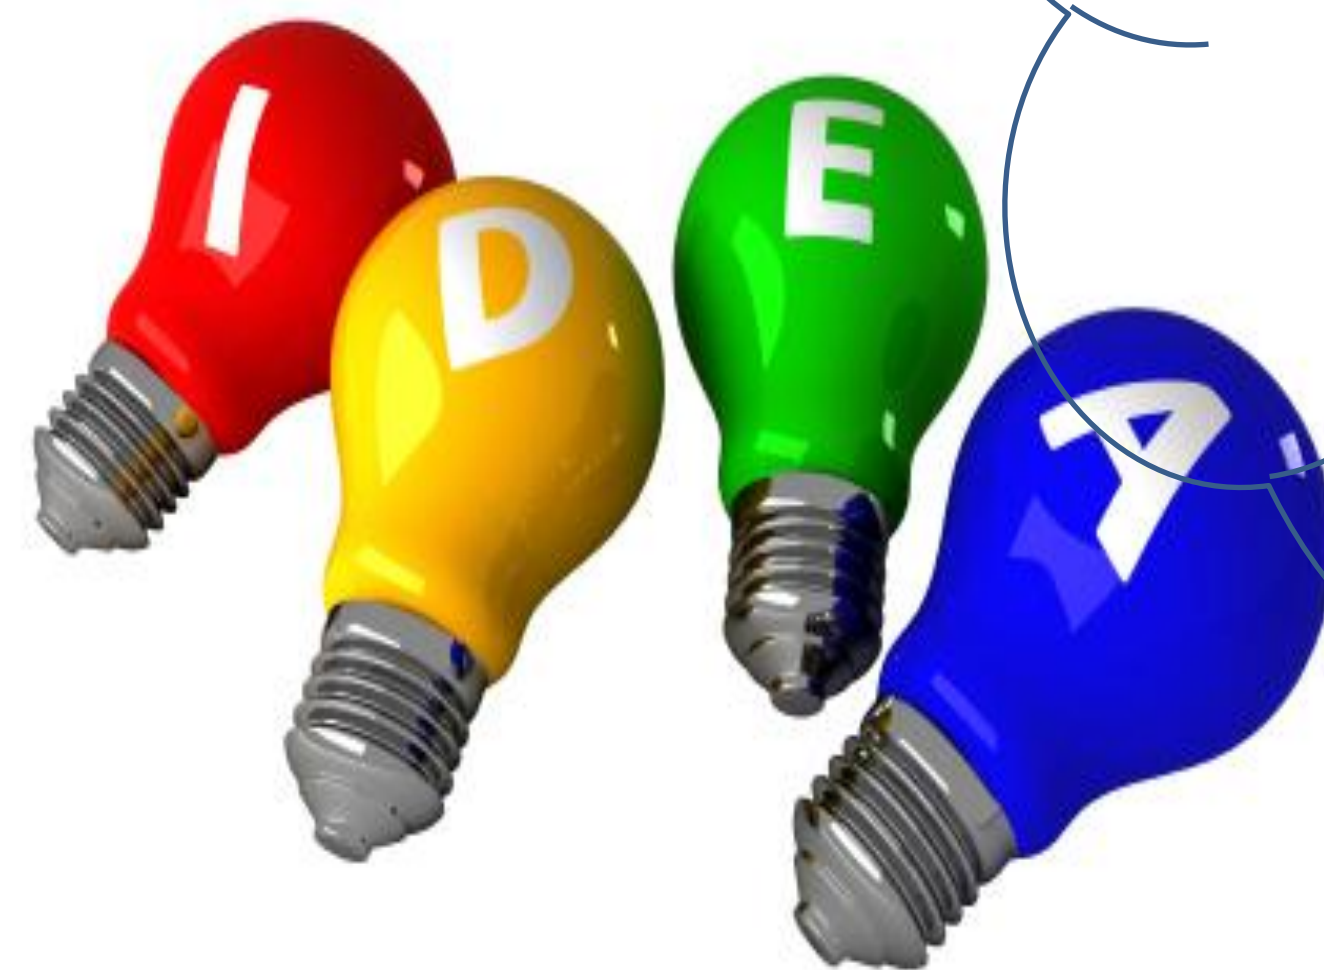
When departments have ear thermometers that are defective or damaged, they will bring the ear thermometer to MMD for one to one exchange. In 2014, MMD noticed that 49 ear thermometers had ejection rings that were broken by user handling.

MMD invited the vendor for discussion to determine the root cause of the damage. After reviewing the product instruction manual, the conclusion was that users inadvertently discharged the used ear probe incorrectly, hence breaking the ejection ring.

The team decided to create a poster to remind users how to properly discharge used ear probes.
