A Systematic Risk-Mitigating Approach to Rectify a Hazardous Operating Table Design

Singapore Healthcare Management 2016

Chia Soon Noi, KK Women's and Children's Hospital
Yin Shanjing, KK Women's and Children's Hospital
Ong Lay Teng, KK Women's and Children's Hospital

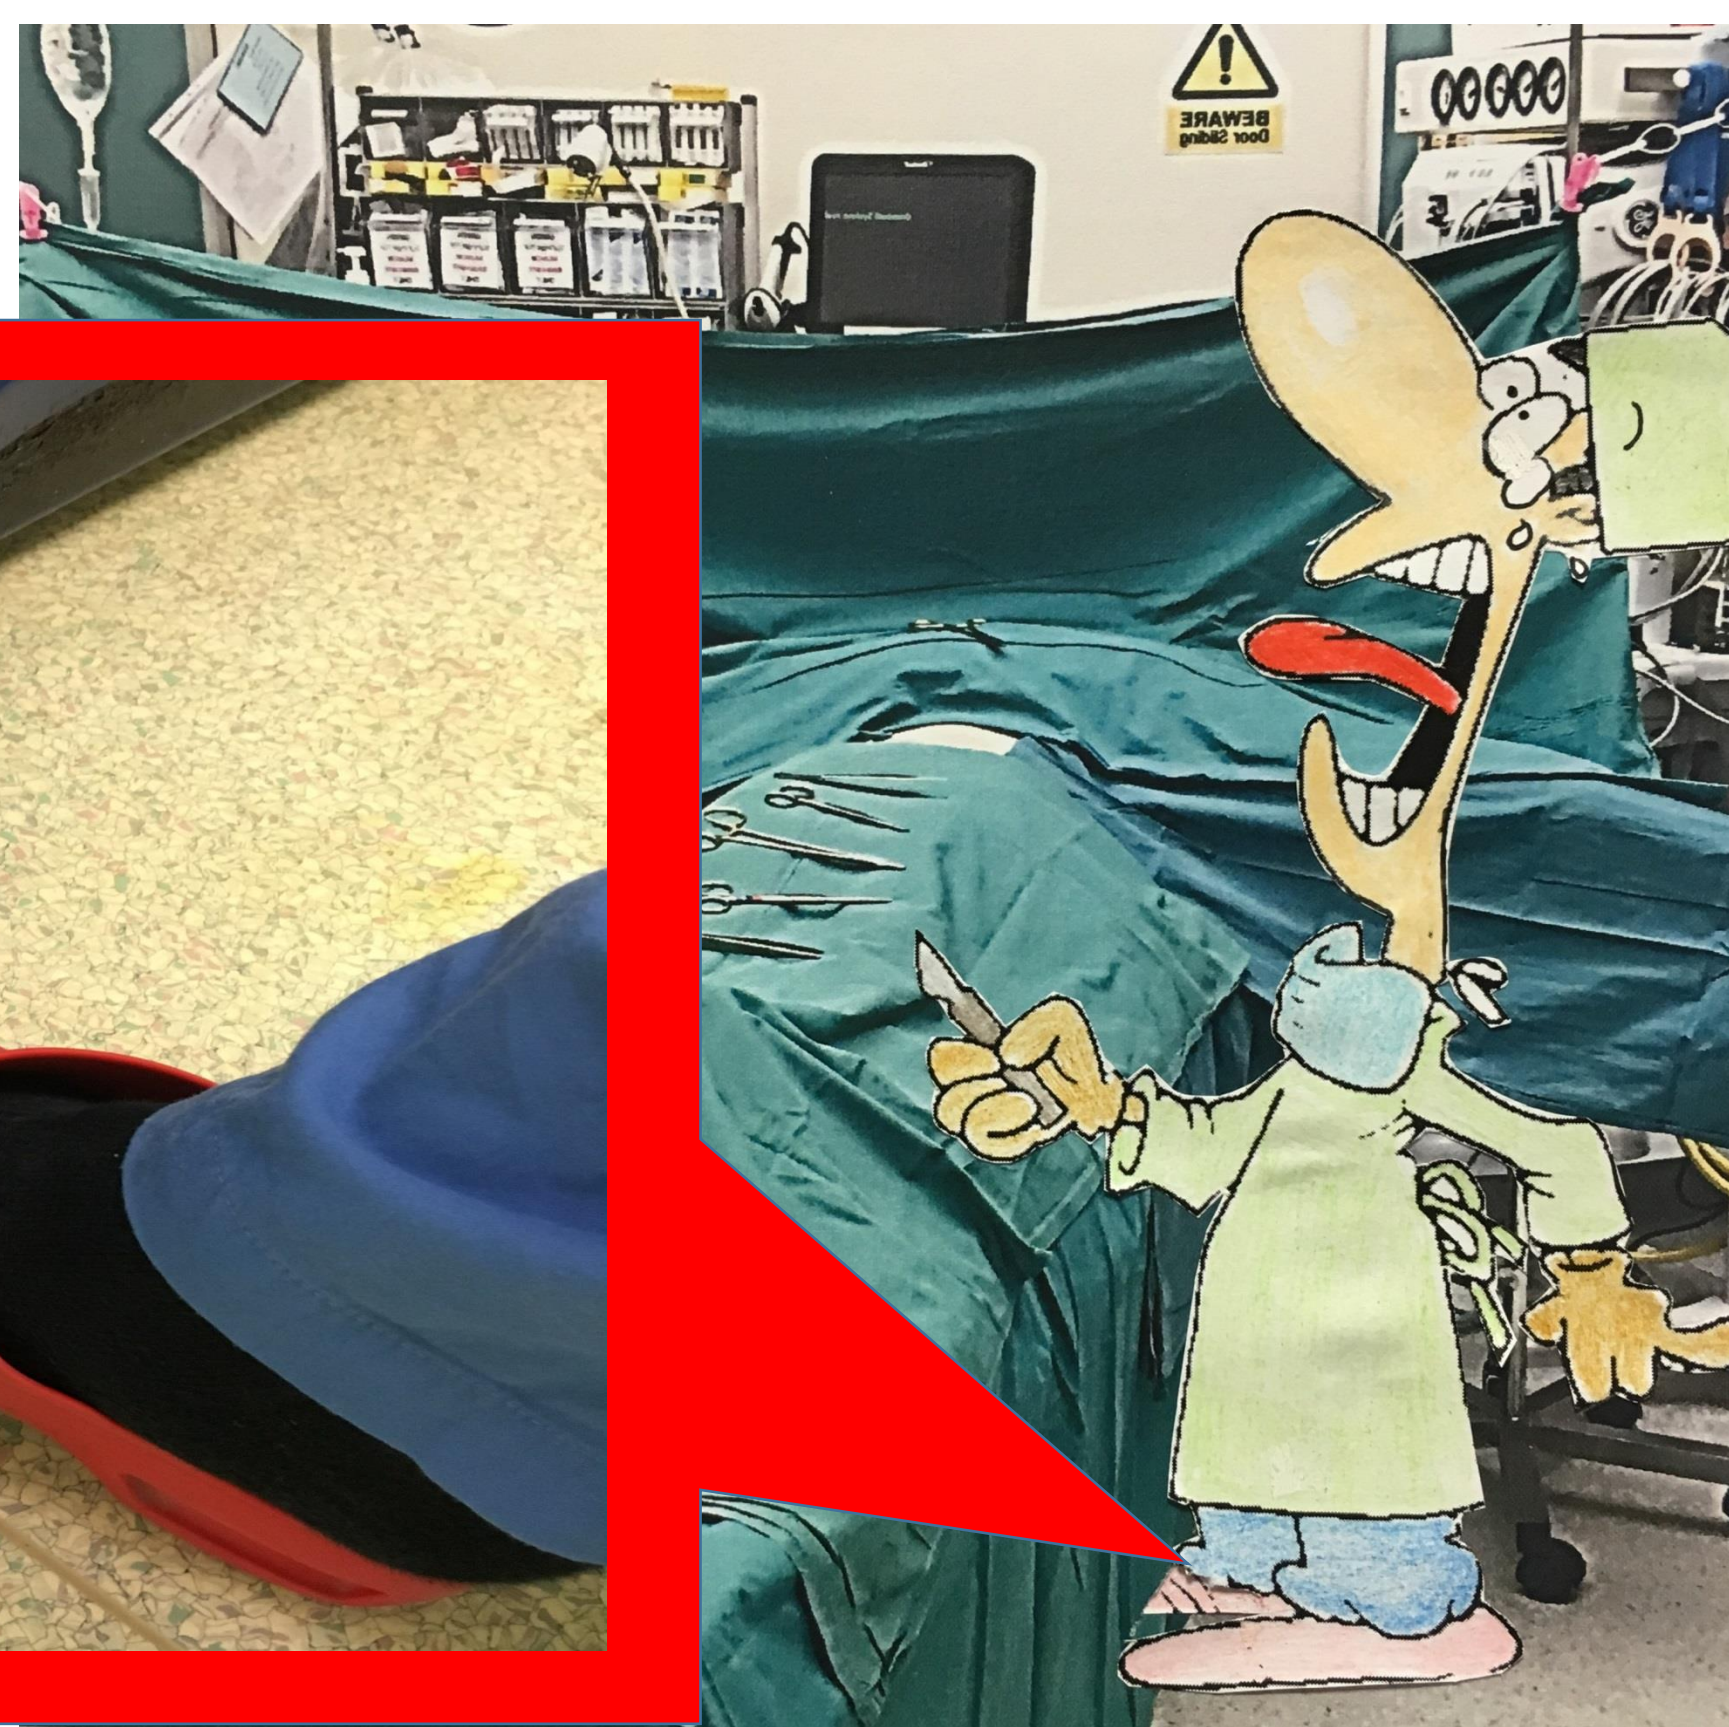
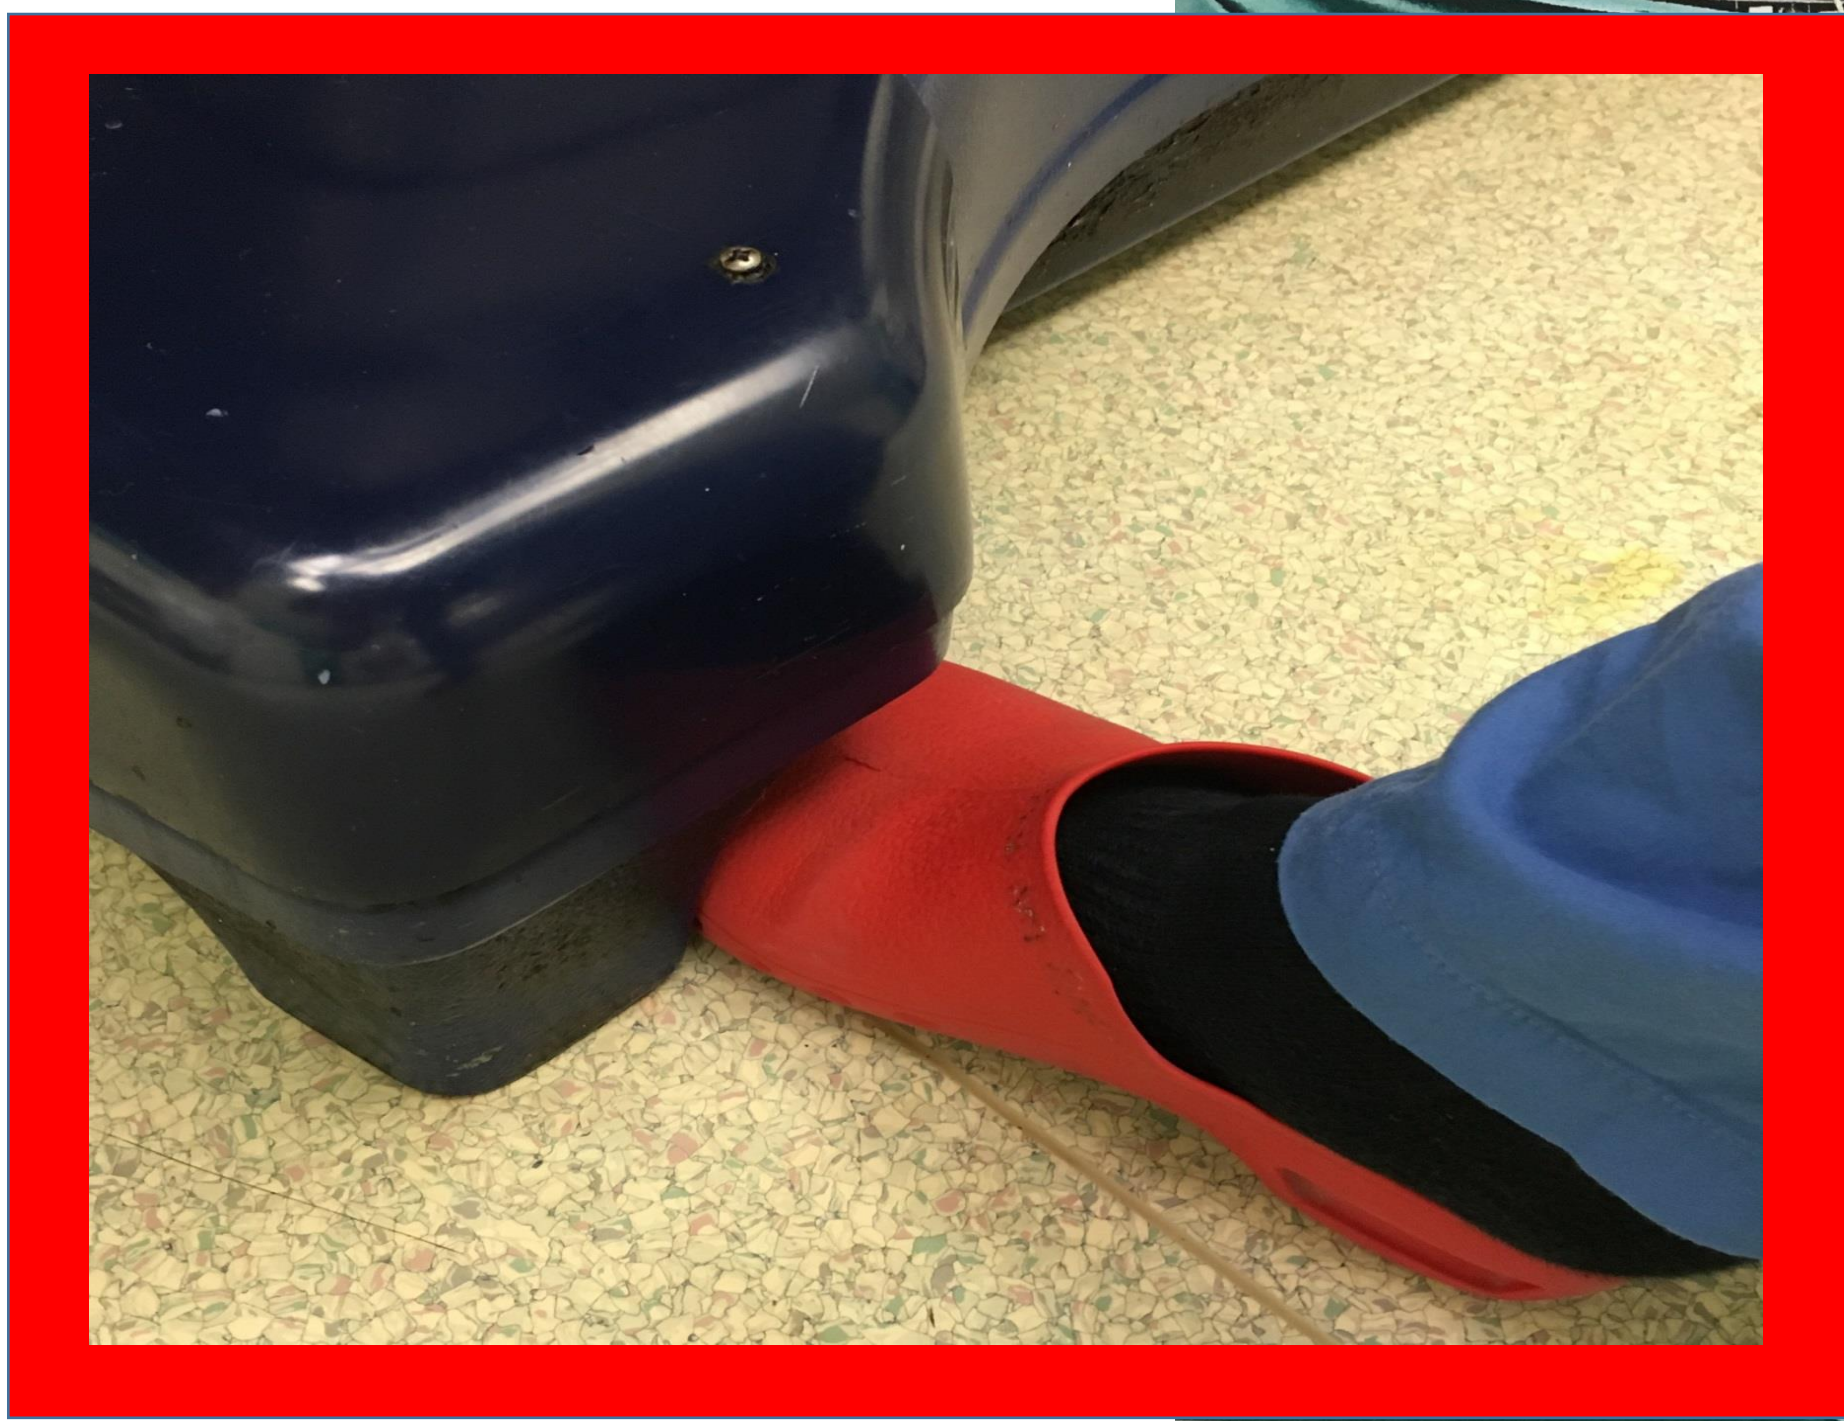
Fig 1: Operating table and its parts

There were two incidents of foot injury resulting from operating table swerved during table manipulation intraoperative on two separate occasions within a period of three years. One surgeon sustained toe fracture while the other had bruises and abrasion on the foot. Both hospital and vendor engineers were unable to identify the cause of the swerve.

After multiple trials, the swerve of operating table was finally simulated. The operating table foot portion was break for lithotomy position and these two screws were found to be resting on the base when the break was more than 90°. The screws on the foot portion of the operating table lifted the base when patient's head is lowered intra-operatively. This happened under surgical drapes therefore surgical team was unaware. When table was manipulated, the screws disengaged from the based causing the swerve and a sudden drop of the base of the operating table resulting in the foot injury.

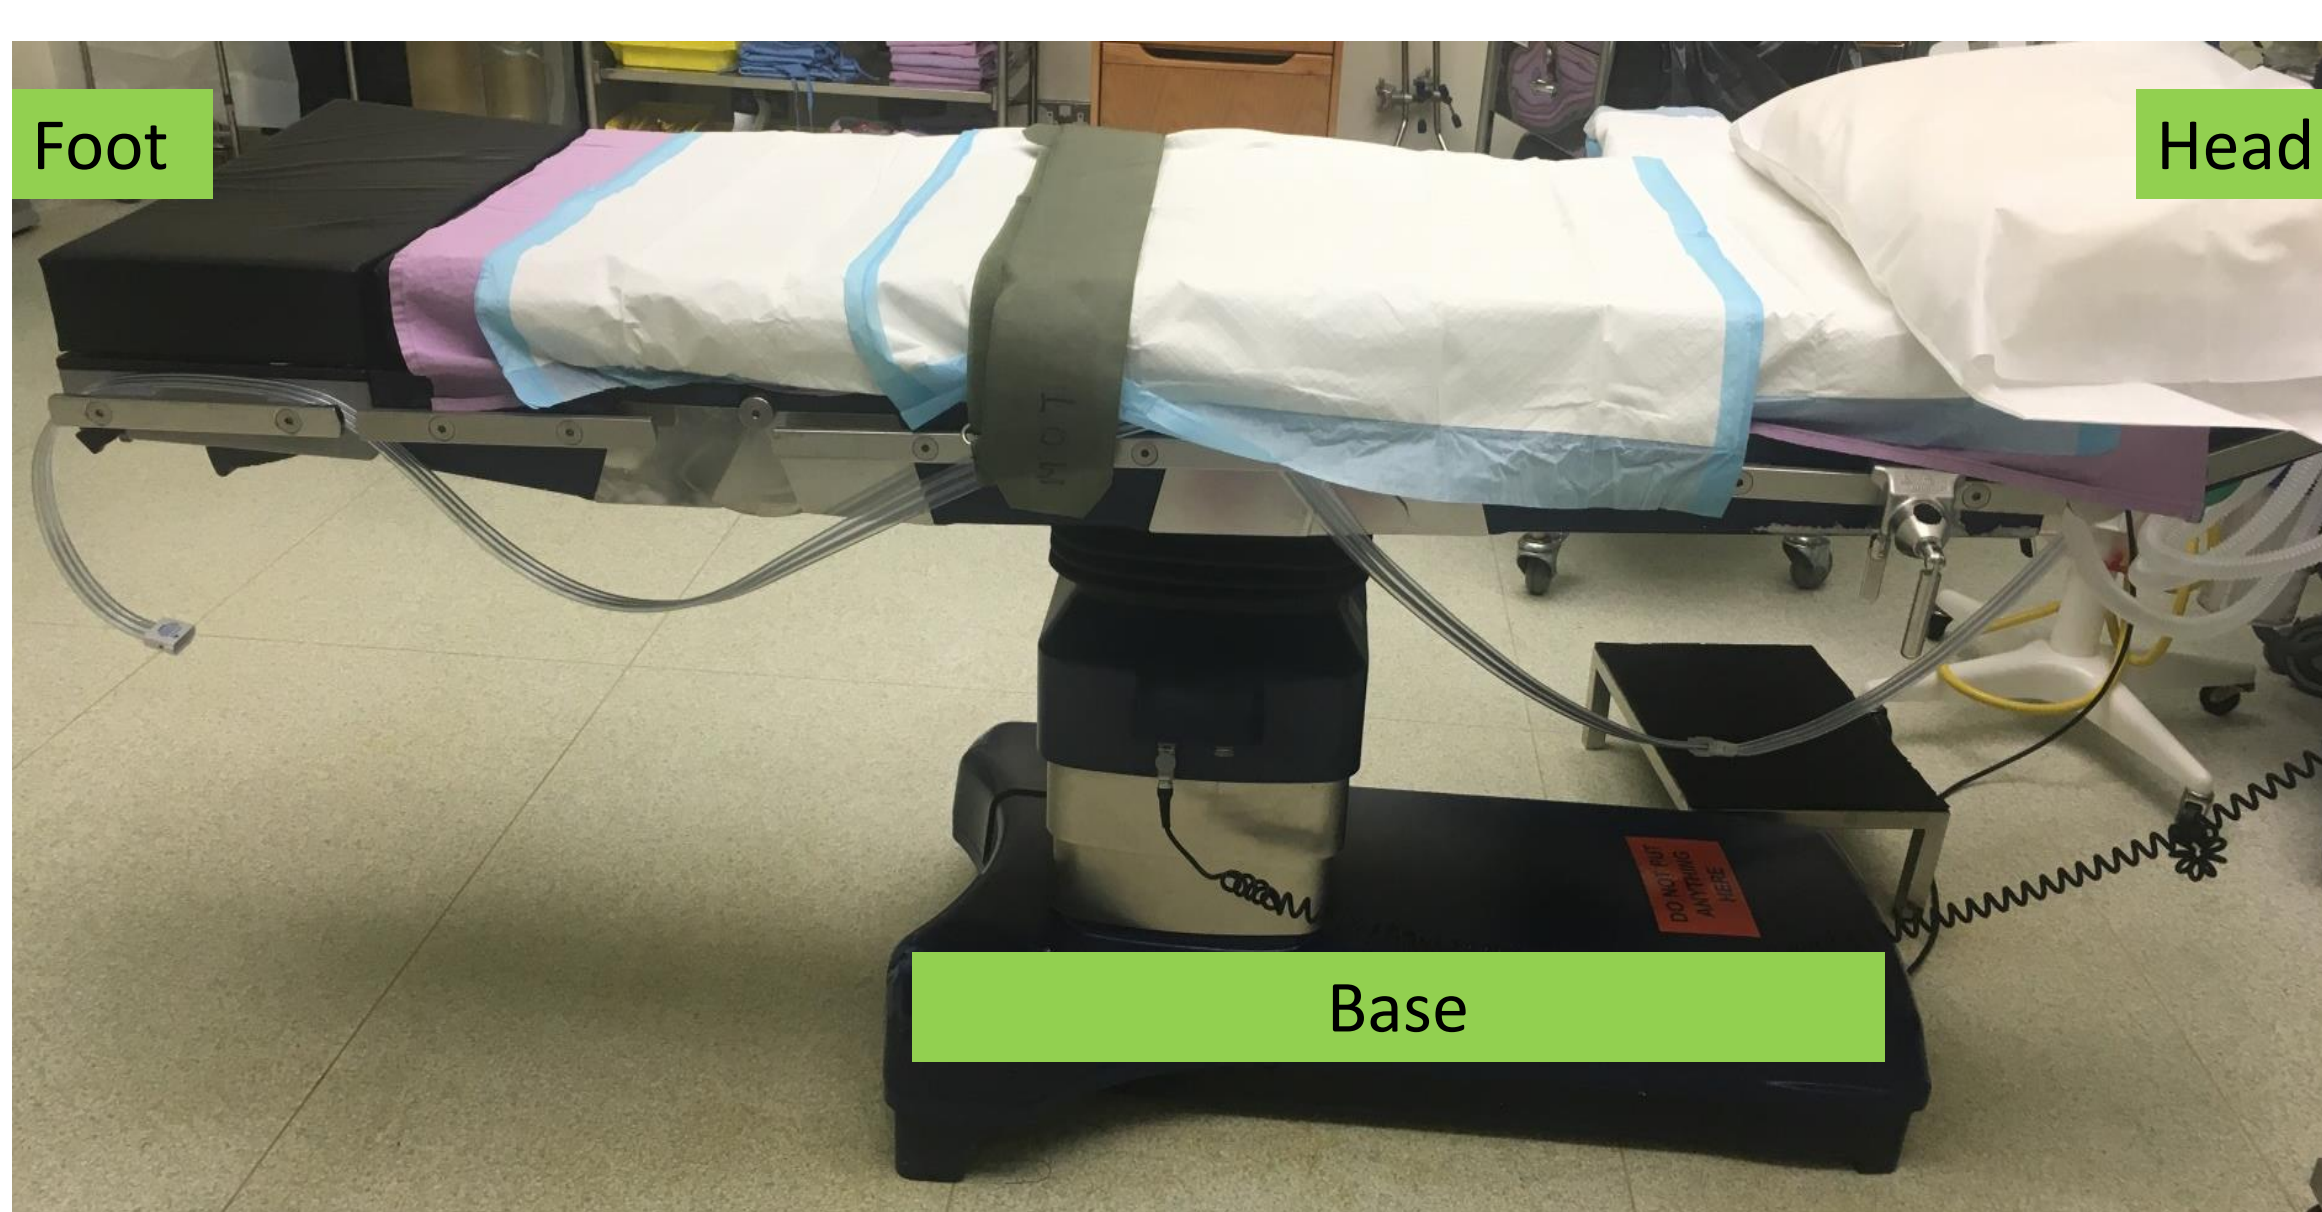
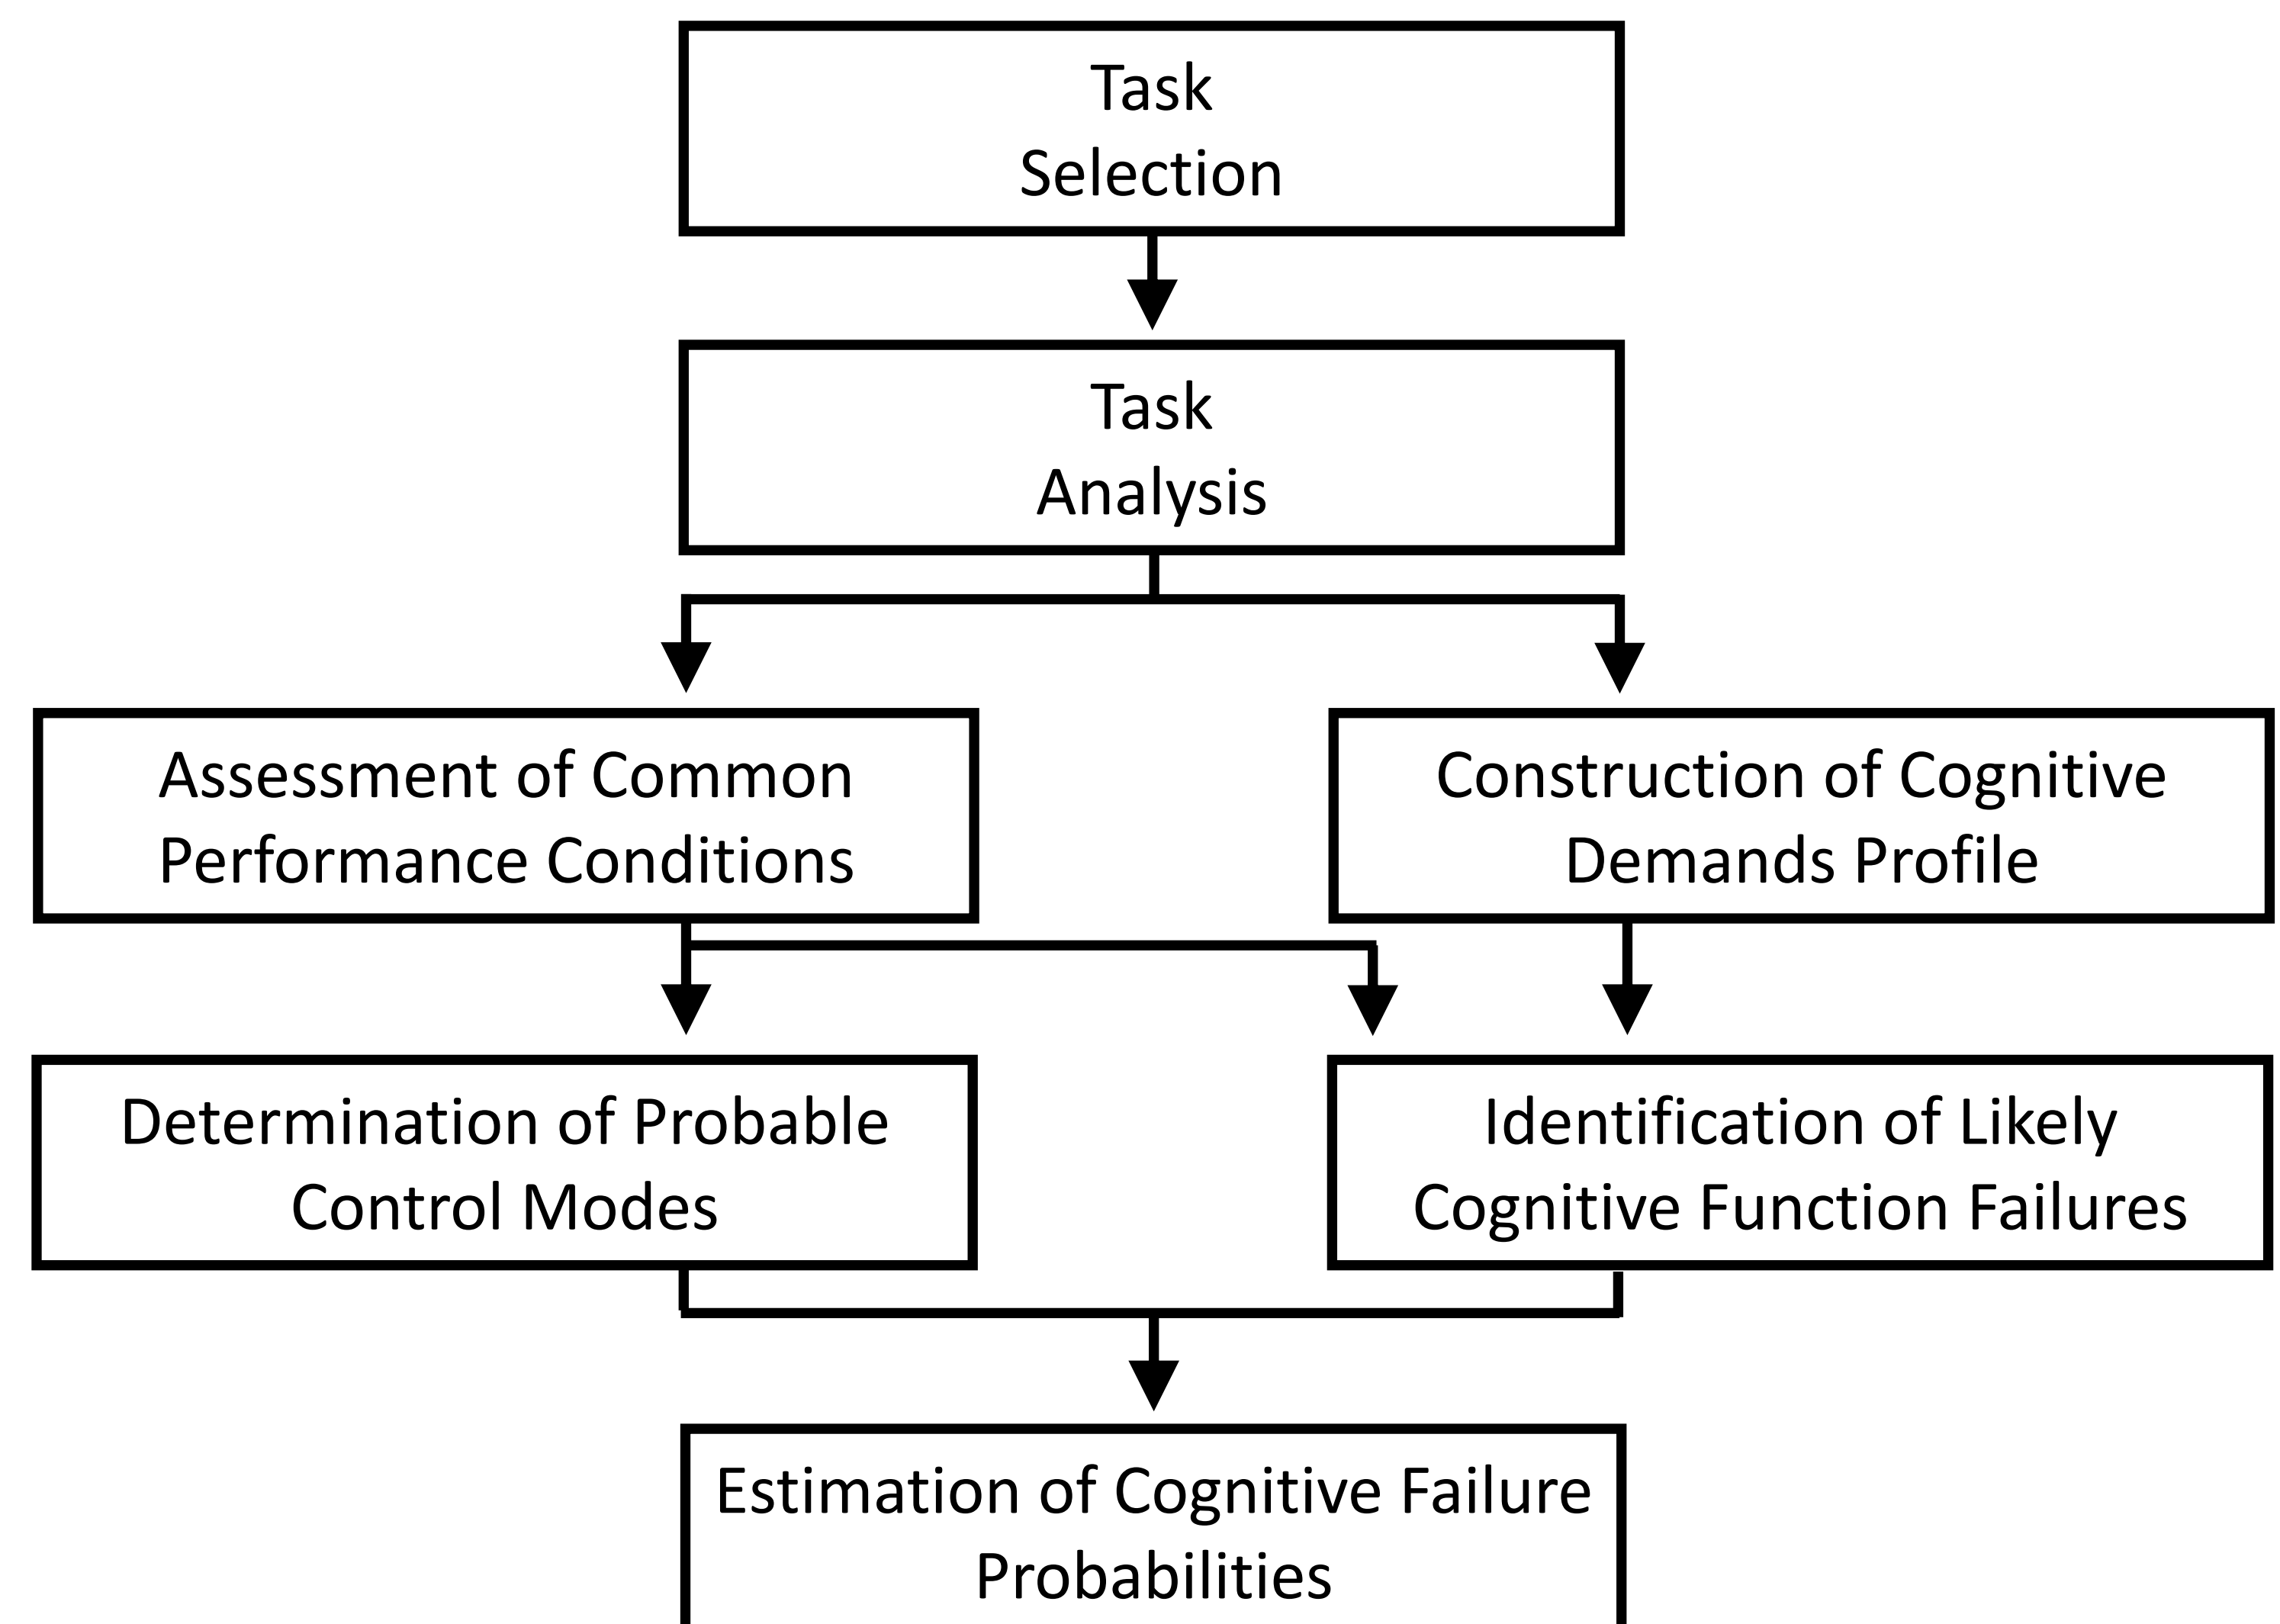
Decision was made to engage the Human Factor Specialist to explore the preventive measures for such incidents. Understanding the various parts and normal function of the operating table is essential to further examine the operating table (Fig 1). Careful examination of the operating table was performed with multiple simulations of various positions of the operating table to explore reason for the swerve.
