To Reduce the Rate of Breakage of Periodontal Probe during the Central Sterile Service Department (CSSD) Sterilisation Process

Singapore Healthcare Management 2021

National Dental Centre Singapore

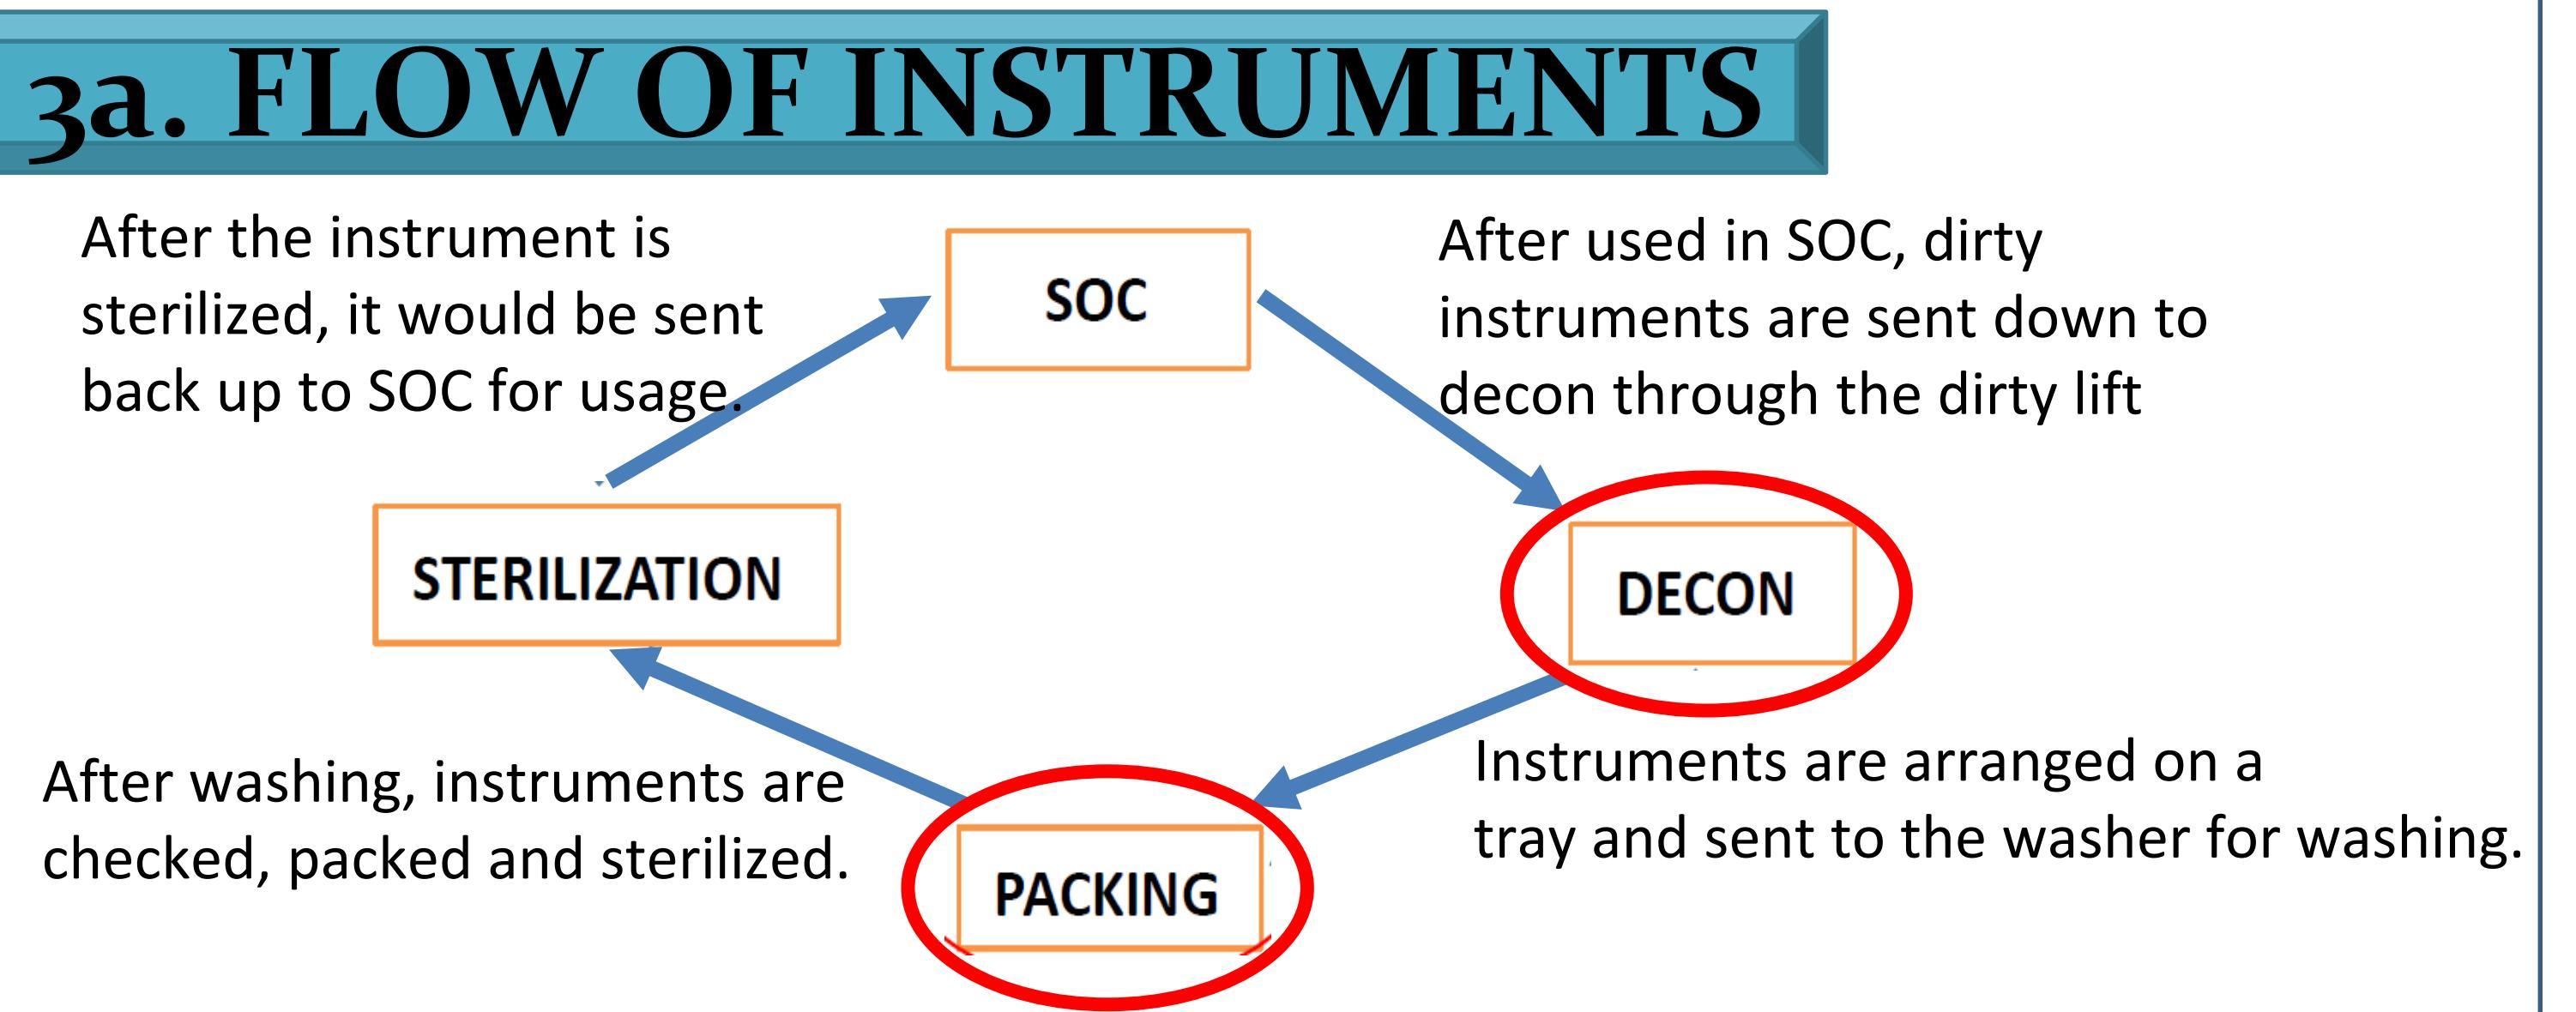
2. Breakage happens within the CSSD sterilization process.

If an instrument is found broken or faulty, it will be condemned and

replaced. The replacement of broken perio probe would typically take 15 mins, however, if there are no existing stock, replacement lead time could take up to 3 months.

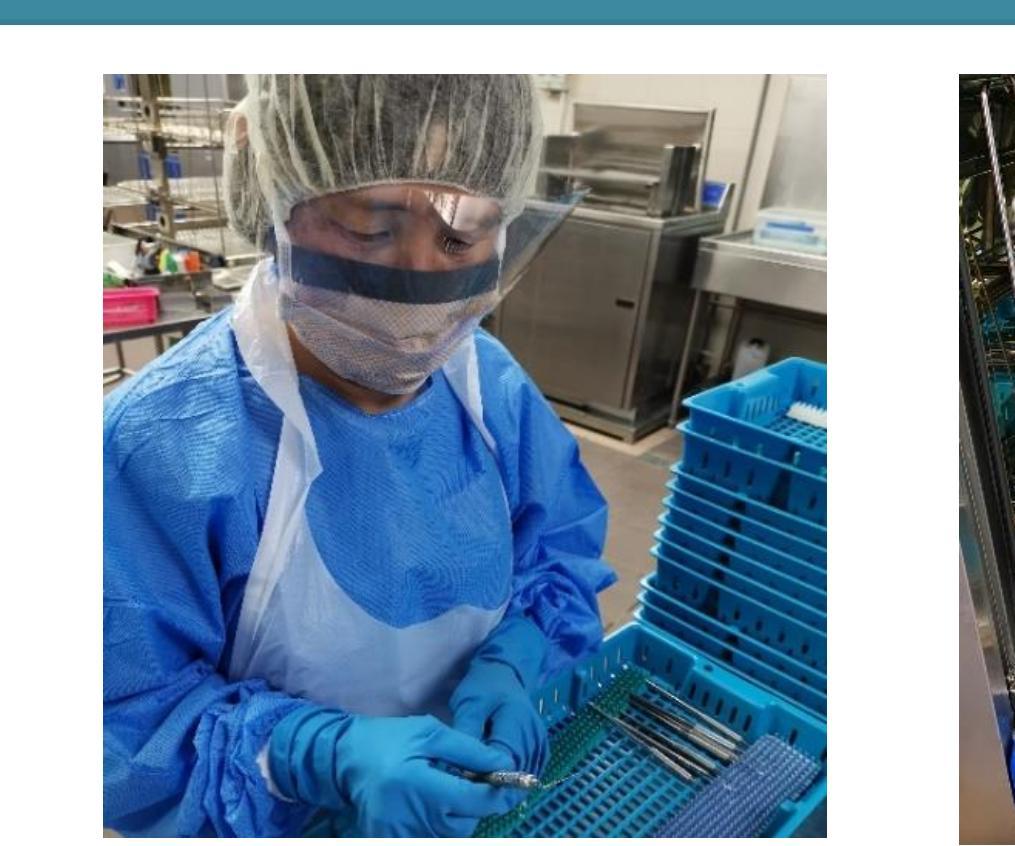
(1) Dirty Instrument receiving station

Not able to identify at which point in the sterilisation workflow did the instrument breakage occur.

(1)Perio probe that is received in broken condition, in the dirty instrument receiving station will be marked with rubber band. (2)Perio probe that is found broken after washer station will be segregated without rubber band.
