Singapore Healthcare Management 2021

Mini C-arm Protector-

The Shield that protects the Mini C-arm

Changi General Hospital
SingHealth

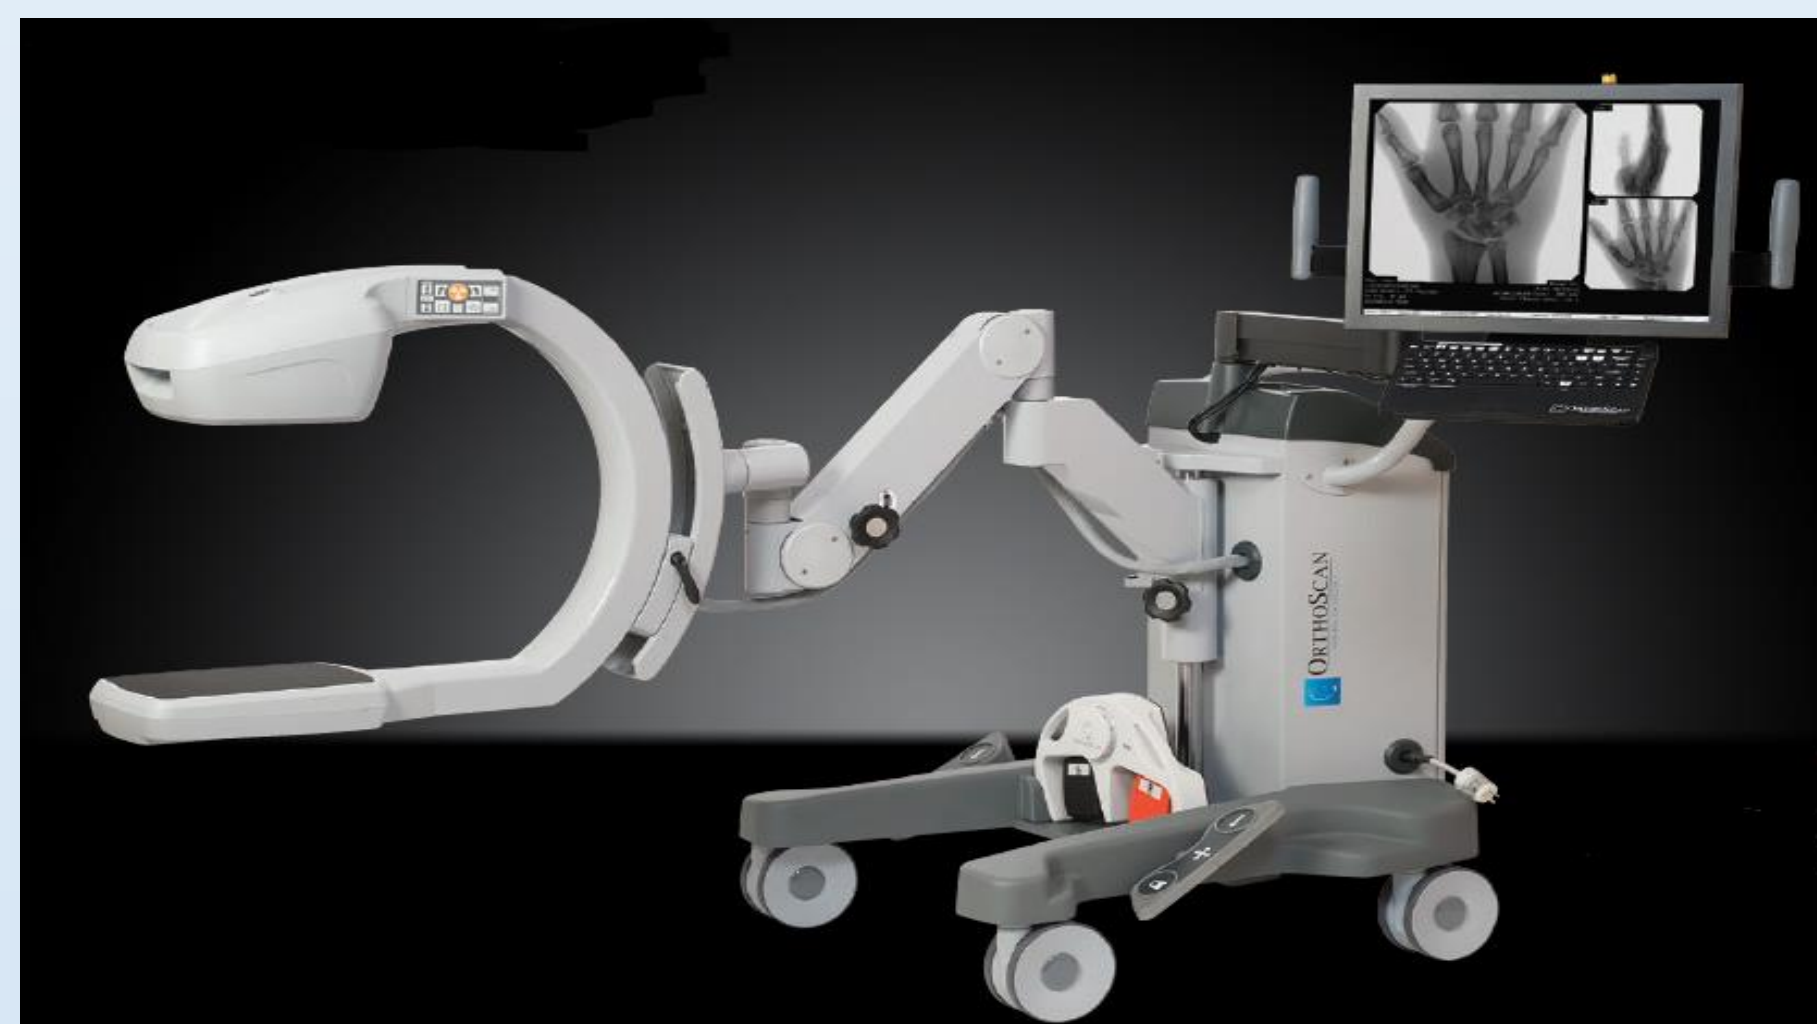
Full view of Mini C-arm

The Mini C-arm combines the components of a standard full-sized C-arm into a compact one-piece system designed especially for extremity orthopedic imaging. It is widely used in orthopedic surgeries especially in upper limb and foot/ankle surgeries.

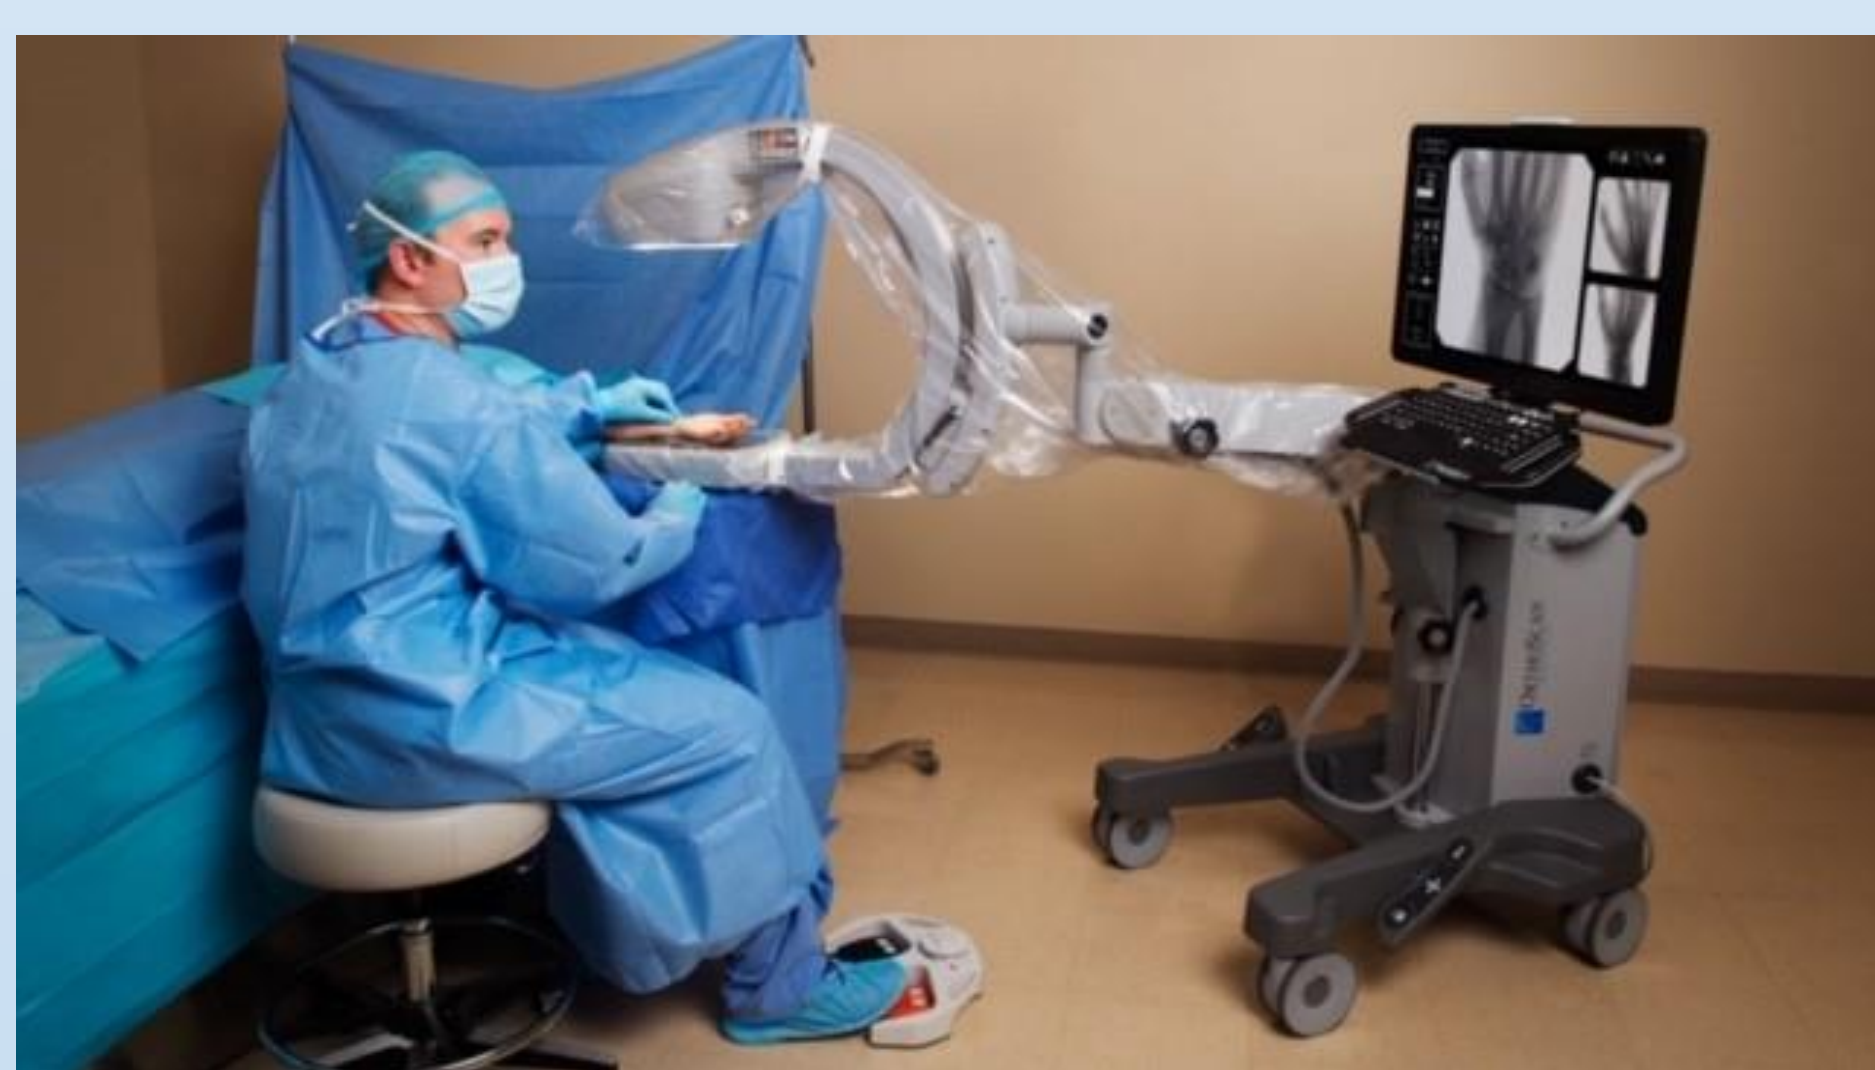
Upper limb surgery with Mini C-arm

During the surgery, the surgeon places the operated limb on the flat detector of the Mini C-arm. The surgeon drills the limb under guidance from the imaging concurrently. However, at times, due to the size and the density of the bones, the drill bits may go thru the bones causing damages to the Mini C-arm drape or even the detector.

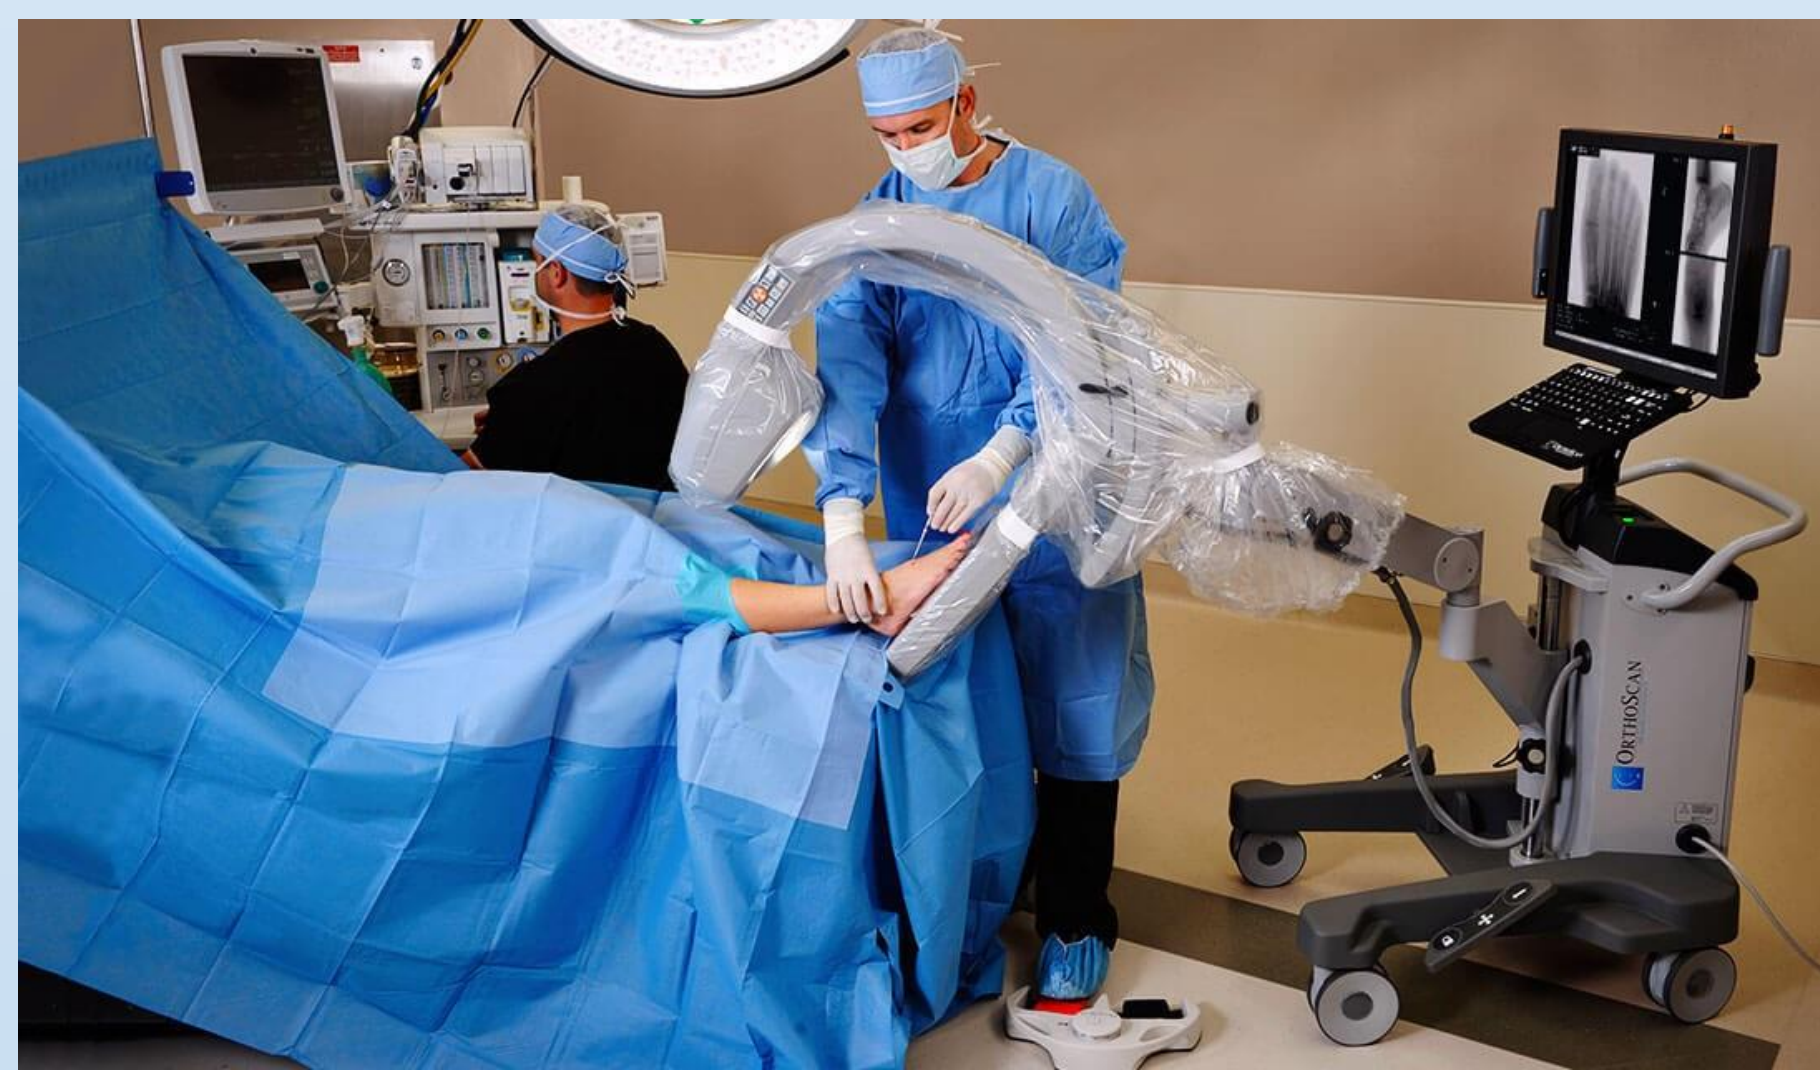
Lower limb surgery with Mini C-arm

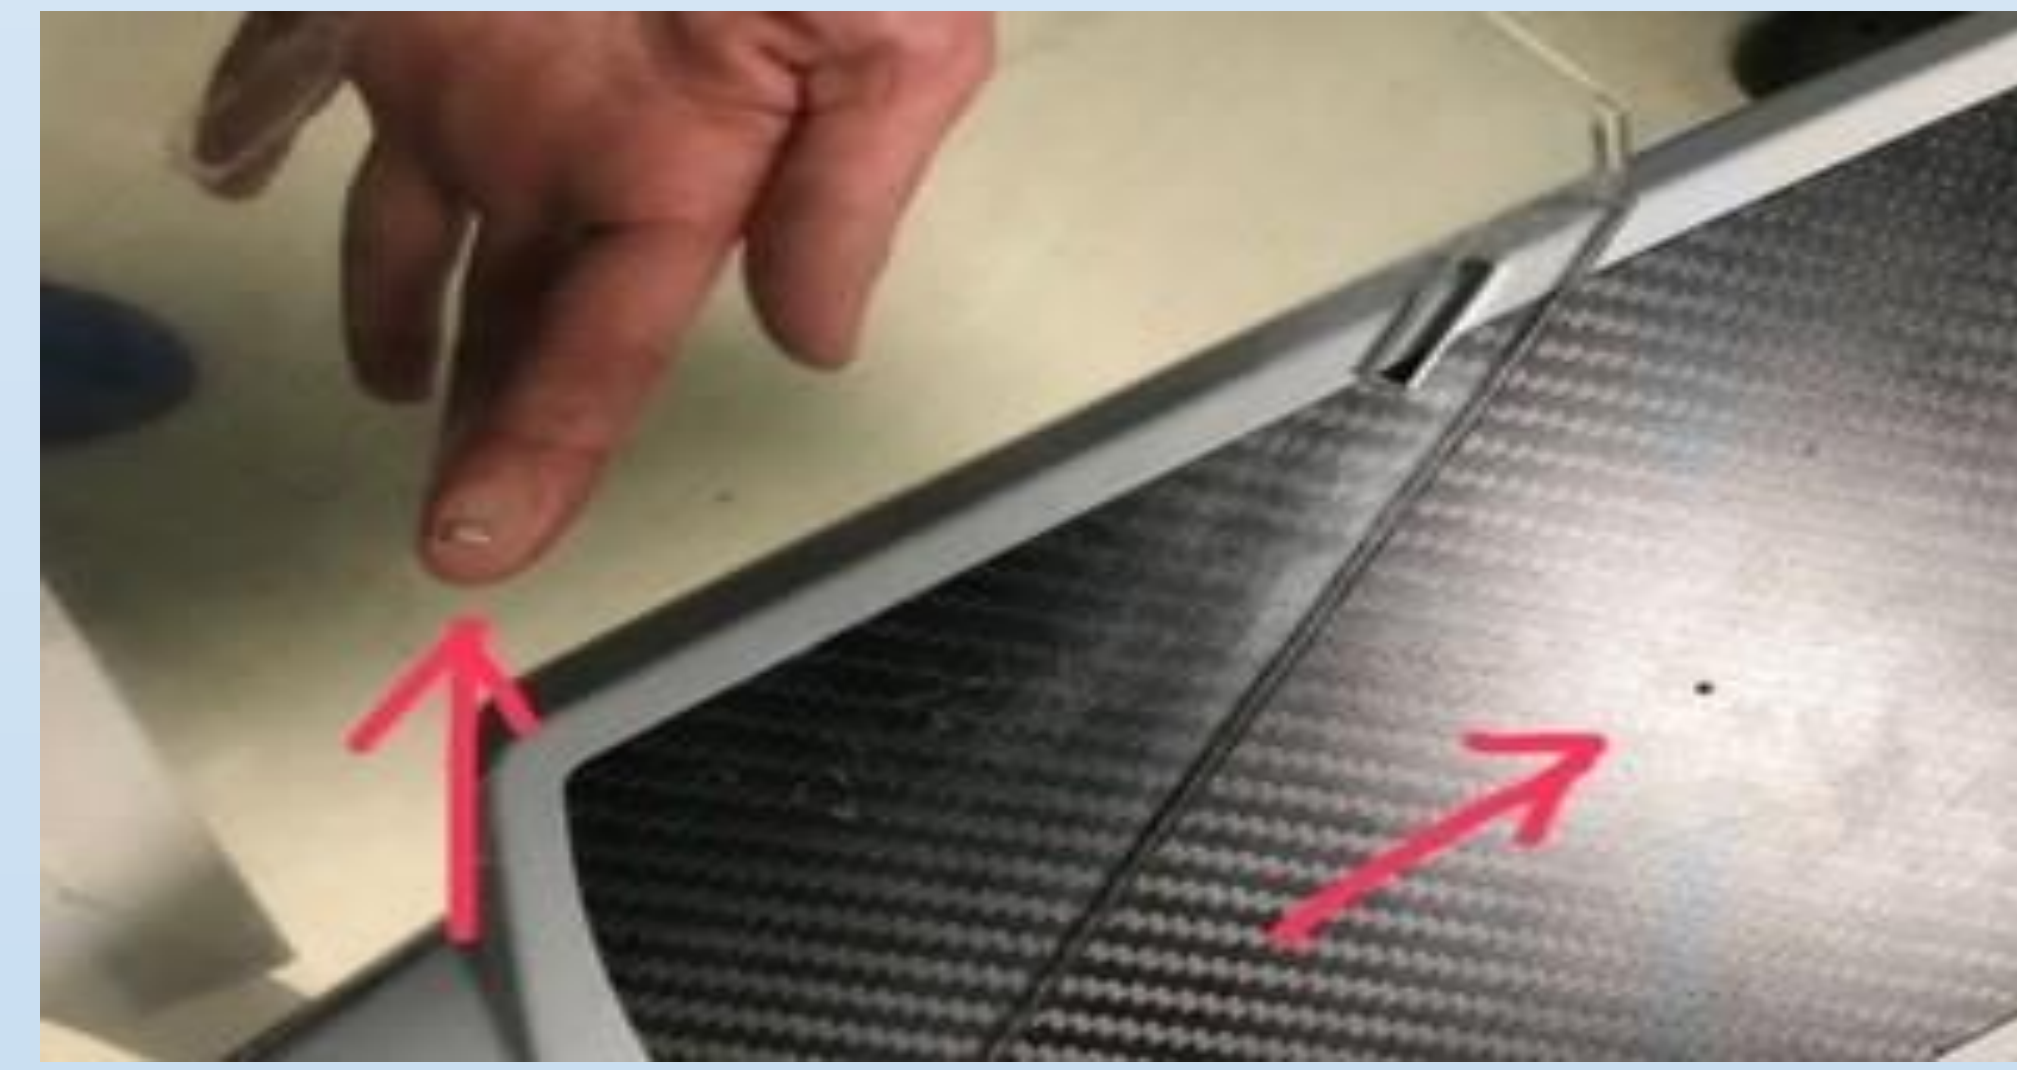
Holes on Mini C-arm detector and cover

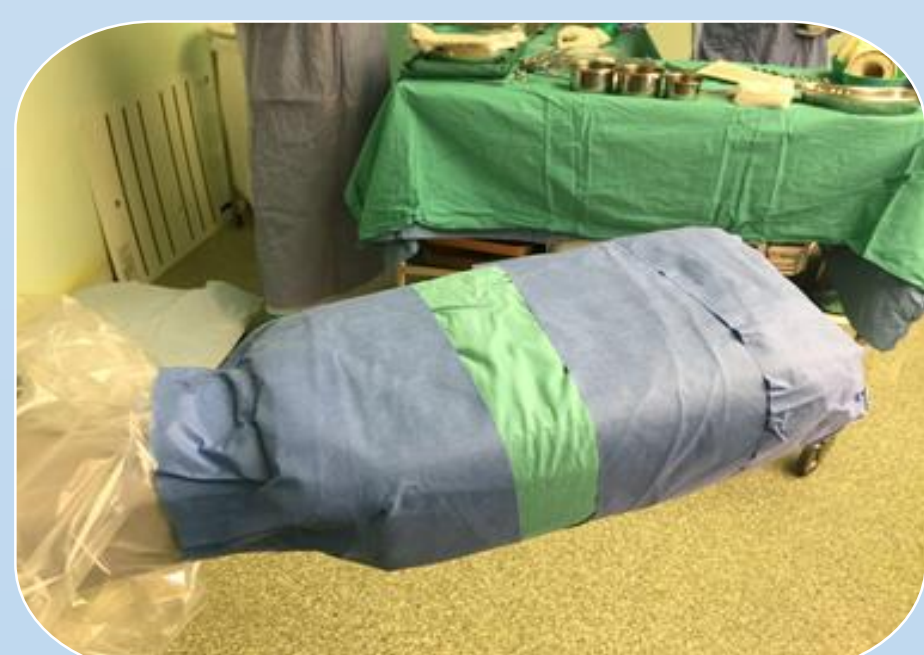
Using stack of linen to protect the flat detector

- Time consuming to secure and remove the stack of linen
- Drill/wires are sharp, they still penetrates through linen and causes damages to the detector
- Incident of penetration onto the flat detector (machine breakdown)

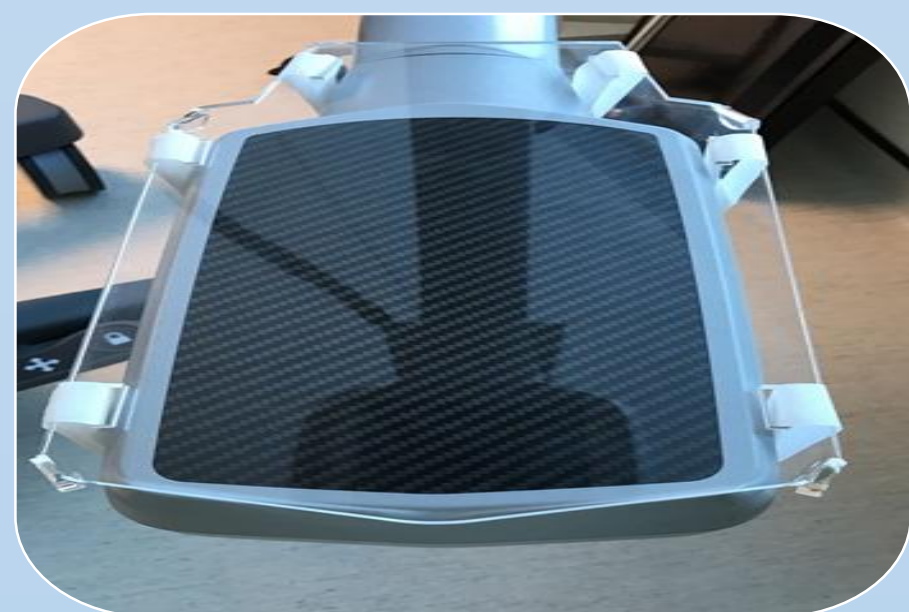
Custom made a single layer acrylic plastic protector

- More durable compared to stack of linen
- Likely chances of penetration onto the machine when not cautious (6 puncture holes found on the acrylic protector)

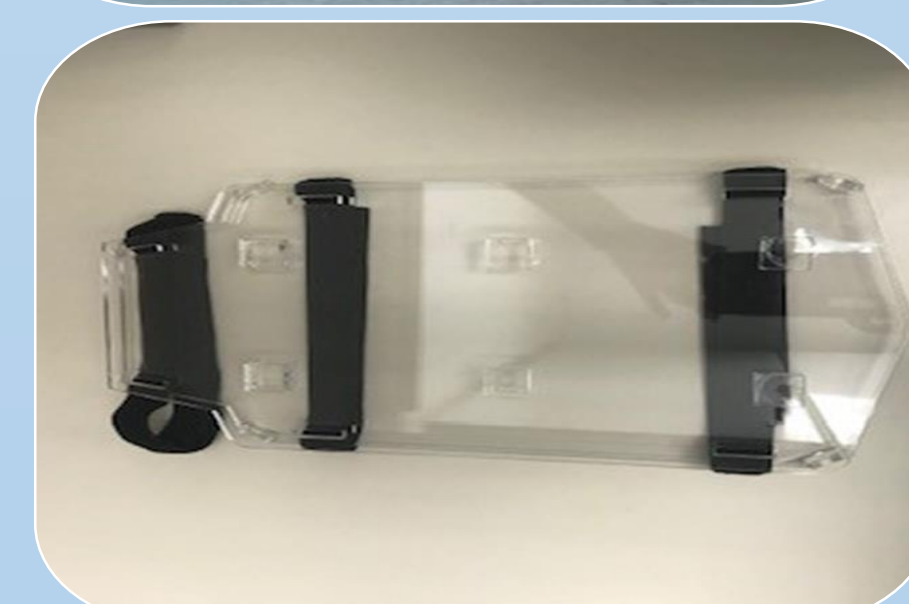
Custom made double layer acrylic plastic protector

- Double protections
- Eliminate chances of penetration onto the mini c-arm
- Removable for cleaning and maintenance of the machine
- Washable and safe to use disinfectant for infection control purpose

The idea of double layer acrylic protector was originated from the concept of dual cortex of the bone structure. The team brainstormed to customize protector for the mini c-arm. The design of the protector was enhanced through the PDSA cycle.
