Redesign of Patient Operation Gown

Singapore Healthcare Management 2023

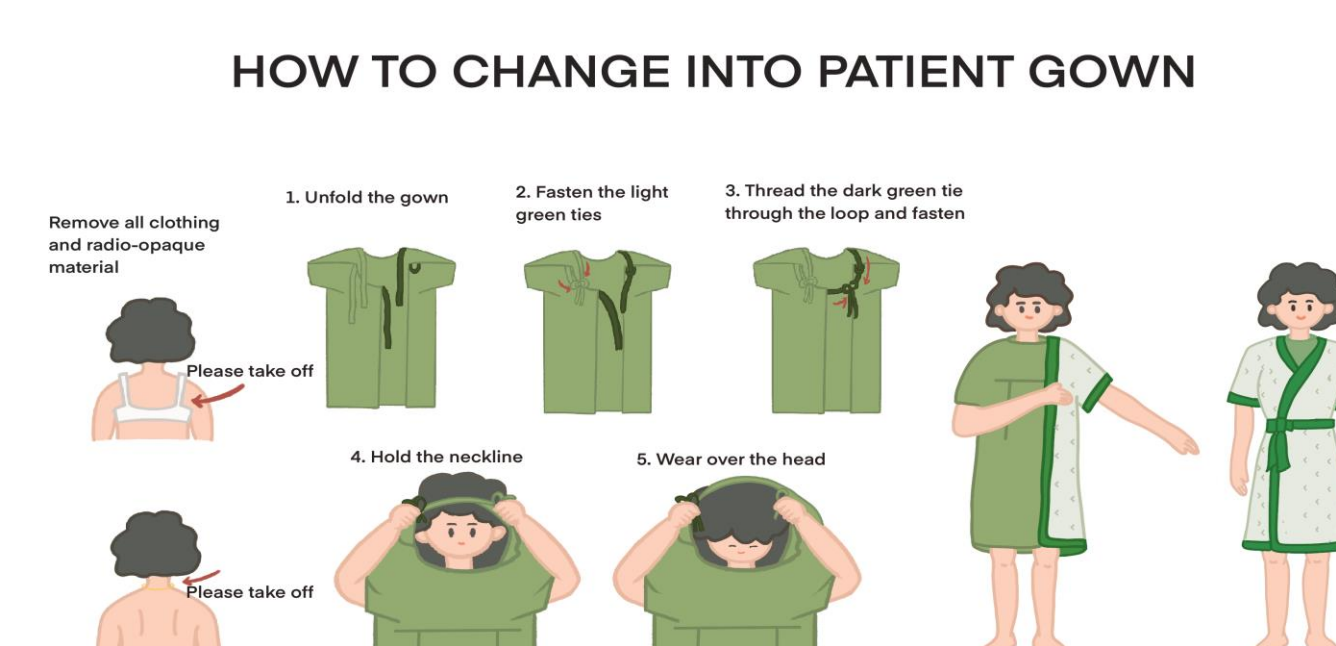
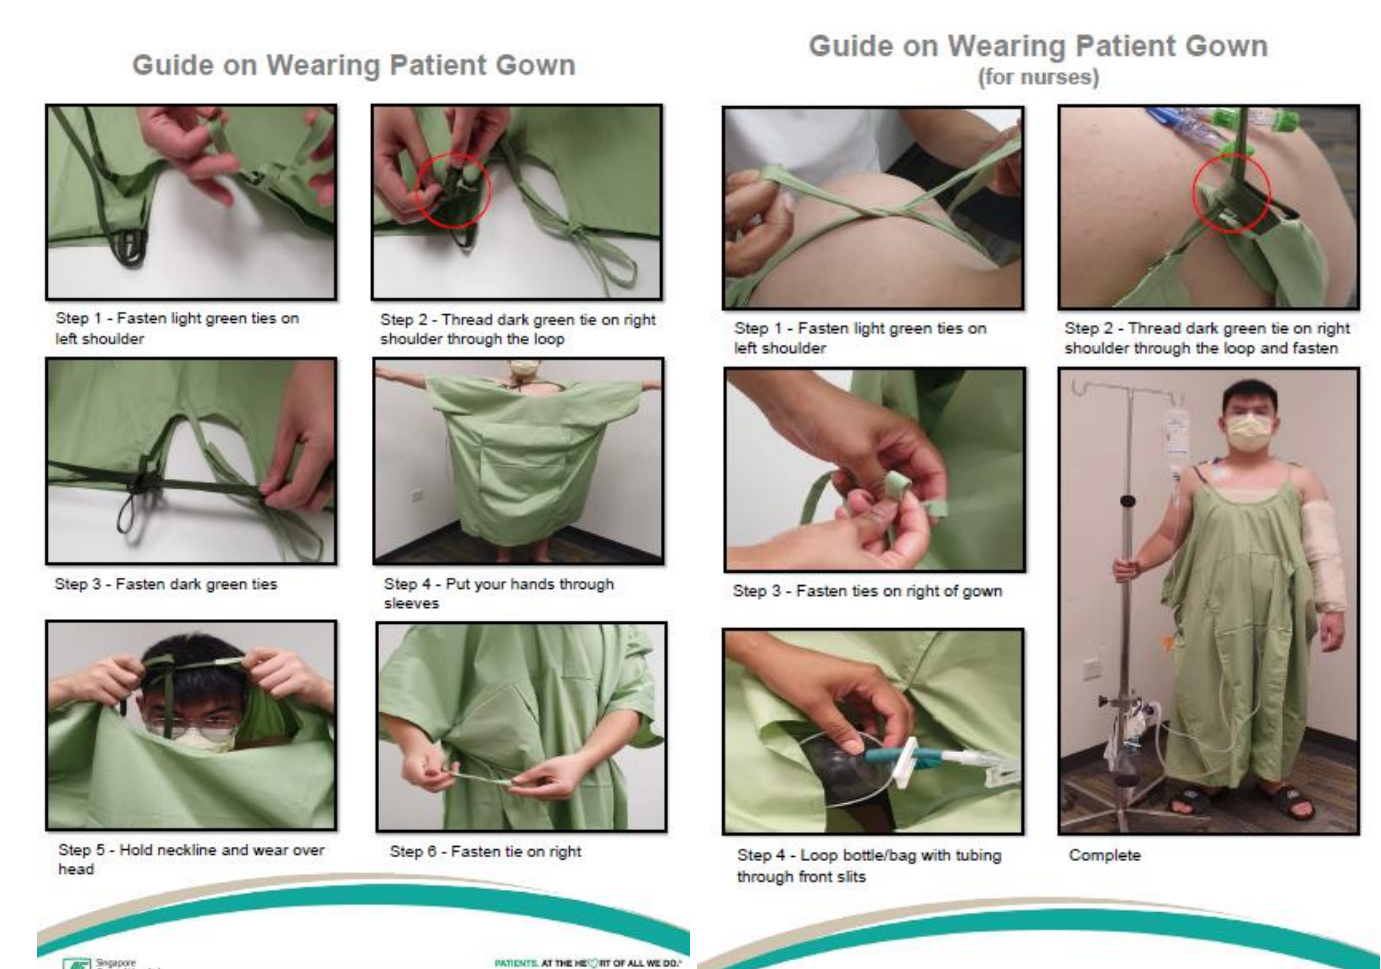
1. Posters and videos to guide nurses on how to put on the new patient gown (right picture) are easily accessible to relevant staff on various platforms.
2. Posters to also guide patients on how to put on the new gown are available and displayed in patient changing room at outpatient setting areas.
